**Management
Asbestos Survey
Report**

**Moreton in Marsh Area Centre
High Street
Moreton in Marsh
GL56 0AX**

**Cotswold District Council
Council Offices
Trinity Road
Cirencester
GL7 1PX**

Ledbury Surveys Ltd

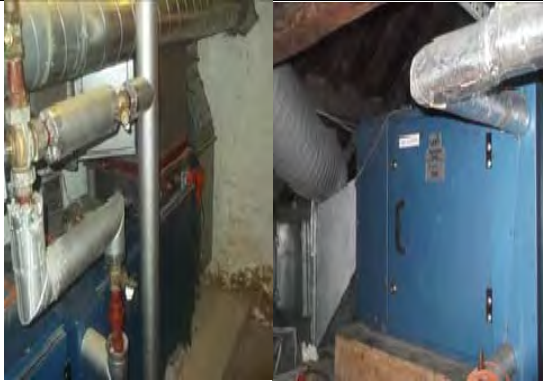
Worksheet Number	1

Floor/Room	Throughout					
Room /Area	Throughout					
Description	Gaskets, Ropes and Seals to Plant					
Sample No	Presumed					
Asbestos Type	Chrysotile					
Lab Reference	-					
Date of Next Inspection	8th September 2015					
Priority Risk Assessment						
Normal occupant activity/ Likelihood of disturbance						
Normal occupant activity	0 1 2 3	Rare disturbance Low disturbance activities Periodic disturbance High levels of disturbance)	Accessibility	0 1 2 3	Usually inaccessible or unlikely to be disturbed Occasionally likely to be disturbed Easily disturbed Routinely disturbed	0 1
Likelihood of disturbance	0 1 2 3	Outdoors Large rooms or well ventilated areas Rooms up to 10m ² Confined spaces	Extent/ Amount	0 1 2 3	Small amounts or items (e.g. strings gaskets) Less than 10m ² or 10lin/m pipe run Between 10m ² & 50m ² or 10lin/m or 50 lin/m pipe run More than 50m ² or 50lin/m of pipe run	1 2 3

Management Score						
MRA + PRA	SCORE		For management purposes a RISK RATING (MRA + PRA) of less than 9 presents a VERY LOW RISK, between 10 and 13 a LOW RISK and from 14 to 17 a MEDIUM RISK 18 + HIGH RISK			
4+ 2	6 Very Low					
Recommendations:	Label and monitor in accordance with CAR 2012

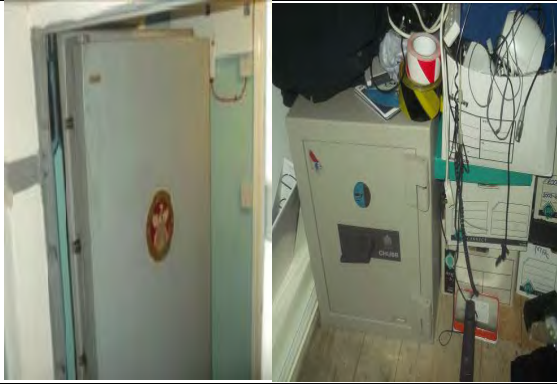
Worksheet Number	2

Floor/Room	Ground					
Room /Area	Strong Room and Cupboard Under Stairs					
Description	Insulation Board Laminate to Safes					
Sample No	Presumed					
Asbestos Type	Crocidolite					
Lab Reference	-					
Date of Next Inspection	8 th September 2015					
Priority Risk Assessment						
Normal occupant activity/ Likelihood of disturbance						
Normal occupant activity	0 1 2 3	Rare disturbance Low disturbance activities Periodic disturbance High levels of disturbance)	Accessibility	0 1 2 3	Usually inaccessible or unlikely to be disturbed Occasionally likely to be disturbed Easily disturbed Routinely disturbed	0 1
Likelihood of disturbance	0 1 2 3	Outdoors Large rooms or well ventilated areas Rooms up to 10m ² Confined spaces	Extent/ Amount	0 1 2 3	Small amounts or items (e.g. strings gaskets) Less than 10m ² or 10lin/m pipe run Between 10m ² & 50m ² or 10lin/m or 50 lin/m pipe run More than 50m ² or 50lin/m of pipe run	1 2 3

Management Score						
MRA + PRA	SCORE		For management purposes a RISK RATING (MRA + PRA) of less than 9 presents a VERY LOW RISK, between 10 and 13 a LOW RISK and from 14 to 17 a MEDIUM RISK 18 + HIGH RISK			
6+ 2	8 Very Low					
Recommendations:	Label and monitor in accordance with CAR 2012

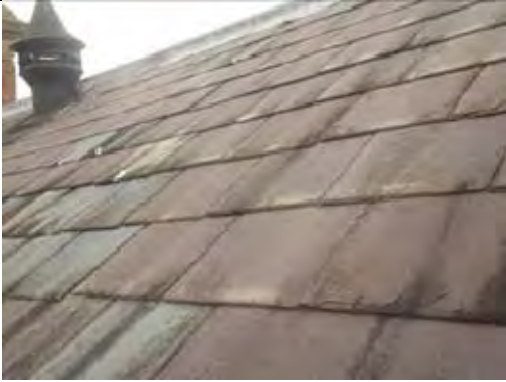
Worksheet Number	3

Floor/Room	Roof						
Room /Area	Roof						
Description	Cement Slates Intermixed with Natural Slates						
Sample No	Strongly Presumed						
Asbestos Type	Chrysotile						
Lab Reference	-						
Date of Next Inspection	8th September 2015						
Priority Risk Assessment							
Normal occupant activity/ Likelihood of disturbance							
Normal occupant activity	0 1 2 3	Rare disturbance Low disturbance activities Periodic disturbance High levels of disturbance)	Accessibility	0 1 2 3	Usually inaccessible or unlikely to be disturbed Occasionally likely to be disturbed Easily disturbed Routinely disturbed	0 1	
Likelihood of disturbance	0 1 2 3	Outdoors Large rooms or well ventilated areas Rooms up to 10m ² Confined spaces	Extent/ Amount	0 1 2 3	Small amounts or items (e.g. strings gaskets) Less than 10m ² or 10lin/m pipe run Between 10m ² & 50m ² or 10lin/m or 50 lin/m pipe run More than 50m ² or 50lin/m of pipe run	0 2 3

Management Score							
MRA + PRA	SCORE		For management purposes a RISK RATING (MRA + PRA) of less than 9 presents a VERY LOW RISK, between 10 and 13 a LOW RISK and from 14 to 17 a MEDIUM RISK 18 + HIGH RISK				
3+ 2	5 Very Low						
Recommendations:	Label and monitor in accordance with CAR 2012

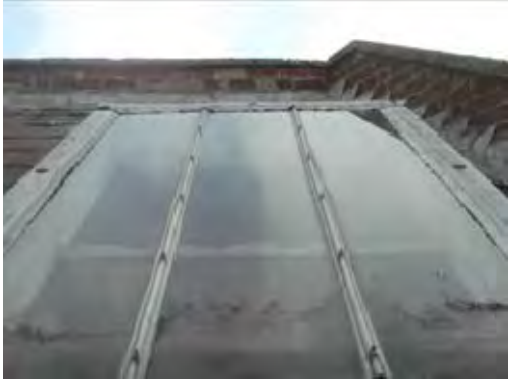
Worksheet Number	4

Floor/Room	Roof					
Room /Area	Roof					
Description	Rope Seals to Roof Lights					
Sample No	Presumed					
Asbestos Type	Chrysotile					
Lab Reference	-					
Date of Next Inspection	8th September 2015					
Priority Risk Assessment						
Normal occupant activity/ Likelihood of disturbance						
Normal occupant activity	0 1 2 3	Rare disturbance Low disturbance activities Periodic disturbance High levels of disturbance)	Accessibility	0 1 2 3	Usually inaccessible or unlikely to be disturbed Occasionally likely to be disturbed Easily disturbed Routinely disturbed	0 1
Likelihood of disturbance	0 1 2 3	Outdoors Large rooms or well ventilated areas Rooms up to 10m ² Confined spaces	Extent/ Amount	0 1 2 3	Small amounts or items (e.g. strings gaskets) Less than 10m ² or 10lin/m pipe run Between 10m ² & 50m ² or 10lin/m or 50 lin/m pipe run More than 50m ² or 50lin/m of pipe run	0 2 3

Management Score						
MRA + PRA	SCORE	For management purposes a RISK RATING (MRA + PRA) of less than 9 presents a VERY LOW RISK, between 10 and 13 a LOW RISK and from 14 to 17 a MEDIUM RISK 18 + HIGH RISK				
4 + 2	6 Very Low					
Recommendations:	Label and monitor in accordance with CAR 2012

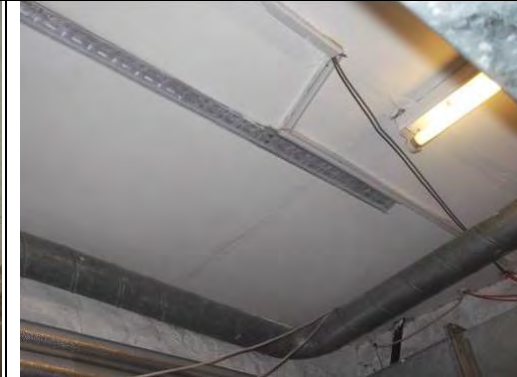
General view of Plant Room. Presumed asbestos gaskets, ropes and seals to plant
Chrysotile

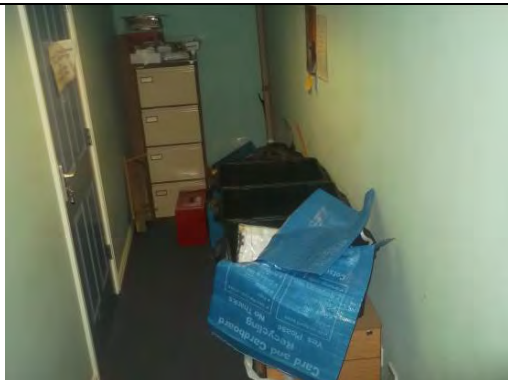
Presumed asbestos insulation board
laminate to safe
Crocidolite

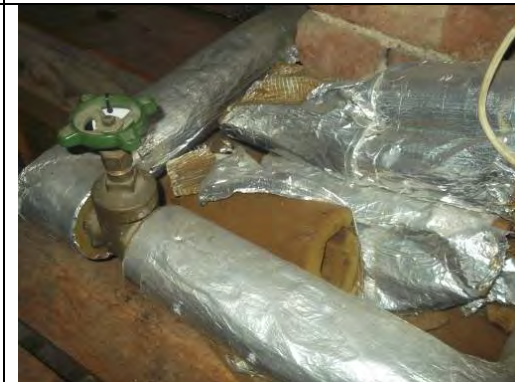
Presumed asbestos gasket, ropes and seals to plant

Chrysotile

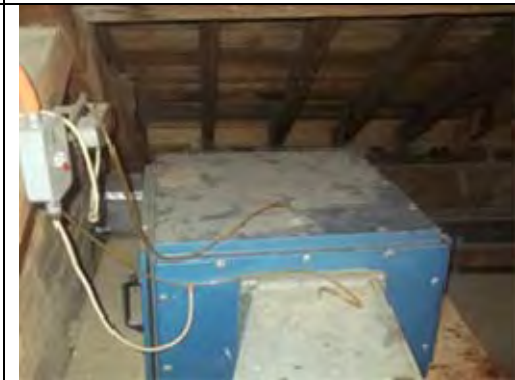
Presumed asbestos gaskets, ropes and seals
to plant
Chrysotile
