**Management  
Asbestos Survey  
Report**

**Cotswold District Council  
Council Offices  
Trinity Road  
Cirencester  
Gloucestershire  
GL7 1PX**

Trinity Road Offices  
Trinity Road  
Cirencester

**On Behalf of Cotswold District Council**

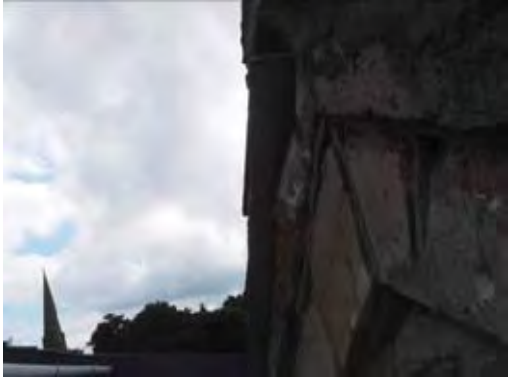
<b>Worksheet Number</b>	1

<b>Floor/Room</b>	Roof				
<b>Room /Area</b>	Roof				
<b>Description</b>	Cement Under Cloaking				
<b>Sample No</b>	CDCOTR/1				
<b>Asbestos Type</b>	Chrysotile				
<b>Lab Reference</b>	SCO/14/28133				
<b>Date of Next Inspection</b>	15 <sup>th</sup> September 2015				
<b>Priority Risk Assessment</b>					
<b>Normal occupant activity/ Likelihood of disturbance</b>					
<b>Normal occupant activity</b>	0 1 2 3	Rare disturbance Low disturbance activities Periodic disturbance High levels of disturbance)	<b>Accessibility</b>	0 1 2 3	Usually inaccessible or unlikely to be disturbed Occasionally likely to be disturbed Easily disturbed Routinely disturbed
<b>Likelihood of disturbance</b>	0 1 2 3	Outdoors Large rooms or well ventilated areas Rooms up to 10m <sup>2</sup> Confined spaces	<b>Extent/ Amount</b>	0 1 2 3	Small amounts or items (e.g. strings gaskets) Less than 10m <sup>2</sup> or 10lin/m pipe run Between 10m <sup>2</sup> & 50m <sup>2</sup> or 10lin/m or 50 lin/m pipe run More than 50m <sup>2</sup> or 50lin/m of pipe run

<b>Management Score</b>					
<b>MRA + PRA</b>	<b>SCORE</b>	For management purposes a RISK RATING (MRA + PRA) of less than 9 presents a VERY LOW RISK, between 10 and 13 a LOW RISK and from 14 to 17 a MEDIUM RISK <b>18 + HIGH RISK</b>			
<b>3+2</b>	<b>5 Very Low</b>				
<b>Recommendations:</b>	Label and monitor in accordance with CAR 2012

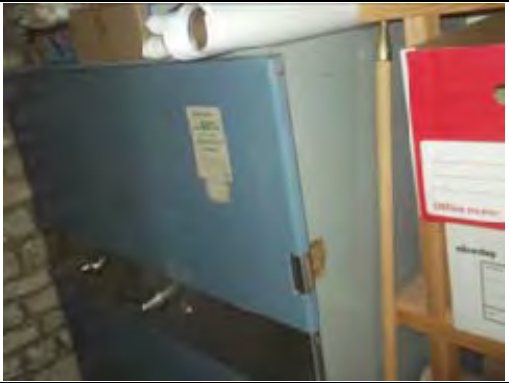
<b>Worksheet Number</b>	<b>2</b>

<b>Floor/Room</b>	<b>Ground</b>				
<b>Room /Area</b>	<b>0.24, 026 0.91, 0.103b</b>				
<b>Description</b>	<b>Insulation Board Steel Laminate Lining to Safes</b>				
<b>Sample No</b>	<b>Presumed</b>				
<b>Asbestos Type</b>	<b>Crocidolite</b>				
<b>Lab Reference</b>	<b>-</b>				
<b>Date of Next Inspection</b>	<b>15<sup>th</sup> September 2015</b>				
<b>Priority Risk Assessment</b>					
<b>Normal occupant activity/ Likelihood of disturbance</b>					
<b>Normal occupant activity</b>	0 1 2 3	Rare disturbance Low disturbance activities Periodic disturbance High levels of disturbance)	<b>Accessibility</b>	0 1 2 3	Usually inaccessible or unlikely to be disturbed Occasionally likely to be disturbed Easily disturbed Routinely disturbed
<b>Likelihood of disturbance</b>	0 1 2 3	Outdoors Large rooms or well ventilated areas Rooms up to 10m <sup>2</sup> Confined spaces	<b>Extent/ Amount</b>	0 1 2 3	Small amounts or items (e.g. strings gaskets) Less than 10m <sup>2</sup> or 10lin/m pipe run Between 10m <sup>2</sup> & 50m <sup>2</sup> or 10lin/m or 50 lin/m pipe run More than 50m <sup>2</sup> or 50lin/m of pipe run

<b>Management Score</b>					
<b>MRA + PRA</b>	<b>SCORE</b>	For management purposes a RISK RATING (MRA + PRA) of less than 9 presents a VERY LOW RISK, between 10 and 13 a LOW RISK and from 14 to 17 a MEDIUM RISK <b>18 + HIGH RISK</b>			
<b>6+ 3</b>	<b>9 Very Low</b>				
<b>Recommendations:</b>	Label and monitor in accordance with CAR 2012

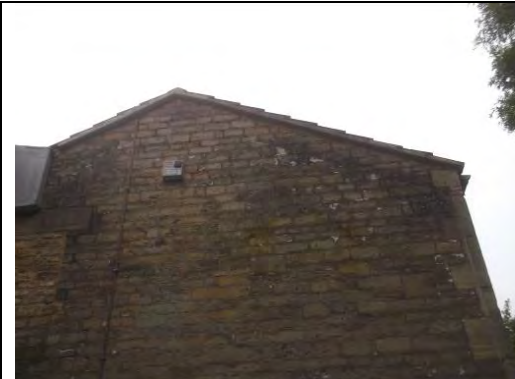
Cement under cladding to roof  
CDCOTR/1  
**Chrysotile**

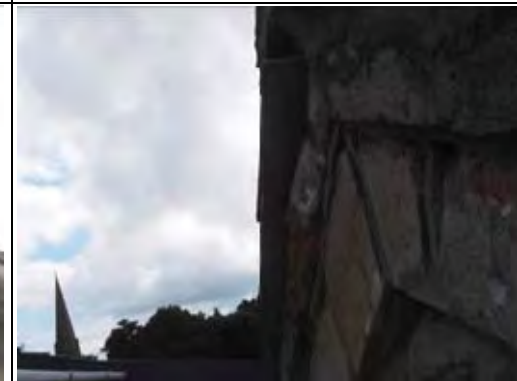
Cement under cloaking to roof  
CDCOTR/1  
**Chrysotile**

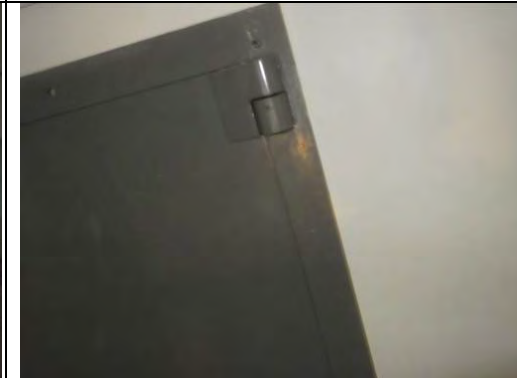
General view of 0.26 Strong Room with Strongly Presumed Asbestos steel laminate fire door  
**Crocidolite**

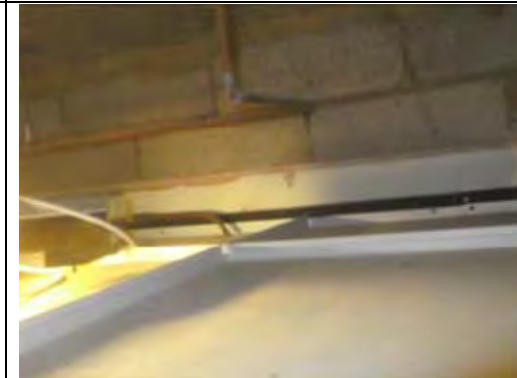
Insulation board ceiling tiles  
CDCOTR/7  
NADIS

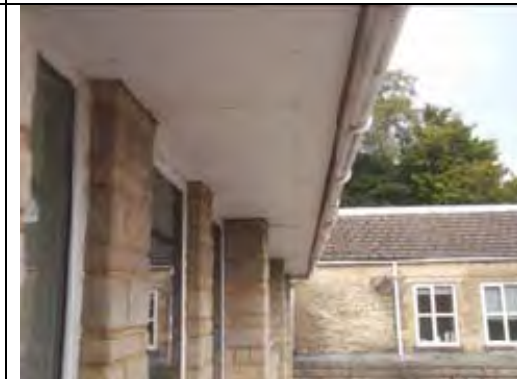
Insulation board soffits  
CDCOTR/9  
NADIS
