Management Asbestos Survey Report

**44 Black Jack Street
Cirencester
GL7 2AA**

**Cotswold District Council
Council Offices
Trinity Road
Cirencester
Gloucestershire
GL7 1PX**

Management Survey

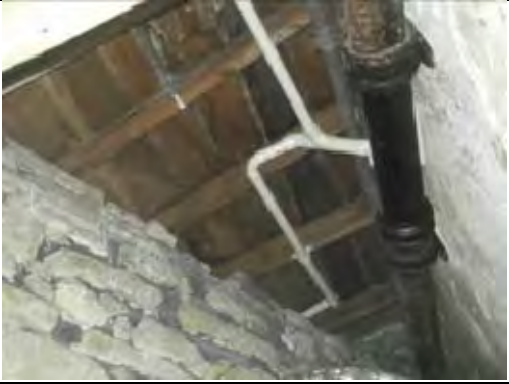
Worksheet Number	1

Floor/Room	Ground						
Room /Area	Cafe Courtyard Cupboard						
Description	Ropes to spigot joints of cast iron pipe						
Sample No	Presumed						
Asbestos Type	Chrysotile						
Lab Reference	-						
Date of Next Inspection	19 th September 2015						
Priority Risk Assessment							
Normal occupant activity/ Likelihood of disturbance							
Normal occupant activity	0 1 2 3	Rare disturbance Low disturbance activities Periodic disturbance High levels of disturbance)	Accessibility	0 1 2 3	Usually inaccessible or unlikely to be disturbed Occasionally likely to be disturbed Easily disturbed Routinely disturbed	0 1	
Likelihood of disturbance	0 1 2 3	Outdoors Large rooms or well ventilated areas Rooms up to 10m ² Confined spaces	Extent/ Amount	0 1 2 3	Small amounts or items (e.g. strings gaskets) Less than 10m ² or 10lin/m pipe run Between 10m ² & 50m ² or 10lin/m or 50 lin/m pipe run More than 50m ² or 50lin/m of pipe run	1 2 3

Extent of damage or deterioration	0 1 2 3	0	Good condition – no visible damage Low damage – a few scratches or surface marks; broken edges on boards, tiles etc. Medium damage: significant breakage of materials or several small areas where material has been damaged revealing loose asbestos fibres. High damage or delamination of materials, sprays and thermal insulation, Visible debris.				
Surface treatment	0 1 2 3	1	Composite materials containing asbestos, reinforced plastics, plasters, resins, vinyl tiles Enclosed sprays and lagging, AIB with exposed face painted or encapsulated) AC sheets Unsealed AIB, or encapsulated lagging sprays Unsealed sprays/ lagging/ textile				
Asbestos type	1 2 3	1	Chrysotile Amphibole asbestos excluding crocidolite Crocidolite				
Total MRA Score	4		Materials with assessment scores of 10 and more are regarded as having a high potential to release fibres if disturbed. Scores of between 7 & 9 have a medium potential and between 5 & 6 low potential. Scores of 4 or less have a very low potential Material risk assessment scores are in RED

Management Score							
MRA + PRA	SCORE		For management purposes a RISK RATING (MRA + PRA) of less than 9 presents a VERY LOW RISK, between 10 and 13 a LOW RISK and from 14 to 17 a MEDIUM RISK 18 + HIGH RISK				
4+ 3	7 Very Low						
Recommendations:	Label and monitor in accordance with CAR 2012

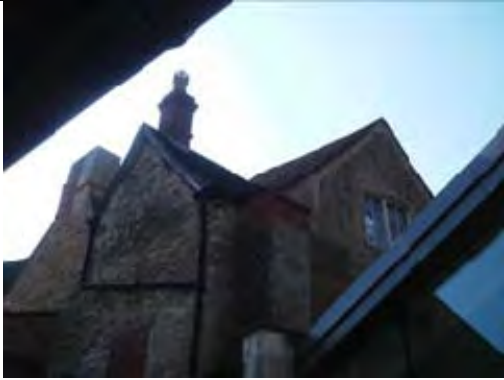
Worksheet Number	2

Floor/Room	Roof						
Room /Area	Roof						
Description	Cement Under Cloaking						
Sample No	Strongly Presumed						
Asbestos Type	Chrysotile						
Lab Reference	-						
Date of Next Inspection	19 th September 2015						
Priority Risk Assessment							
Normal occupant activity/ Likelihood of disturbance							
Normal occupant activity	0 1 2 3	Rare disturbance Low disturbance activities Periodic disturbance High levels of disturbance)	Accessibility	0 1 2 3	Usually inaccessible or unlikely to be disturbed Occasionally likely to be disturbed Easily disturbed Routinely disturbed	0 1	
Likelihood of disturbance	0 1 2 3	Outdoors Large rooms or well ventilated areas Rooms up to 10m ² Confined spaces	Extent/ Amount	0 1 2 3	Small amounts or items (e.g. strings gaskets) Less than 10m ² or 10lin/m pipe run Between 10m ² & 50m ² or 10lin/m or 50 lin/m pipe run More than 50m ² or 50lin/m of pipe run	1 2 3

Extent of damage or deterioration	0 1 2 3	0	Good condition – no visible damage Low damage – a few scratches or surface marks; broken edges on boards, tiles etc. Medium damage; significant breakage of materials or several small areas where material has been damaged revealing loose asbestos fibres. High damage or delamination of materials, sprays and thermal insulation, Visible debris.				
Surface treatment	0 1 2 3	1	Composite materials containing asbestos, reinforced plastics, plasters, resins, vinyl tiles Enclosed sprays and lagging, AIB with exposed face painted or encapsulated) AC sheets Unsealed AIB, or encapsulated lagging sprays Unsealed sprays/ lagging/ textile				
Asbestos type	1 2 3	1	Chrysotile Amphibole asbestos excluding crocidolite Crocidolite				
Total MRA Score	3	3	Materials with assessment scores of 10 and more are regarded as having a high potential to release fibres if disturbed. Scores of between 7 & 9 have a medium potential and between 5 & 6 low potential. Scores of 4 or less have a very low potential Material risk assessment scores are in RED

Management Score							
MRA + PRA	SCORE	For management purposes a RISK RATING (MRA + PRA) of less than 9 presents a VERY LOW RISK, between 10 and 13 a LOW RISK and from 14 to 17 a MEDIUM RISK 18 + HIGH RISK					
3+2	5 Very Low						
Recommendations:	Label and monitor in accordance with CAR 2012

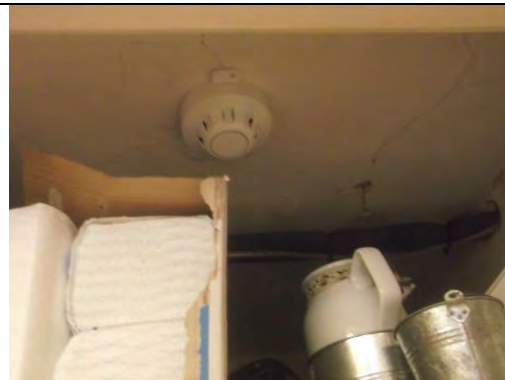
Insulation board boxing
BJC/1
NADIS

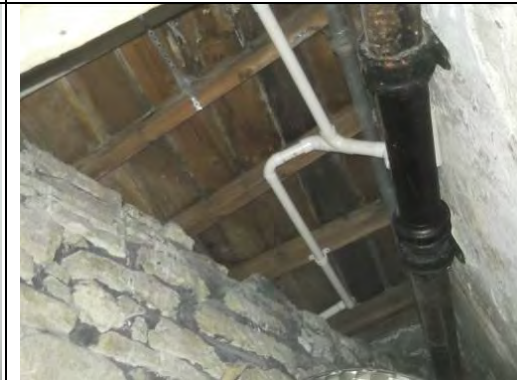
The cast iron pipe within the Café Courtyard is Presumed to have asbestos rope seals to the spigot joints. The WCs were found to have modern non ACM toilet suites. The insulation board boxing within the Ladies WC was found to be proven non ACM. The Stairwell to the First Floor was found to have modern non ACM stair nosings, painted plastered walls and a painted plastered ceiling. The Basement was found to have modern non ACM electrics.

Presumed asbestos rope seals to spigot joints of cast iron pipes

Chrysotile

It is recommended that the presumed items are labelled and monitored in accordance with CAR 2012

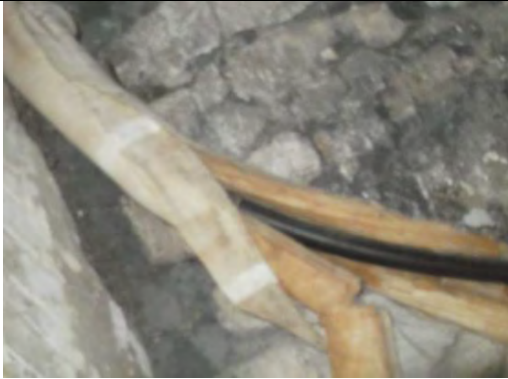
MMMF insulation. Non ACM
