## **Management Asbestos Survey Report**

**Abberley House  
Park Street  
Cirencester  
GL7 2BX**

**Cotswold District Council  
Council Offices  
Trinity Road  
Cirencester  
GL7 1PX**

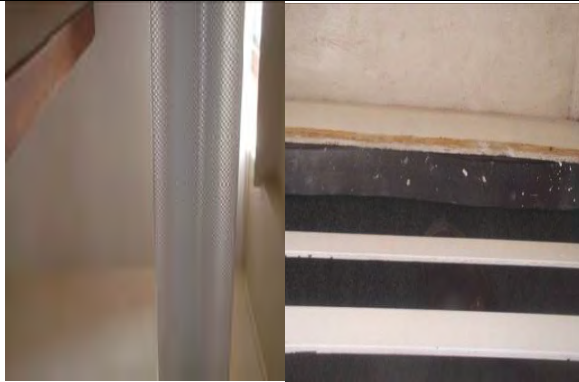
<b>Worksheet Number</b>	1

<b>Floor/Room</b>	Ground					
<b>Room /Area</b>	Stairwell					
<b>Description</b>	Insulation Board					
<b>Sample No</b>	AHC/1					
<b>Asbestos Type</b>	Amosite/ Chrysotile					
<b>Lab Reference</b>	SCO-14-27-420					
<b>Date of Next Inspection</b>	9th September 2015					
<b>Priority Risk Assessment</b>						
<b>Normal occupant activity/ Likelihood of disturbance</b>						
<b>Normal occupant activity</b>	0 1 2 3	Rare disturbance Low disturbance activities Periodic disturbance High levels of disturbance)	Accessibility 0 1 2 3			
<b>Main type of activity in area</b>						
<b>Likelihood of disturbance</b>	0 1 2 3	Outdoors Large rooms or well ventilated areas Rooms up to 10m <sup>2</sup> Confined spaces	Extent/ Amount 0 1 2 3			
<b>Location</b>						
<b>Human exposure potential</b>		<b>Maintenance activity</b>				
<b>Number of occupants</b>	0 1 2 3	0 1 2 3	None 1 – 3 persons 4 – 10 persons Greater than 10 persons	Type of maintenance activity 0 1 2 3	0 1 2 3	Minor disturbance (e.g. possibility of contact when gaining access) Low disturbance (e.g. changing light bulb in AIB ceiling) Medium disturbance (e.g. lifting one/two AIB tiles to replace a valve or to re-cable) High levels of disturbance (e.g. removing several AIB tiles to replace valve/cabling)

It is recommended that the asbestos insulation board to the Stairwell has any exposed faces and edges encapsulated / sealed in the Short Term in the Medium to Long Term the material should be removed.

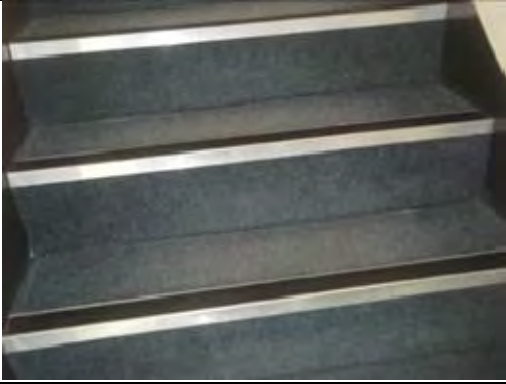
<b>Worksheet Number</b>	2

<b>Floor/Room</b>	Ground					
<b>Room /Area</b>	Stairwell					
<b>Description</b>	Stair Nosings					
<b>Sample No</b>	AHC/1					
<b>Asbestos Type</b>	Chrysotile					
<b>Lab Reference</b>	SCO-14-27-420					
<b>Date of Next Inspection</b>	9 <sup>th</sup> September 2015					
<b>Priority Risk Assessment</b>						
<b>Normal occupant activity/ Likelihood of disturbance</b>						
<b>Normal occupant activity</b>	0 1 2 3	Rare disturbance Low disturbance activities Periodic disturbance High levels of disturbance)	<b>Accessibility</b>	0 1 2 3	Usually inaccessible or unlikely to be disturbed Occasionally likely to be disturbed Easily disturbed Routinely disturbed	0 1
<b>Likelihood of disturbance</b>	0 1 2 3	Outdoors Large rooms or well ventilated areas Rooms up to 10m <sup>2</sup> Confined spaces	<b>Extent/ Amount</b>	0 1 2 3	Small amounts or items (e.g. strings gaskets) Less than 10m <sup>2</sup> or 10lin/m pipe run Between 10m <sup>2</sup> & 50m <sup>2</sup> or 10lin/m or 50 lin/m pipe run More than 50m <sup>2</sup> or 50lin/m of pipe run	1 2 3

<b>Management Score</b>						
<b>MRA + PRA</b>	<b>SCORE</b>	For management purposes a RISK RATING (MRA + PRA) of less than 9 presents a VERY LOW RISK, between 10 and 13 a LOW RISK and from 14 to 17 a MEDIUM RISK <b>18 + HIGH RISK</b>				
<b>2 + 5</b>	<b>7 Very Low</b>					
<b>Recommendations:</b>	Label and monitor in accordance with CAR 2012

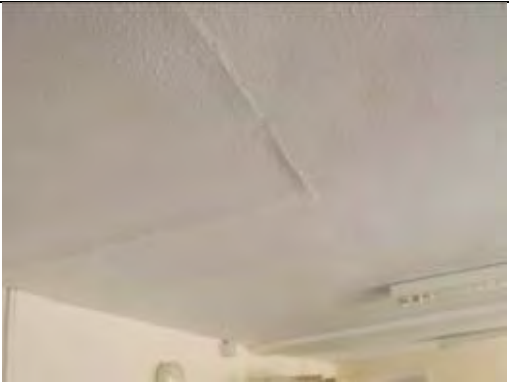
<b>Worksheet Number</b>	<b>3</b>

<b>Floor/Room</b>	<b>First Floor and Second Floor</b>					
<b>Room /Area</b>	<b>Office 3 and 8</b>					
<b>Description</b>	<b>Textured Coating</b>					
<b>Sample No</b>	<b>AHC/3 &amp; 10</b>					
<b>Asbestos Type</b>	<b>Chrysotile</b>					
<b>Lab Reference</b>	<b>SCO-14-27-420</b>					
<b>Date of Next Inspection</b>	<b>9<sup>th</sup> September 2015</b>					
<b>Priority Risk Assessment</b>						
<b>Normal occupant activity/ Likelihood of disturbance</b>						
<b>Normal occupant activity</b>	0 1 2 3	Rare disturbance Low disturbance activities Periodic disturbance High levels of disturbance)	<b>Accessibility</b>	0 1 2 3	Usually inaccessible or unlikely to be disturbed Occasionally likely to be disturbed Easily disturbed Routinely disturbed	0 1
<b>Likelihood of disturbance</b>	0 1 2 3	Outdoors Large rooms or well ventilated areas Rooms up to 10m <sup>2</sup> Confined spaces	<b>Extent/ Amount</b>	0 1 2 3	Small amounts or items (e.g. strings gaskets) Less than 10m <sup>2</sup> or 10lin/m pipe run Between 10m <sup>2</sup> & 50m <sup>2</sup> or 10lin/m or 50 lin/m pipe run More than 50m <sup>2</sup> or 50lin/m of pipe run	2 3

<b>Management Score</b>						
<b>MRA + PRA</b>	<b>SCORE</b>		For management purposes a RISK RATING (MRA + PRA) of less than 9 presents a VERY LOW RISK, between 10 and 13 a LOW RISK and from 14 to 17 a MEDIUM RISK <b>18 + HIGH RISK</b>			
<b>4+ 6</b>	<b>10 Low</b>					
<b>Recommendations:</b>	Label and monitor in accordance with CAR 2012

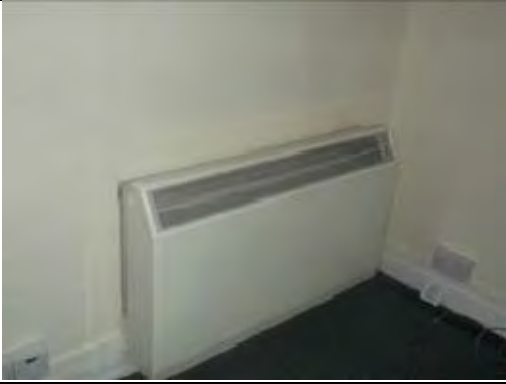
<b>Worksheet Number</b>	4

<b>Floor/Room</b>	First Floor and Second Floor					
<b>Room /Area</b>	Offices					
<b>Description</b>	Insulation Board to Night Storage Heaters					
<b>Sample No</b>	Presumed					
<b>Asbestos Type</b>	Crocidolite					
<b>Lab Reference</b>	-					
<b>Date of Next Inspection</b>	9 <sup>th</sup> September 2015					
<b>Priority Risk Assessment</b>						
<b>Normal occupant activity/ Likelihood of disturbance</b>						
<b>Normal occupant activity</b>	0 1 2 3	Rare disturbance Low disturbance activities Periodic disturbance High levels of disturbance)	<b>Accessibility</b>	0 1 2 3	Usually inaccessible or unlikely to be disturbed Occasionally likely to be disturbed Easily disturbed Routinely disturbed	0   <b>1</b>
<b>Likelihood of disturbance</b>	0 1 2 3	Outdoors Large rooms or well ventilated areas Rooms up to 10m <sup>2</sup> Confined spaces	<b>Extent/ Amount</b>	0 1 2 3	Small amounts or items (e.g. strings gaskets) Less than 10m <sup>2</sup> or 10lin/m pipe run Between 10m <sup>2</sup> & 50m <sup>2</sup> or 10lin/m or 50 lin/m pipe run More than 50m <sup>2</sup> or 50lin/m of pipe run	1 2 3

<b>Management Score</b>						
<b>MRA + PRA</b>	<b>SCORE</b>	For management purposes a RISK RATING (MRA + PRA) of less than 9 presents a VERY LOW RISK, between 10 and 13 a LOW RISK and from 14 to 17 a MEDIUM RISK <b>18 + HIGH RISK</b>				
<b>6+ 5</b>	<b>11 Low</b>					
<b>Recommendations:</b>	Label and monitor in accordance with CAR 2012

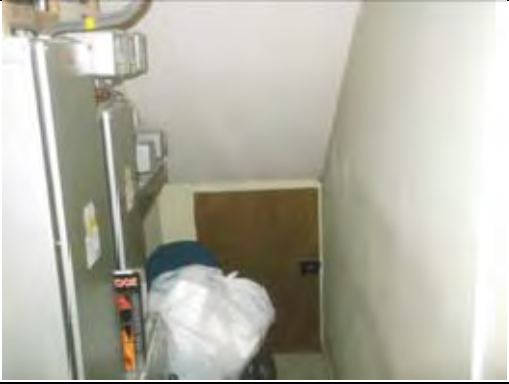
<b>Worksheet Number</b>	<b>5</b>

<b>Floor/Room</b>	<b>First Floor Second Floor and Ground Floor</b>						
<b>Room /Area</b>	<b>Offices</b>						
<b>Description</b>	<b>Flash Guards, Ropes and Seals</b>						
<b>Sample No</b>	<b>Presumed</b>						
<b>Asbestos Type</b>	<b>Chrysotile</b>						
<b>Lab Reference</b>	<b>-</b>						
<b>Date of Next Inspection</b>	<b>9<sup>th</sup> September 2015</b>						
<b>Priority Risk Assessment</b>							
<b>Normal occupant activity/ Likelihood of disturbance</b>							
<b>Normal occupant activity</b>	0 1 2 3	Rare disturbance Low disturbance activities Periodic disturbance High levels of disturbance)	<b>Accessibility</b>	0 1 2 3	Usually inaccessible or unlikely to be disturbed Occasionally likely to be disturbed Easily disturbed Routinely disturbed	0   <b>1</b>	
<b>Likelihood of disturbance</b>	0 1 2 3	Outdoors Large rooms or well ventilated areas Rooms up to 10m <sup>2</sup> Confined spaces	<b>Extent/ Amount</b>	0 1 2 3	Small amounts or items (e.g. strings gaskets) Less than 10m <sup>2</sup> or 10lin/m pipe run Between 10m <sup>2</sup> & 50m <sup>2</sup> or 10lin/m or 50 lin/m pipe run More than 50m <sup>2</sup> or 50lin/m of pipe run	1 2 3

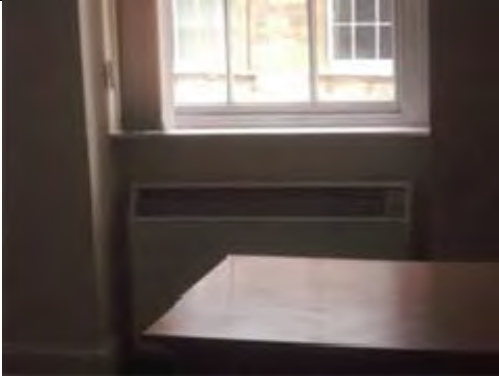
<b>Worksheet Number</b>	<b>6</b>

<b>Floor/Room</b>	<b>First Floor</b>						
<b>Room /Area</b>	<b>Offices 1 and 2</b>						
<b>Description</b>	<b>Insulation Board Presumed to be behind Night Storage Heaters</b>						
<b>Sample No</b>	<b>Presumed</b>						
<b>Asbestos Type</b>	<b>Crocidolite</b>						
<b>Lab Reference</b>	<b>-</b>						
<b>Date of Next Inspection</b>	<b>9th September 2015</b>						
<b>Priority Risk Assessment</b>							
<b>Normal occupant activity/ Likelihood of disturbance</b>							
<b>Normal occupant activity</b>	0 1 2 3	Rare disturbance Low disturbance activities Periodic disturbance High levels of disturbance)	<b>Accessibility</b>	0 1 2 3	Usually inaccessible or unlikely to be disturbed Occasionally likely to be disturbed Easily disturbed Routinely disturbed	0   <b>1</b>	
<b>Likelihood of disturbance</b>	0 1 2 3	Outdoors Large rooms or well ventilated areas Rooms up to 10m <sup>2</sup> Confined spaces	<b>Extent/ Amount</b>	0 1 2 3	Small amounts or items (e.g. strings gaskets) Less than 10m <sup>2</sup> or 10lin/m pipe run Between 10m <sup>2</sup> & 50m <sup>2</sup> or 10lin/m or 50 lin/m pipe run More than 50m <sup>2</sup> or 50lin/m of pipe run	1 2 3

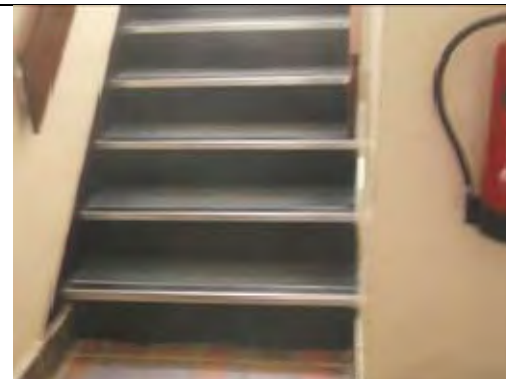
Stair nosings  
AHC/2  
Chrysotile

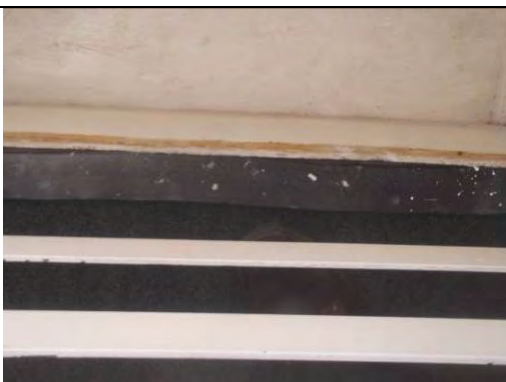
Insulation board to edge of landing floor  
AHC/1  
Amosite/ Chrysotile

It is recommended that the asbestos insulation board to the Stairwell has any exposed faces and edges encapsulated / sealed in the Short Term in the Medium to Long Term the material should be removed.

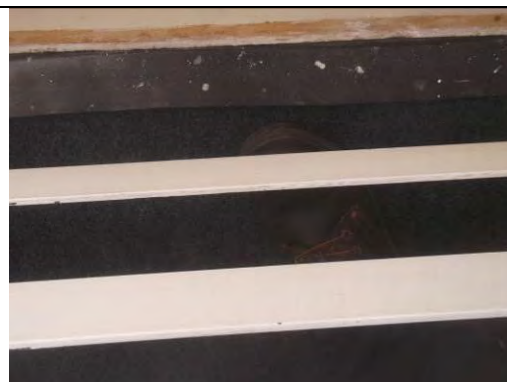
Insulation board  
AHC/1  
Amosite/ Chrysotile

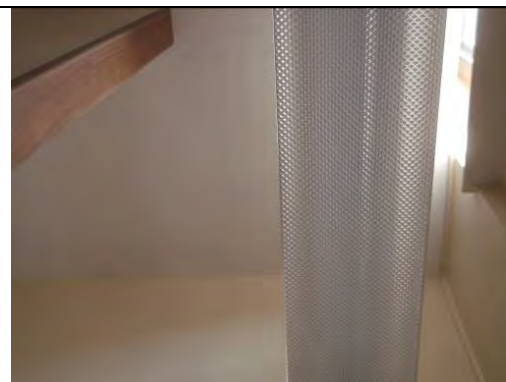
Insulation board to ceiling VS to  
AHC/1  
Amosite/ Chrysotile

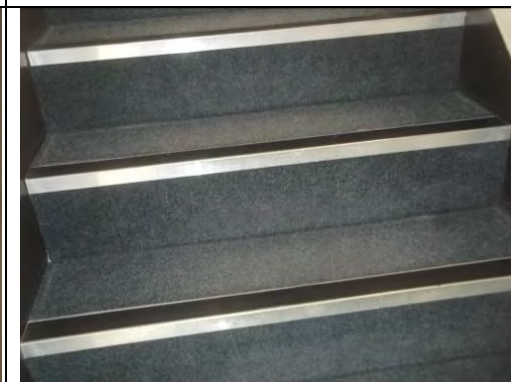
Stair nosings  
AHC/2  
Chrysotile

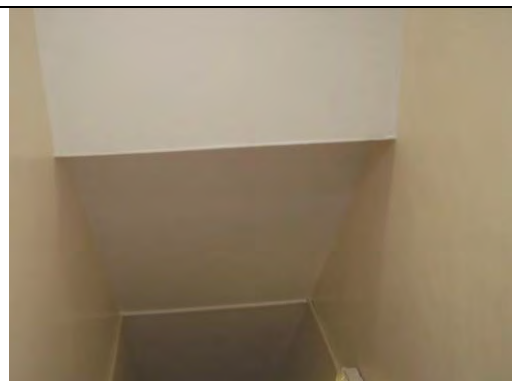
Insulation board  
VS- AHC/1  
Amosite/ Chrysotile

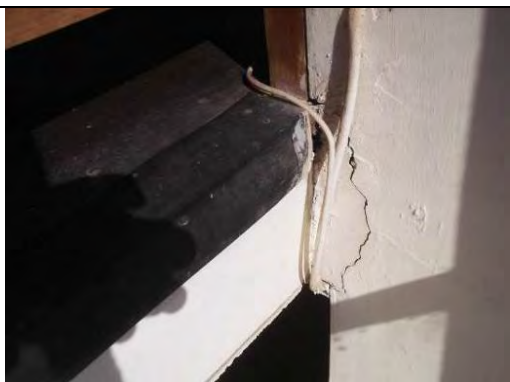
Insulation board  
VS- AHC/1  
Amosite/ Chrysotile

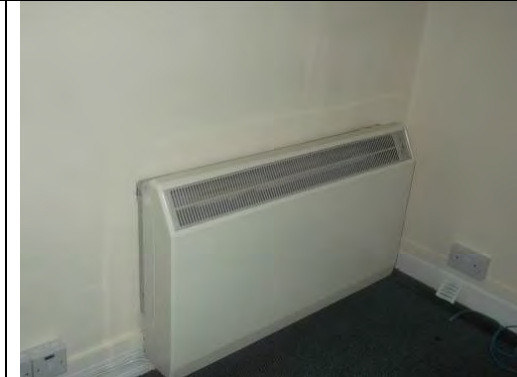
Presumed asbestos insulation board, ropes and seals to heater  
**Crocidolite**

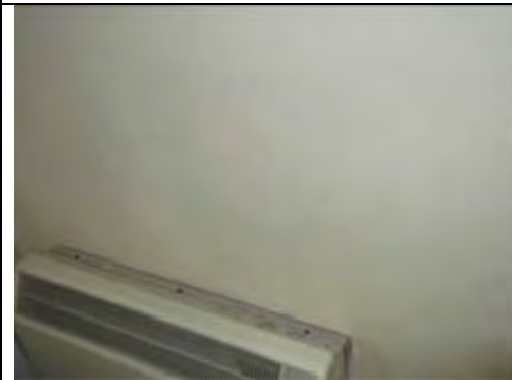
Presumed asbestos insulation board, ropes  
and seals to night storage heater  
Crocdiolite

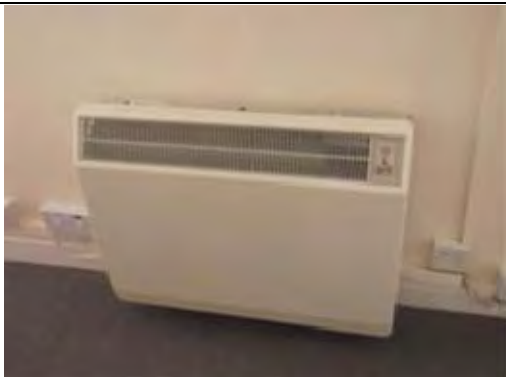
Presumed asbestos insulation board, ropes and seals to heater  
**Crocidolite**

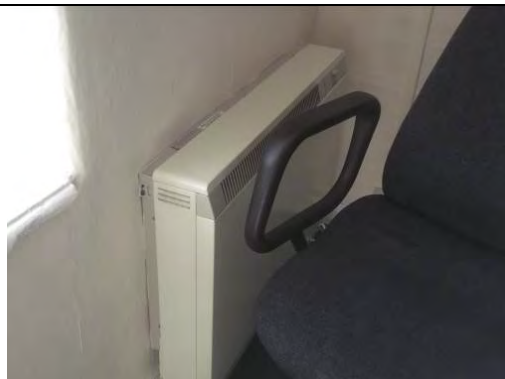
Presumed asbestos insulation board, ropes  
and seals to night storage heater  
**Chrysotile**
