WILD Project

Rivers Management Plan

for Fairford Parish

May 2016

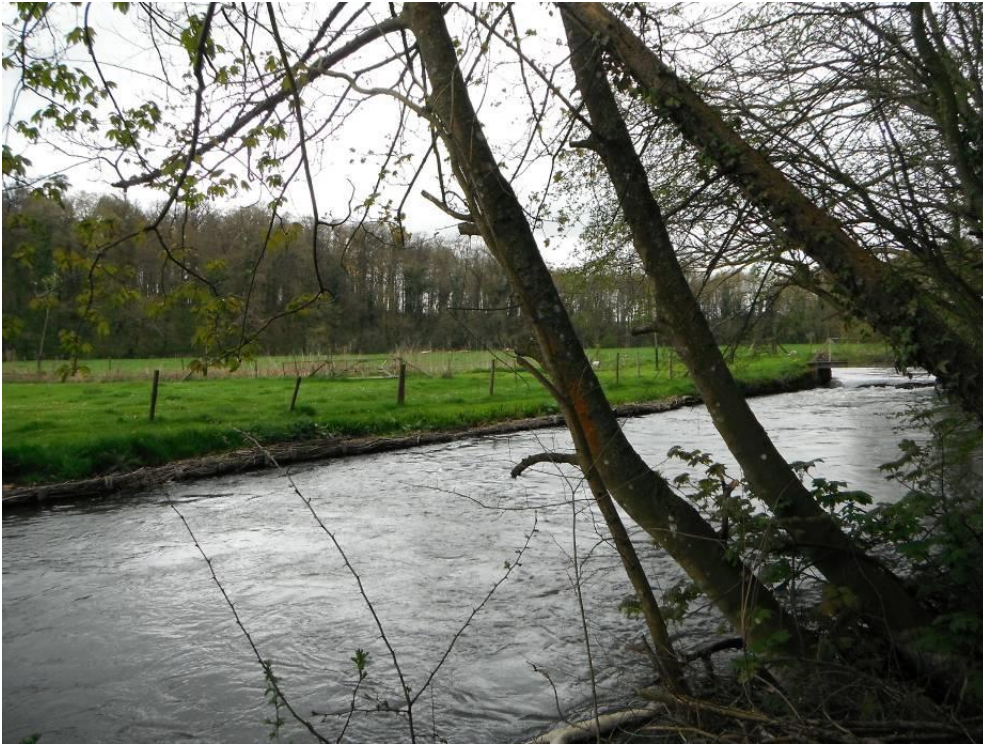
Photo 1 the river at the most upstream end of the Fairford parish is very wide straight and shallow and the adjacent land use is arable

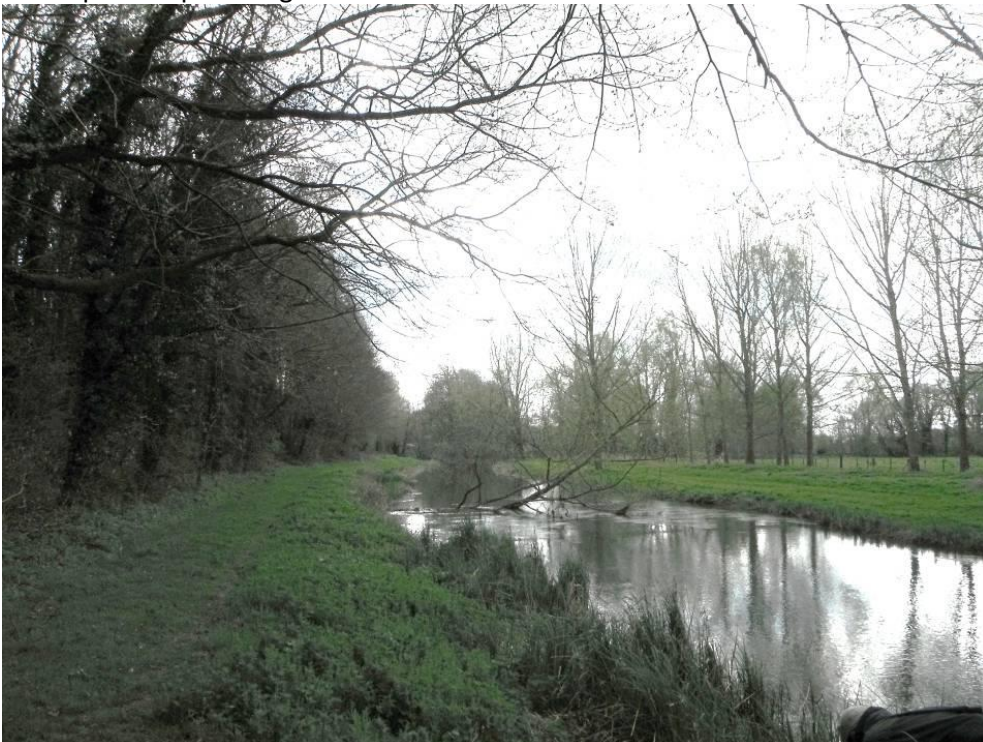
Photo 2 the river is overwide and straight providing a very poor variety of habitats; however there is some Large Woody debris present providing some variation

The Coln is has some good morphological sections in the upstream section of the Fairford Parish however the straighter sections which would benefit from Large Woody Debris deflectors and channel narrowing works. Creating structures such as simple log-berms or flow deflectors to narrow the channel diversify the flow of river currents, scour gravels or adding gravel to create a more diverse river habitat is key to supporting species like native wild Brown Trout. See Appendix 5: WTT Manual Large Woody Debris.

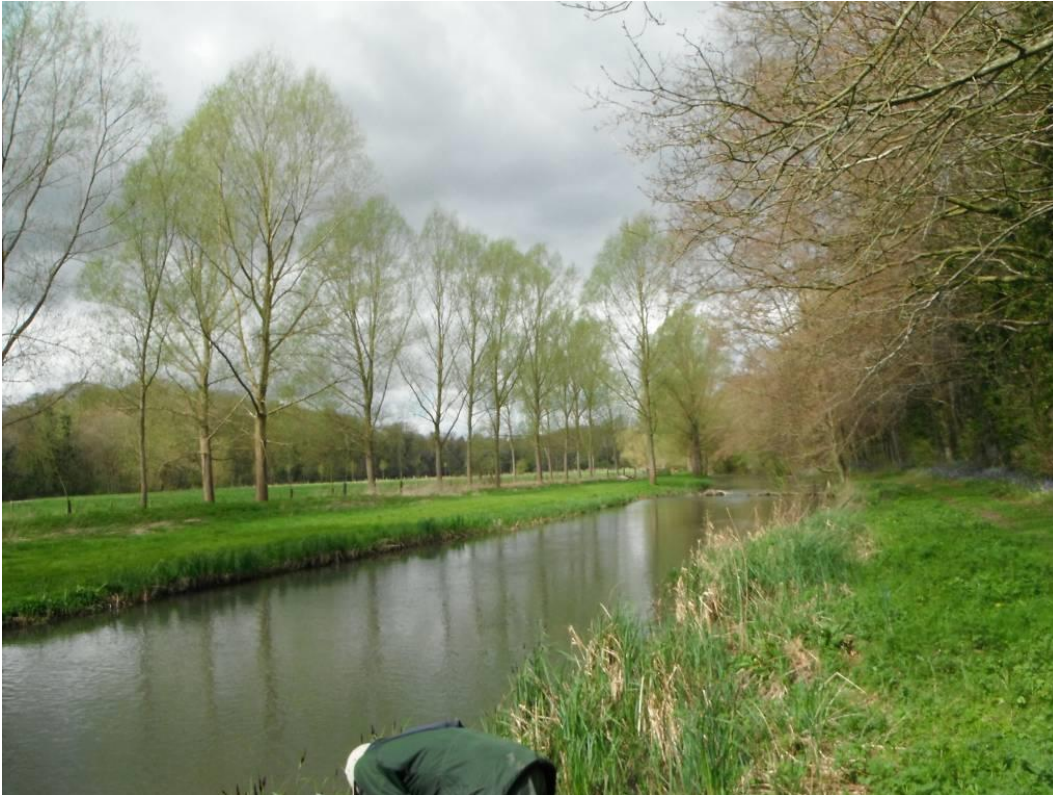
Photo 3 the river is still over wide shallow and straight with no variation in the habitat

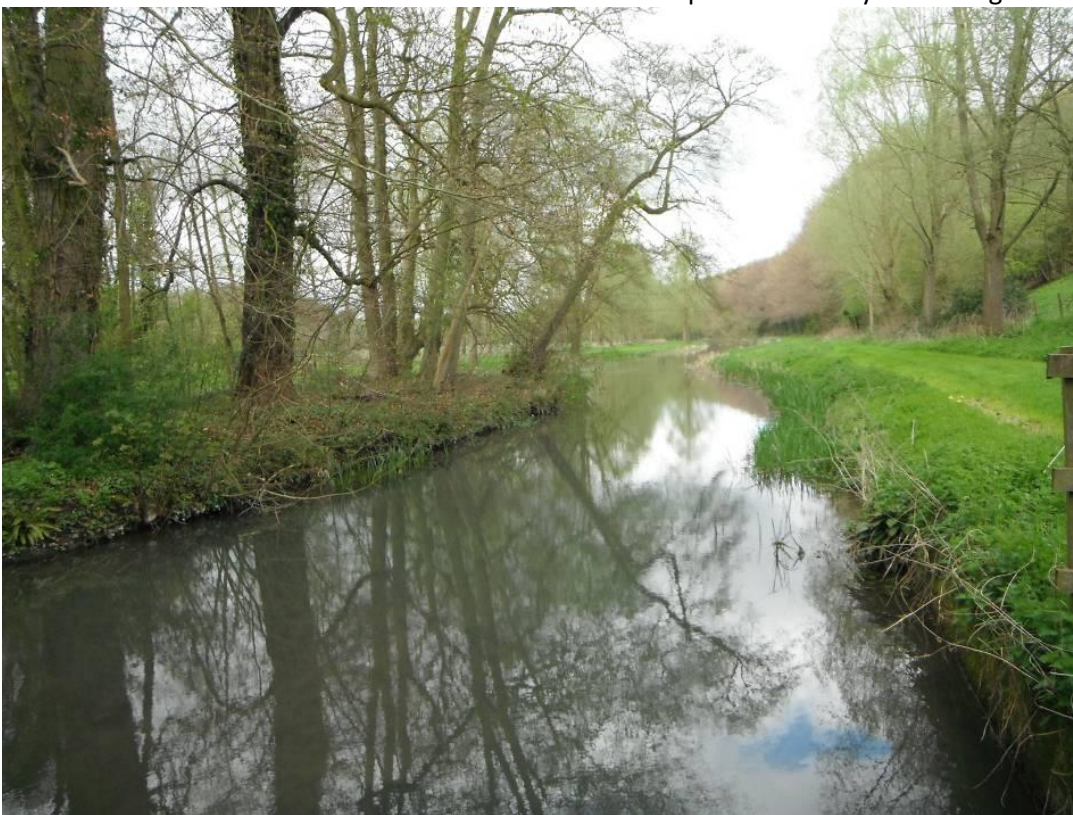
Photo 4 the river here has a island in the middle which improves flows by narrowing the river to two channels

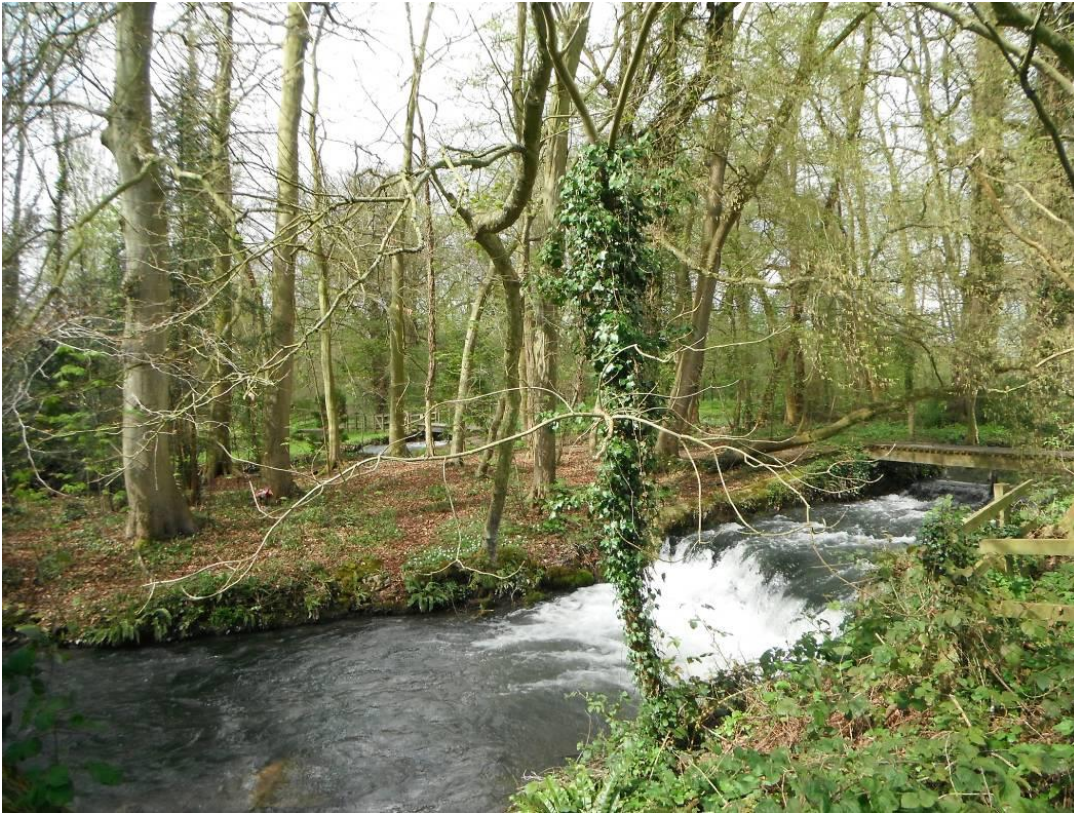
Photo 5 at the downstream end of the island there are two weirs which are obviously one of the many barriers to fish migration along the River Coln

There are three barriers/constraints to fish movements/migration within the parish of Fairford, two at Fairford and one at the top of the Broad Water. Any modification or removal would obviously require a high level of landowner co-operation which may difficult when high levels of fish stocking are routine.

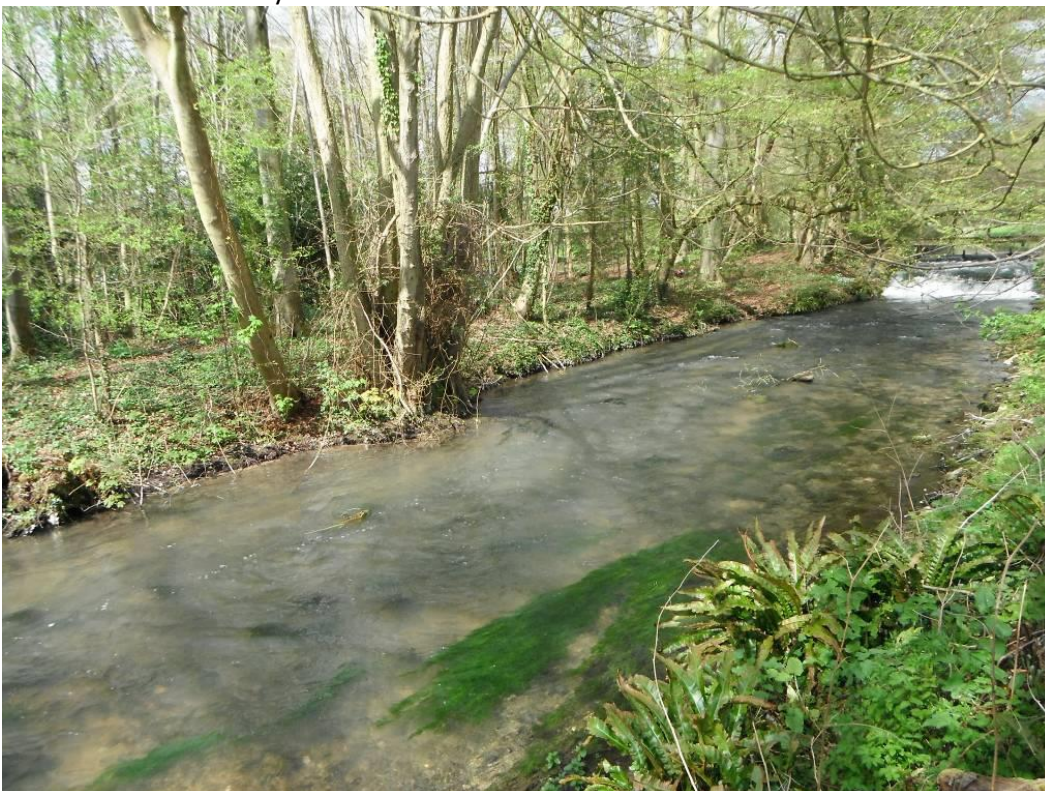
Photo 6 where the island narrows the channel has better flow allowing aquatic plants like *Ranunculus spp.* to grow this however this is the only area it was noted

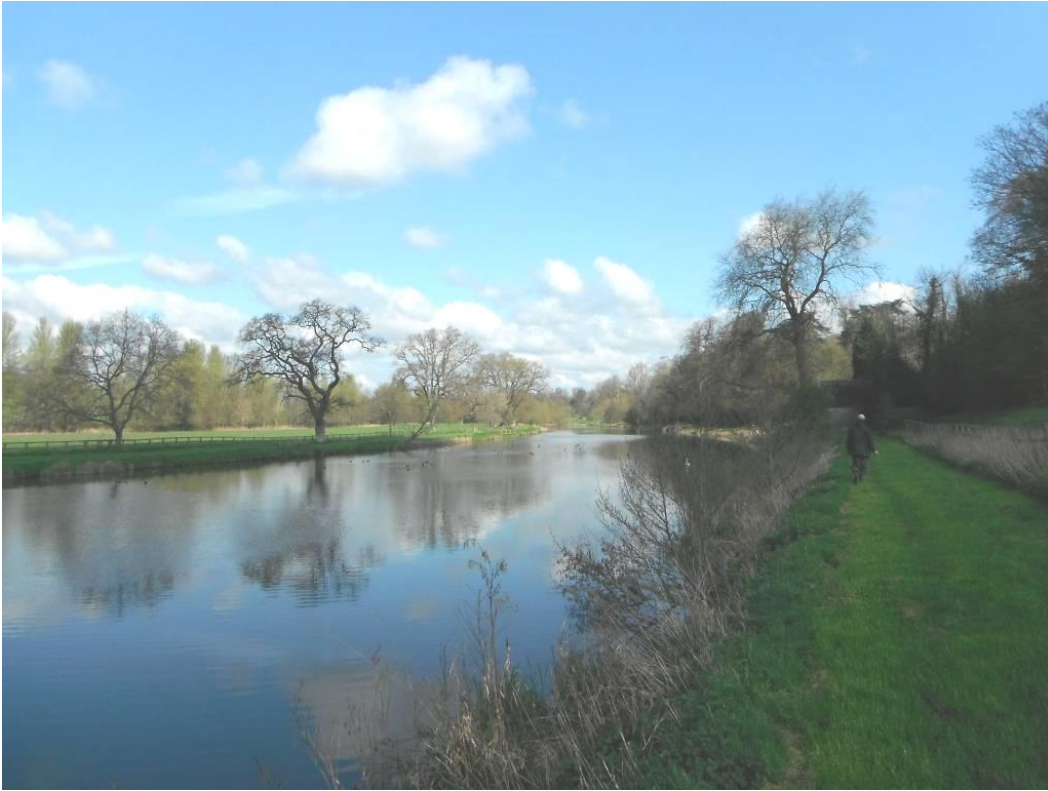
The over half of the river through the Fairford parish has been subject to major modification to its morphology it being effectively dammed by the mill at Fairford thereby creating an online lake within Fairford Park where the river (called Broad Water) would have naturally had been. This changes the ecology of the habitat to that of standing water rather than a river which obviously changes the species that can thrive in this habitat.

Photo 7 this photo taken of the Broad Water section of the river shows how the river has effectively been dammed to create an online lake, obviously this will not provide a suitable habitat for river species like wild brown trout hence the requirement for artificial stocking but would suit Carp

There is a small channel that runs parallel to the river through Fairford Park which is closer to a river habitat, if this channel could be enhanced to create meanders via re-routing or the introduction of large woody debris and gravel it could potentially provide a connecting habitat for river species past the unsuitable Broad Water.

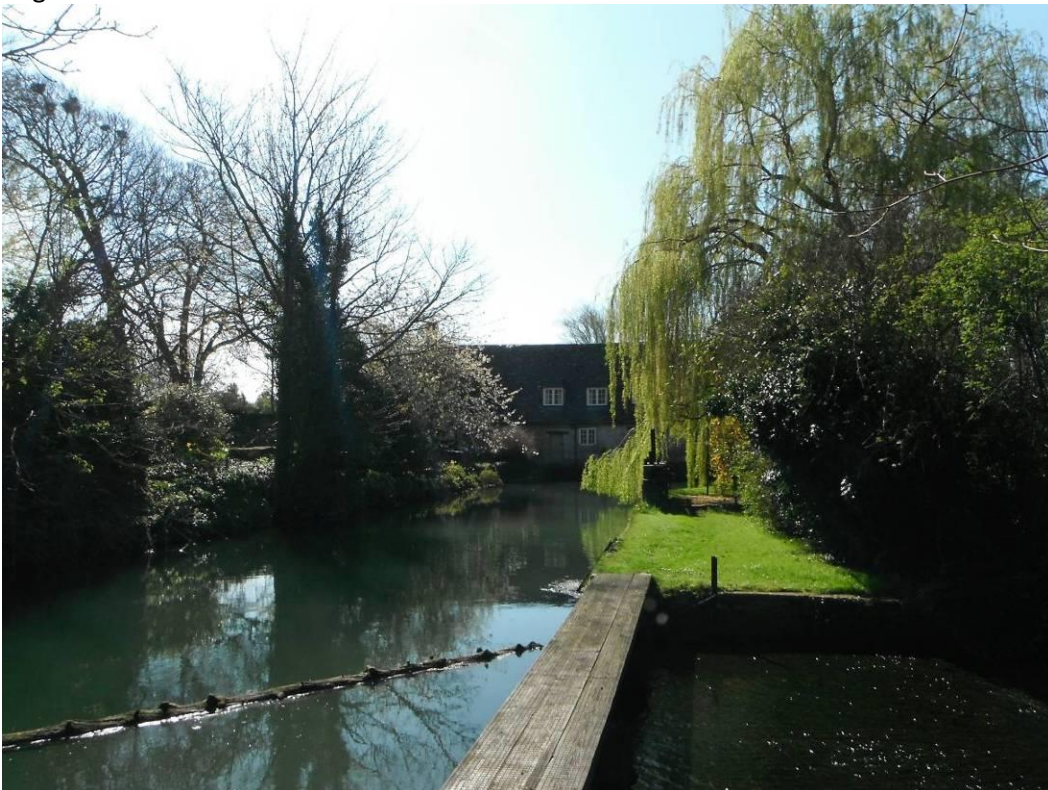
Photo 8 shows the Mill at Fairford which is effectively the dam on the Broad Water and also another barrier to fish movement, the channel here is actually split in two with a bypass channel which may be easier to modify for fish migration

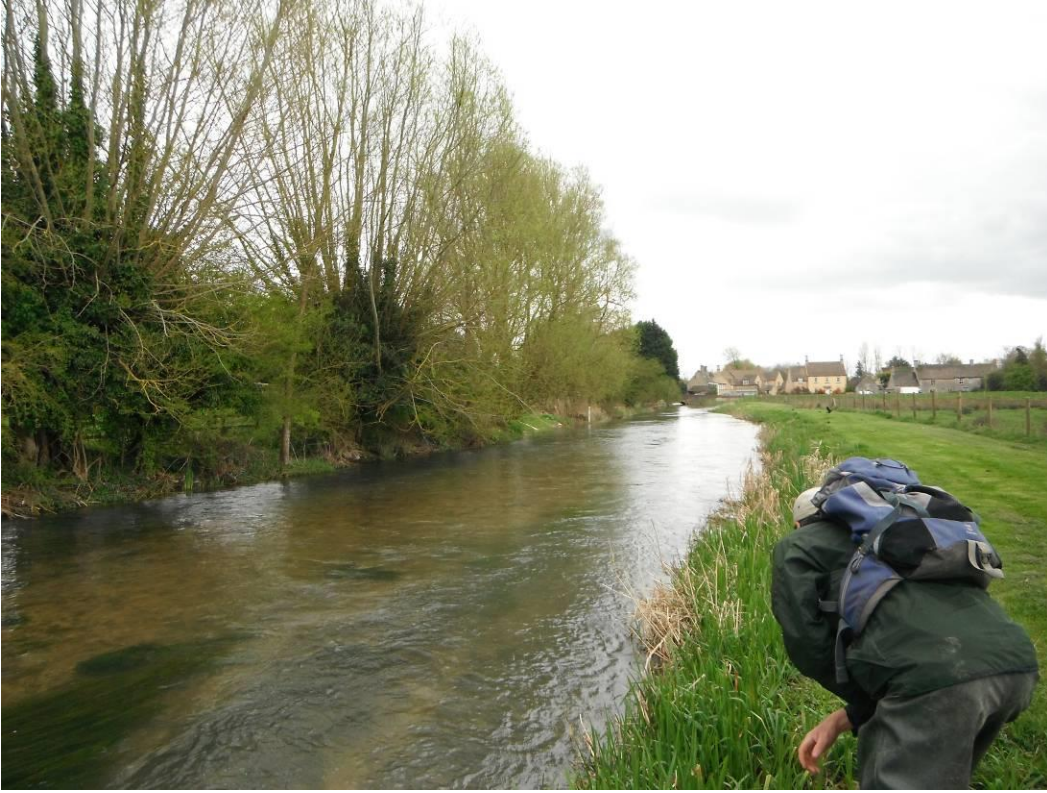
Photo 9 the River in Fairford between the Mill and the main road bridge is again overwide, straight and shallo. It did have good marginal vegetation for species like water vole but was not ideal for natural fish populations although one fisherman reported regularly catching Grayling here.

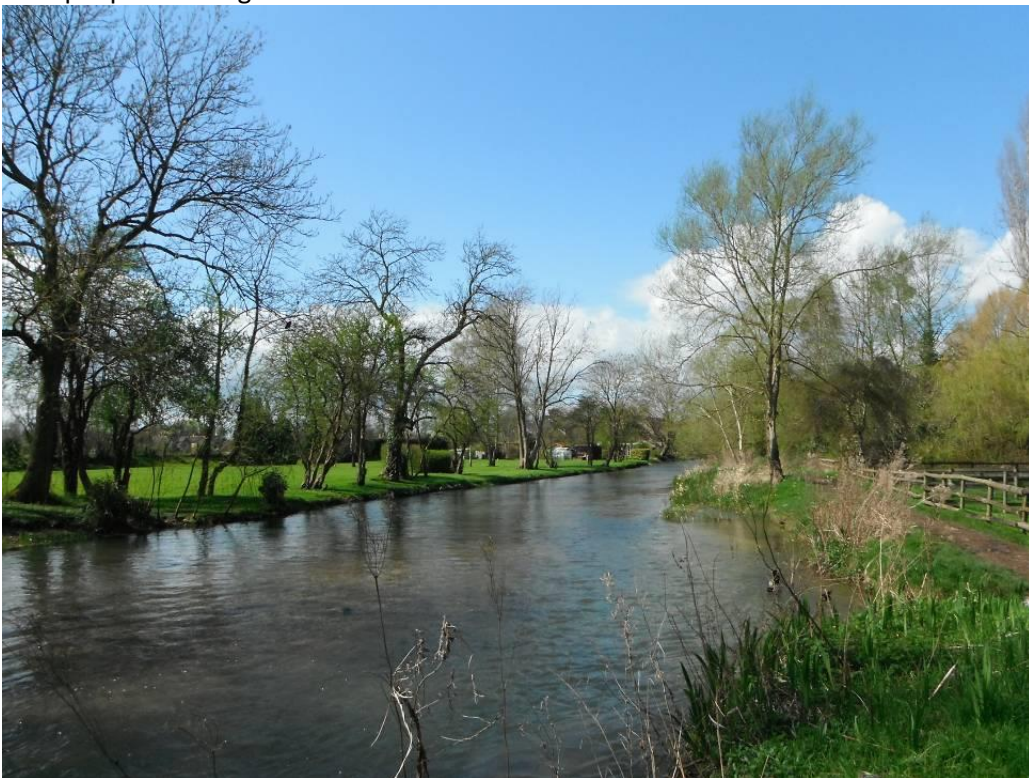
Photo 12 the river downstream of the town is still overwide and straight but it does have footpaths alongside it meaning local people have a good connection to the river

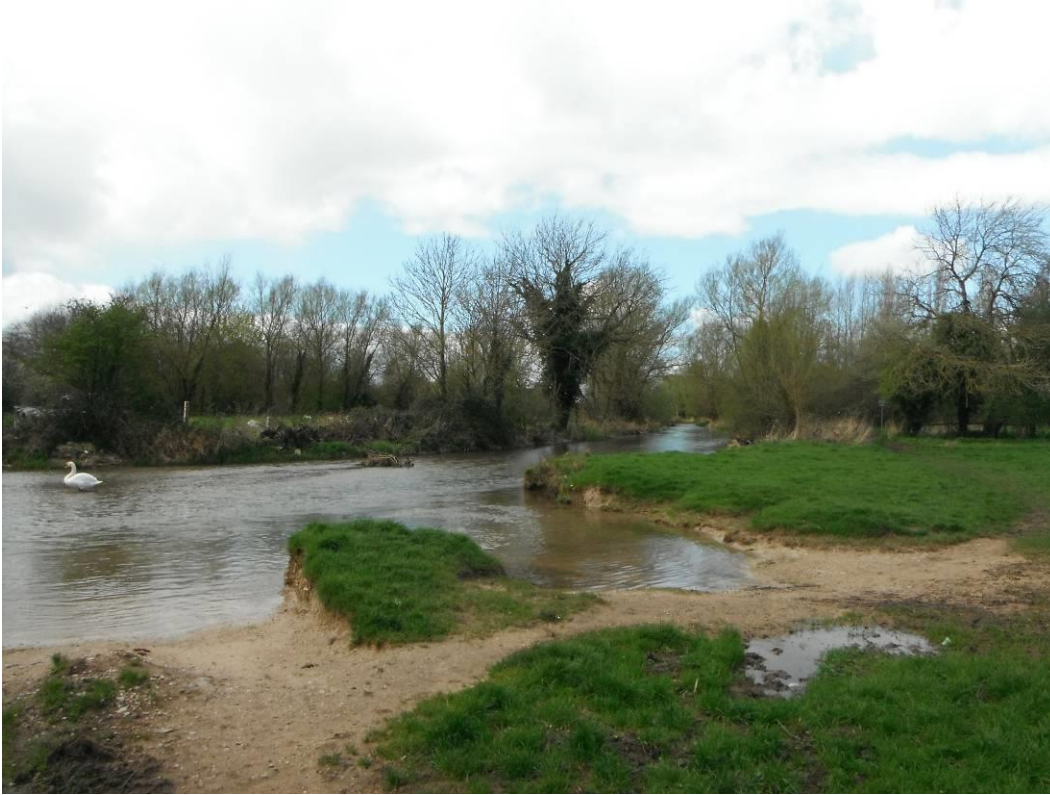
Photo 13 as the river moves away from the town the land becomes more pastoral here the banks have been damaged by vehicle access across the river

There are some sections along an associated channel of the River Coln where riverside fencing would be beneficial to the ecology of the river because the bank was damaged by livestock accessing the water to drink and cool down. This damages vegetation eventually leading to increasing erosion of the banks and pollutes the water via sediment/mud being washed into the river.

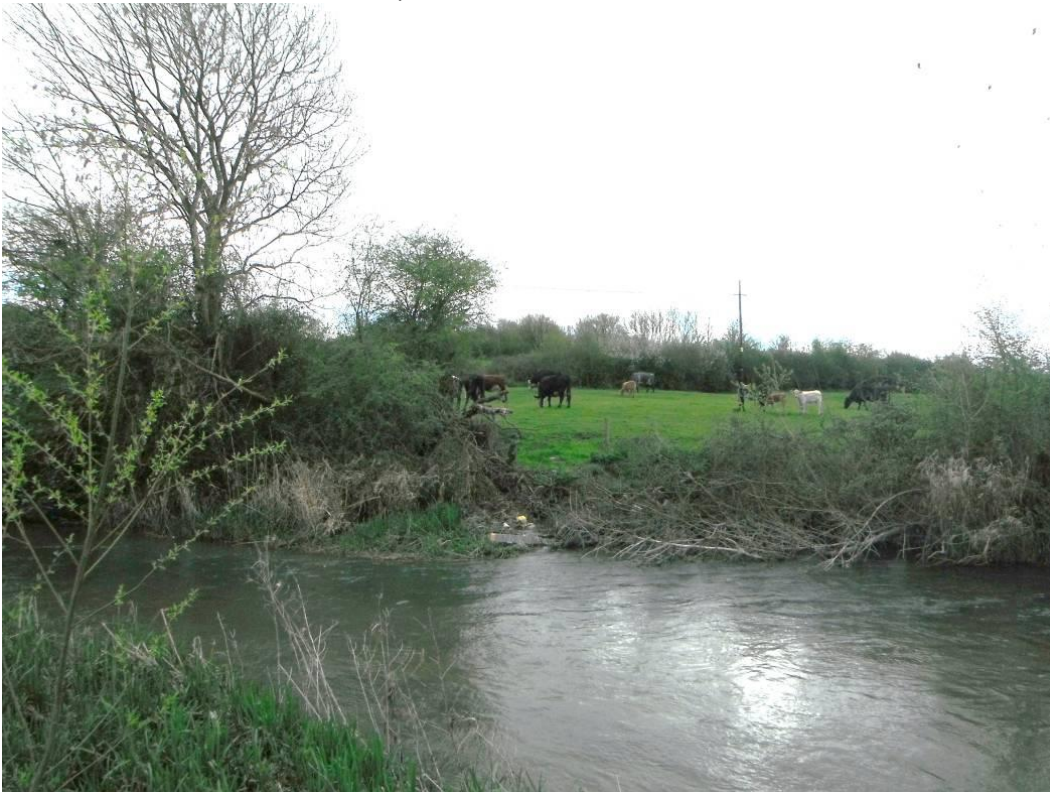
Photo 14 yet again the river returns to its over-wide, straight form overall the river was one of the most featureless sections of river within the waterpark area
