# Character Area 1: Ashcroft

# Character Area 1: Ashcroft – Key Characteristics

## Character Area 1: Ashcroft - Negative Features & Issues:

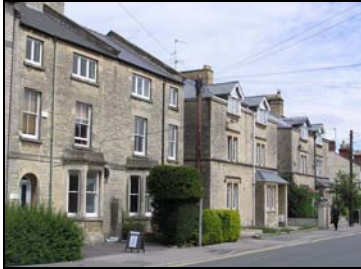
305

- rock-faced limestone building elevations with smooth ashlar limestone dressings and stone chimney stacks [307 & 315];
  - squared rubble limestone elevations, with smooth ashlar limestone dressings, stone chimney stacks, some with half dormers [304-5 & 311];

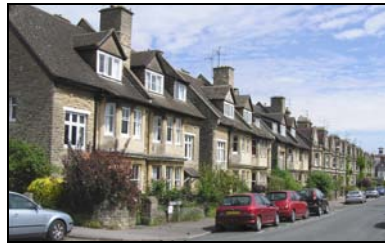
308

- rock-faced limestone elevations with ashlar limestone dressings with matching chimney stacks to red clay tile or Cotswold stone tile roofs [318] some with gables set at right angles to pitched roofs [308 & 316];

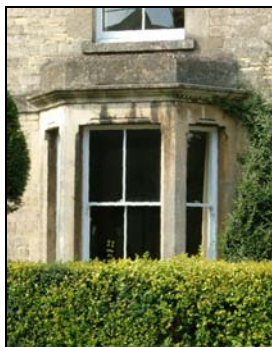
319

- Bay windows, mostly canted, and either with slate hipped roofs or parapet style, some with ornate pierced detail [319-22 & 342];

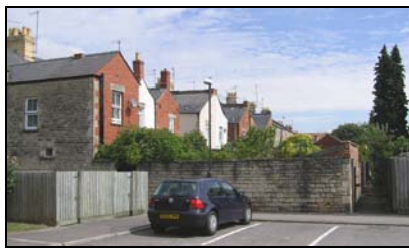
323

- Two-storey, single-bay, rear bathroom and kitchen extensions with pitched slate roofs [323-325];
- Gaps between each terrace or between semi-detached pairs allowing glimpses into rear gardens and or development beyond [339-42];

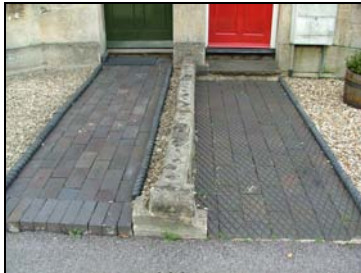
330

- Paired doorways with timber-framed panelled doors with square-headed or arched-headed fanlights over [343-45];
- Staffordshire Blue paviments, and/or engineering bricks to domestic pathways, bordered by blue clay/terracotta tiles in rope or chevron pattern [330-332];

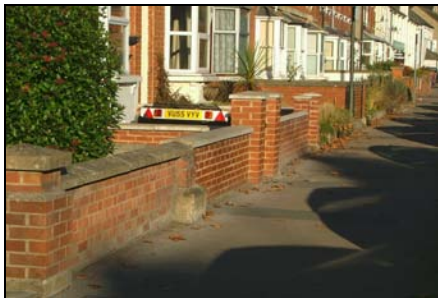
333

- Simple architectural detail, including dentilled eaves cornices in contrasting brick, with occasional terracotta panels and carved capitals, polychrome detailing with contrasting materials to windows and door surrounds, and crested ridge tiles [347-49];
- Timber-boarding to gables and porches, and decorated timber bargeboards to some properties in St Peter's Road [346-49] and a number of good traditional timber shopfronts [313 & 326];
- A variety of boundary treatments, from low brick walls and iron railings, to low stone bases with iron railings, stone or brick walls with matching gate posts / pillars, and dense neatly-cut box hedging and/or topiary [333-338];

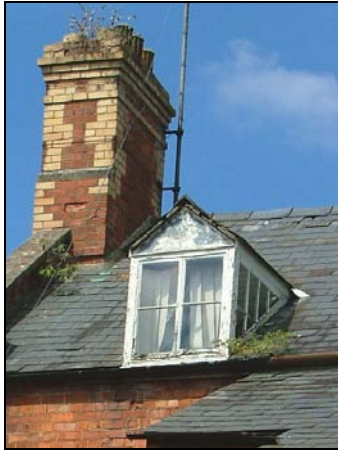
353

- A lack of maintenance to a few properties [353];
- Visual clutter created by traffic-related signage and road markings, and telegraph poles and wires [354 & 362]
- Loss of and/or replacement of architectural details with inappropriate designs and materials including use of plastic for windows and doors [355-58] which undermine the cohesive design of terraces and semi-detached pairs, and the use of artificial stone products that weather unsympathetically [361];
- Painted and rendered façades which detract from the traditional natural materials of brick and stone throughout the character area [359-60];

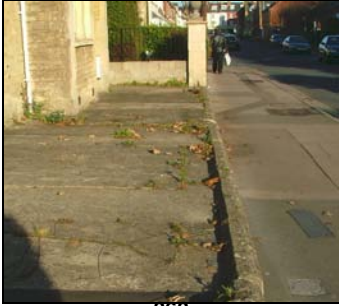
363

- Loss of boundary features including walls, railings and/or hedges, some through lack of maintenance, others to provide off-street car parking [363-365];
- Uninspiring buildings terminating views [366].
