Character Area 6: Beeches & City Bank

Character Area 6: Beeches & City Bank – Key Characteristics

Character Area 6: Beeches & City Bank – Negative Features & Issues

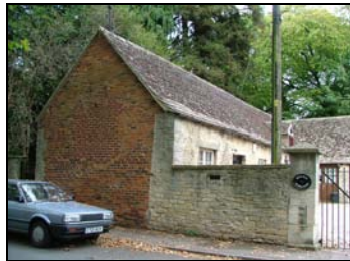
590

- The Character Area is predominantly residential, but also contains an art gallery, The Phoenix Centre [594], a small restaurant, a sports club and Ingleside School [590];

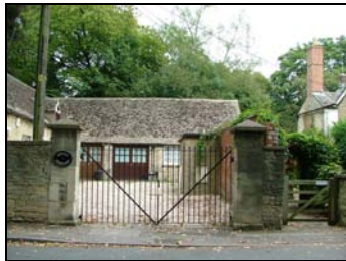
592

- The local limestone predominates for building elevations, chimney stacks and boundary walls whilst the one brick terrace [596] coupled with several brick chimneys and boundary walls, and parts of the former railway line [607], add colour and variety to the various architectural forms [588 & 591] with roofs of either Cotswold limestone [592] or Welsh slate [593];

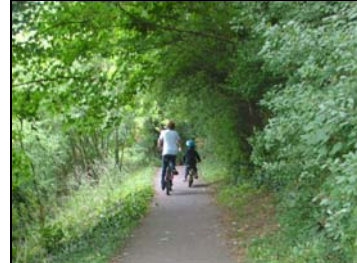
598

- Dissected lengthways by two divergent branches of the River Churn [587 & 589], the area contains two large public recreation grounds:
 - one to the north of the raised bank of the former railway line which crosses the area on a diagonal curve from east to west; this area doubles as a sports field for the adjacent Cirencester County School [598], and

- Views are an especially important feature [the principle views are marked on Map N on page 53] and include views across open land [598], along pedestrian routes, and limited views towards Cirencester Parish Church to the northwest – just glimpsed from the raised City Bank [597] – and towards the spire of Holy Trinity Church to the west;

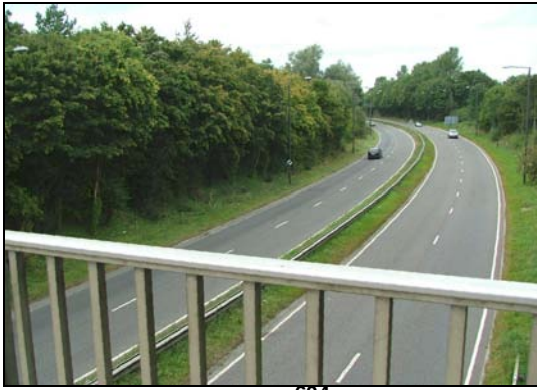
604

- Trees play a vital role in the character area, not just in screening it from the busy ring-road [604], but in providing colour, texture, shade and visual interest throughout the area;
- Boundary walls, built predominantly of limestone rubble, make an important contribution in defining and containing spaces, ensuring a sense of enclosure and demarcating private and public spaces [600 & 603].

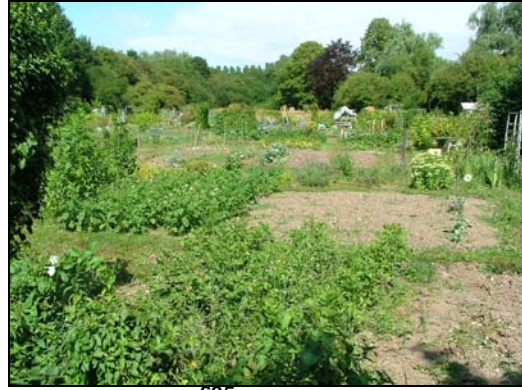
605

- A long narrow strip of land to the south of the curving railway line is home to colourful allotment gardens protected from winds by the railway bank and a corresponding bank of trees [605];

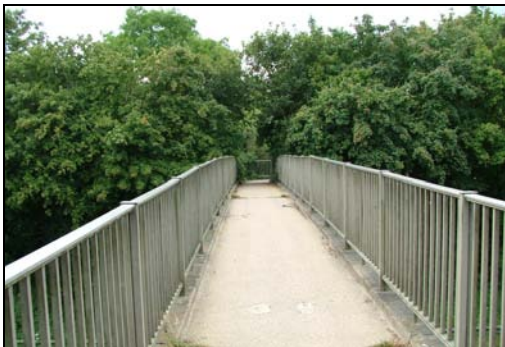
608

- The southern tip of the character area follows the route of the River Churn as far south as its junction with the dual-carriageway, before it diverts under the road towards the Kingsmeadow Services on Cricklade Street, and this section also includes a small number of allotment gardens and a bridge over the ringroad, providing a vital pedestrian link to this area from the major residential development of Kingshill [608-9];

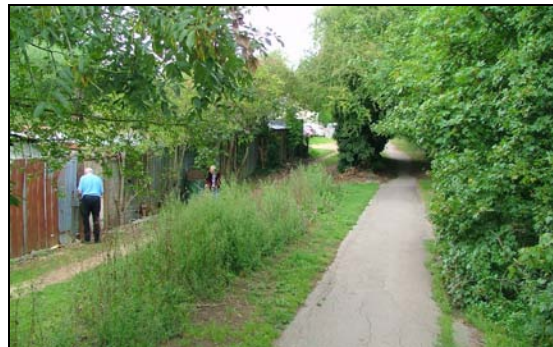
609

- The majority of the relatively few buildings contained within the character area are located at the northern end, facing London Road, whilst others line Beeches Road, with the former mill further south on the east side; a handful of largely hidden nursery-sheds are the only other buildings [609];

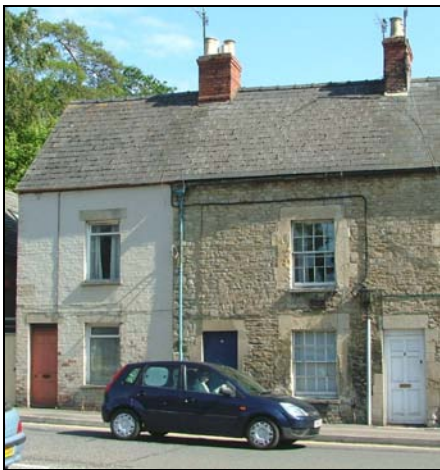
610

- Loss of and/or replacement of details with inappropriate designs and materials, including the use of plastic for windows and doors [610-11];
- Introduction of artificial stone products for elevations and boundary walls that weather unsympathetically, and dilute the historic character of the area [612];
- Unattractive utilitarian extensions and ancillary buildings, often highly visible from public places, for example, side and rear extensions to the former mill building [613];
- A large number of scrap vehicles surrounding the former mill [614];
- Visual clutter created by traffic-related signage and road markings, and telegraph poles and wires [615-20];
- A lack of maintenance and related vandalism [621, 624-25];

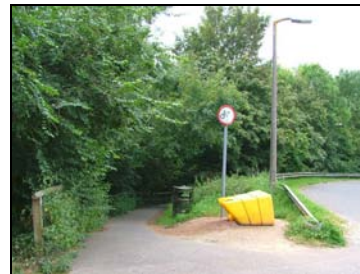
623

- A lack of any real physical interpretation, whether of the archaeological importance of the City Bank, the ecological value of the River Churn, or the historic and architectural value of the railway line, the former mill and/or other buildings located here;
- A lack of directional signage and lighting, leading to perceptions that certain areas and pathways may be unsafe, particularly in the hours of darkness [623].
