# Character Area 3: Western Fringes

# Character Area 3: Western Fringes – Key Characteristics

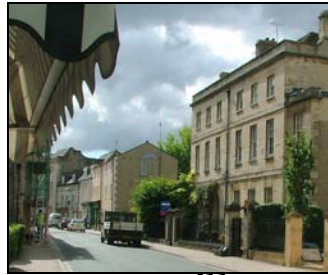
411

- Streets are tightly defined by mostly two-storey to four-storey buildings, built off the back edge of the pavement, in long, narrow, medieval plots, set at right angles to the road [423], and mingling with buildings of later periods whose wider dimensions indicate plot amalgamation, normally in combination with road widening and occasional narrow front gardens bordered by low walls and/or iron railings [411];

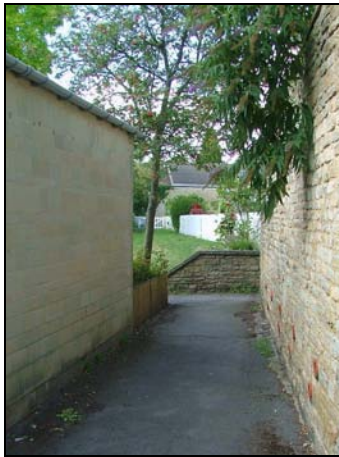
421

- Good permeability allowing a range of pedestrian movement as a result of a network of corridors, most especially through St Clements Walkway [421-22];

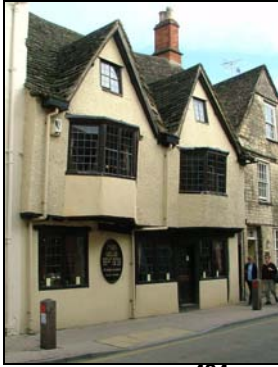
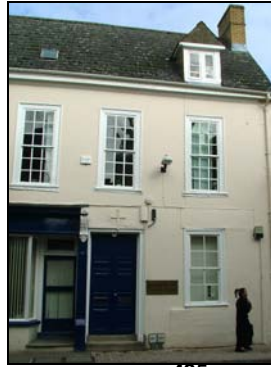
424

- A very varied and rich architecture mix, dating from the seventeenth to twentieth centuries, but predominantly seventeenth and eighteenth century buildings, as well as some of the most historically and architecturally important architecture in the town, including the Weaver's Hall [St Thomas Hospital], Thomas Street, The Woolgatherers House with its counting house and the attached warehouse on Thomas Street, and The Mead and other large eighteenth-century town houses;
- Survival of timber-framed buildings especially in Dollar Street, dating from the later seventeenth century, and evidenced by shallow window reveals but often concealed by rendered facades [424-25];

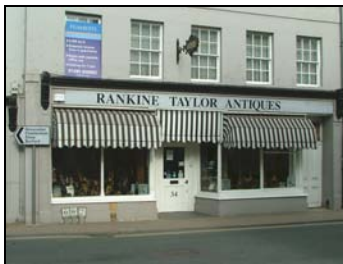
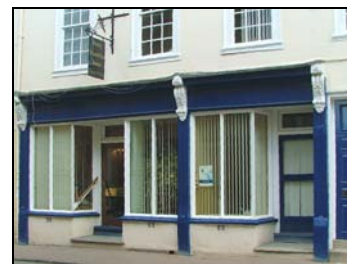
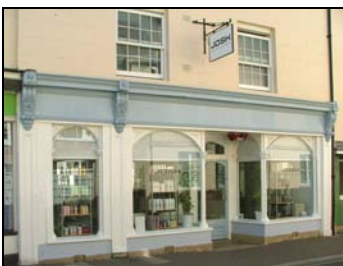
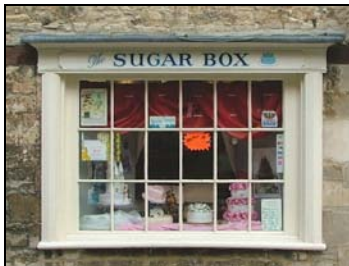
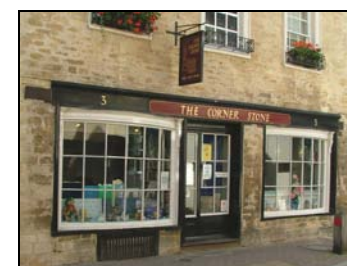
- Use of revivalist and Arts and Crafts derived detailing in the later nineteenth and early twentieth centuries, including hoodmoulds, mullioned windows, tall chimney stacks set at angles, oriel windows and ovolo-shaped openings;
- A roovescape enlivened by tall chimney stacks, large numbers of gabled frontages interspersed with pitched roofs behind parapets and occasional pediments, creating a decidedly vertical emphasis to the street scene;
- A rich array of decorative architectural detail providing visual stimulus and a varied urban scene including some good timber shopfronts [427-432];

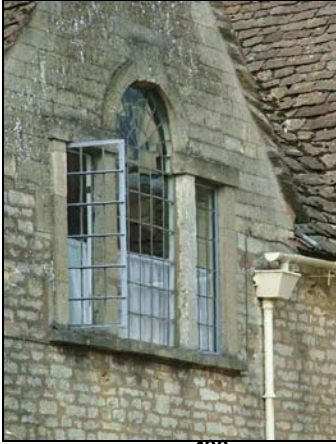
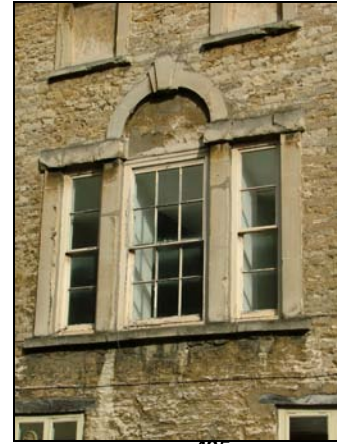
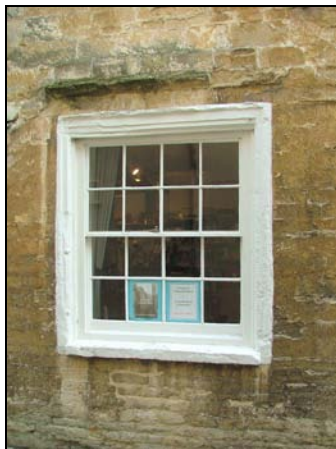
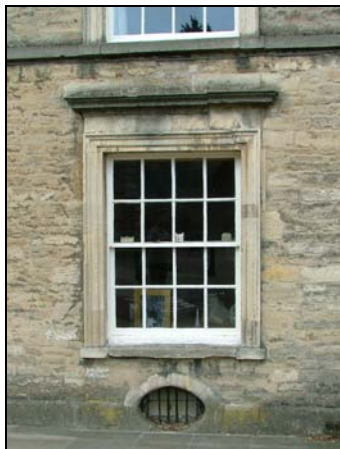
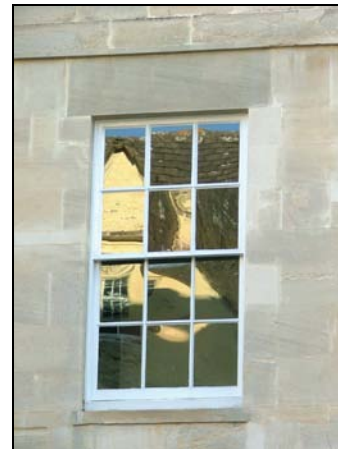
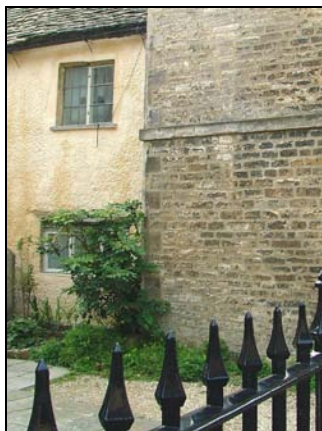
- Materials unite the various architectural styles, with consistent use of rubble limestone for early building elevations, flank walls, chimney stacks, and boundary walls, and the use of limestone slates for roofs creating a very cohesive character, with most later buildings marked by smooth ashlar limestone, or smooth render more suited to the architectural detail of buildings of eighteenth century and later date, in combination with Welsh slate or clay tile, the whole providing a great variety in texture [433-440];

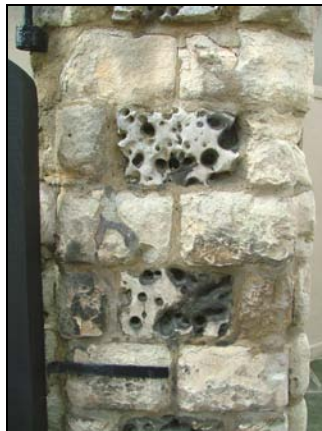
440

- Almost continuous building frontages are broken only by occasional gaps in the street occupied by small private gardens, bordered by high limestone walls [441 & 444], often in combination with limestone pillars and occasional use of tufa [440], a rough, rock-like material used for purposes of rustication;

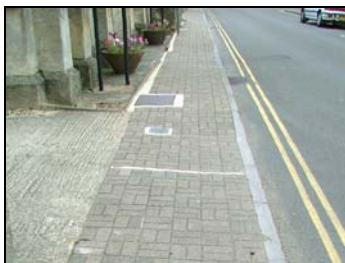
445

- Through-traffic from Tetbury Road to Grove Lane via Park Lane, Park Street, Thomas Street, Dollar Street and Spitalgate Lane, and into the town along Dollar Street towards Market Place has a detrimental impact on the character of the area and threatens pedestrian safety ;
- Poor floorscape comprising non-contextual artificial materials to most pathways is at odds with the natural materials of most buildings, and in other areas, poor maintenance and/or workmanship [445-6];

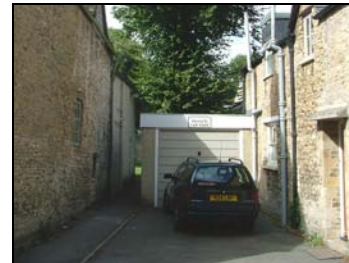
447

- Significant loss of rear gardens and boundary walls to provide car parking [447, 450-51];
- Some backland sites with visible unattractive rear service wings / extensions [448];
- Poorly proportioned later twentieth-century buildings with horizontal emphasis, asymmetric fenestration and inadequate modelling [448-9, 452-3];
- Loss of and/or replacement of architectural details with inappropriate designs and materials including use of artificial stone products that weather unsympathetically;
- Loss of lime render to a number of buildings, most notably to early limestone rubble elevations;

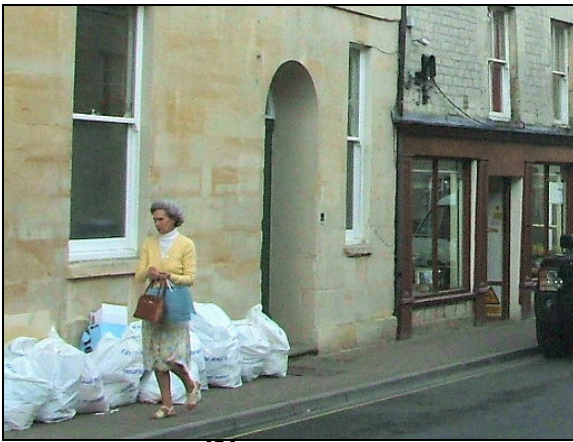
454

- Lack of general maintenance of buildings, including a failure to remove vegetation from gutters [455];
- Lack of provision for rubbish storage [454];
- Extract vents from hot food outlets which are visually intrusive;
- Damaging and inappropriate installation of services to both domestic and commercial buildings [456-57];
- No Buildings of Townscape Merit.
