Old Memorial Hospital Sheep Street Cirencester

Heritage Statement

CA Project: 6008

CA Report: 16470

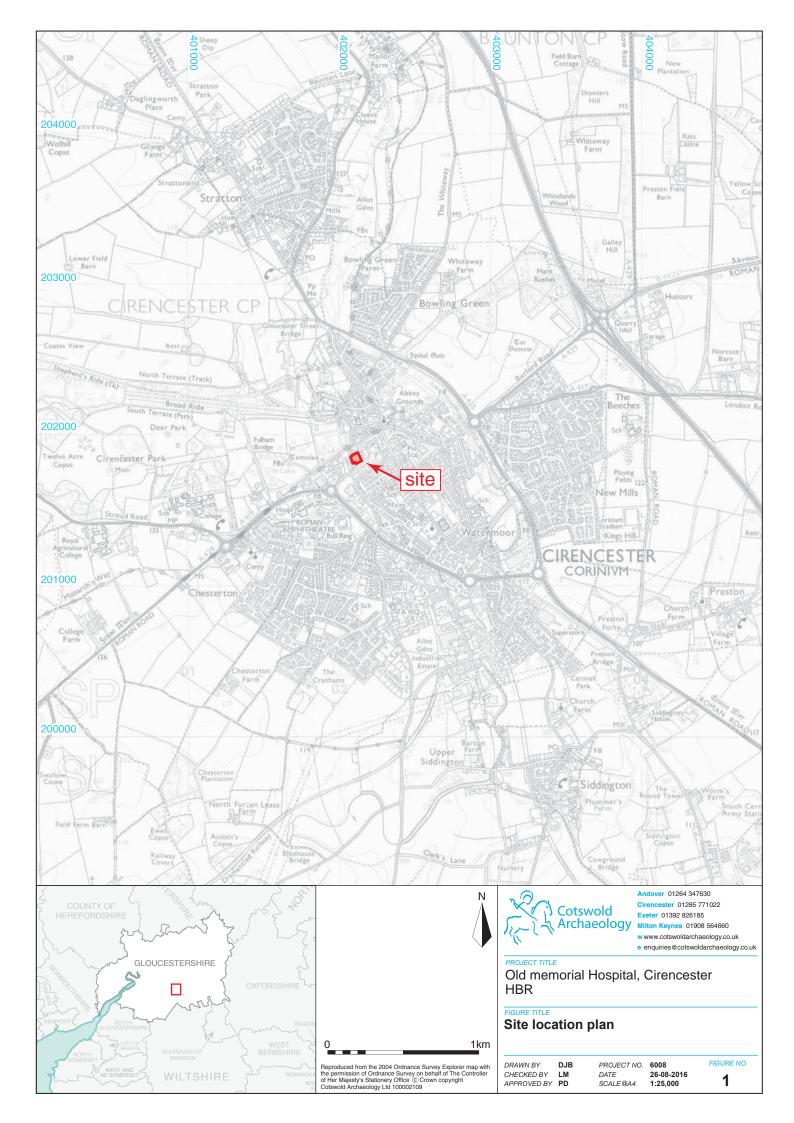
SIte boundary	Andover 01264 347630 Cirencester 01285 771022
1873-5	Cotswold Archaeology www.cotswoldarchaeology.co.uk
1913	e enquiries@cotswoldarchaeology.co.uk PROJECT TITLE Old momential Haanital Circonacator
1913 (demolished)	Old memorial Hospital, Cirencester HBR
1931 (demollished) 1938	FIGURE TITLE Site plan
early NHS	
Reproduced from the digital Ordnance Survey Explorer map with the permission of Ordnance Survey on behalf of The Controller of Her Majesty's Stationery Office © Crown copyright Cotswold Archaeology Ltd 100002109	DRAWN BY DJB PROJECT NO. 6008 FIGURE NO. CHECKED BY LM DATE 26 08 2016 2 APPROVED BY PD SCALE@A4 1:500 2

- 1.8. The site is located on the east side of Sheep Street, Cirencester, in Character Area 6 of the Town Centre Conservation Area, at approximately 114m above Ordnance Datum. The site is bounded by Sheep Street on the west, by the staff car park of Tescoos supermarket on the east, and neighbouring properties on north and south sides (Fig. 2).
- 1.9. The building is surrounded by a modern car park, which represents the hospital grounds acquired in 1931 for the eastern and northern extensions of that year (Fig. 2).

3.1 The building has an irregular, informal plan, which is partly the result of the original design intention and partly due to piecemeal growth, in 1913, 1931, 1938 and postwar. Demolitions since 1984 have removed some additions of 1913 and 1931 (Fig 2 and 3).

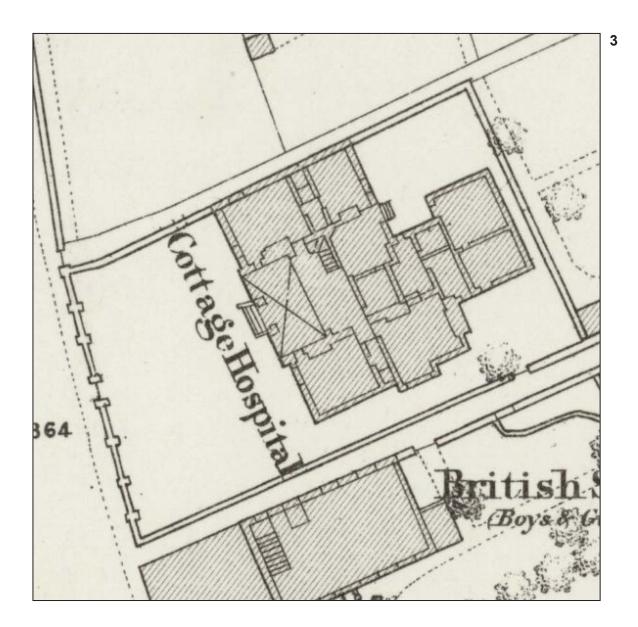
3	The hospital ground plan in 1875 (from the 1:500 OS County Series First edition map of Cirencester)	Andover 01284 347630 Cirencester 01285 771022 Exeter 01392 826185 Milton Keynes 01908 564660 w www.cotswoldarchaeology.co.uk e enquiries@cotswoldarchaeology.co.uk
		Old memorial Hospital, Cirencester HBR
		FIGURE TITLE Historic mapping
		DRAWN BY DJB PROJECT NO. 6008 FIGURE NO. CHECKED BY LM DATE 26-08-2016 APPROVED BY PD SCALE@A4 NA 3

- 1.4. The hospital was founded by Allen Bathurst M.P. (later sixth Earl Bathurst) in memory of his wife, the Hon. Meriel Leicester Warren, ±or the benefit and accommodation of the poor when suffering from disease or accident which cannot be treated adequately in their own homesq (Viner and Viner 2009). This was recorded, monogrammatically, on the cartouche over the entrance. It first appears on mapping in 1875, in unusual detail even for the First County Series 1:500 OS mapping (Fig. 3).

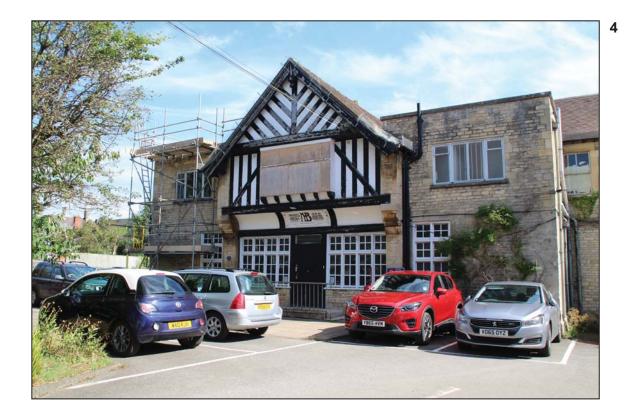
4 The entrance front in 2016 (scale 2m)	Andover 01264 347630 Cirencester 01285 771022 Exeter 01392 826185 Milton Keynes 01908 564660 w www.cotswoldarchaeology.co.uk e enquiries@cotswoldarchaeology.co.uk
	PROJECT TITLE Old memorial Hospital, Cirencester HBR
	FIGURE TITLE Photograph
	DRAWN BY DJB PROJECT NO. 6008 FIGURE NO. CHECKED BY LM DATE 26-08-2016 4

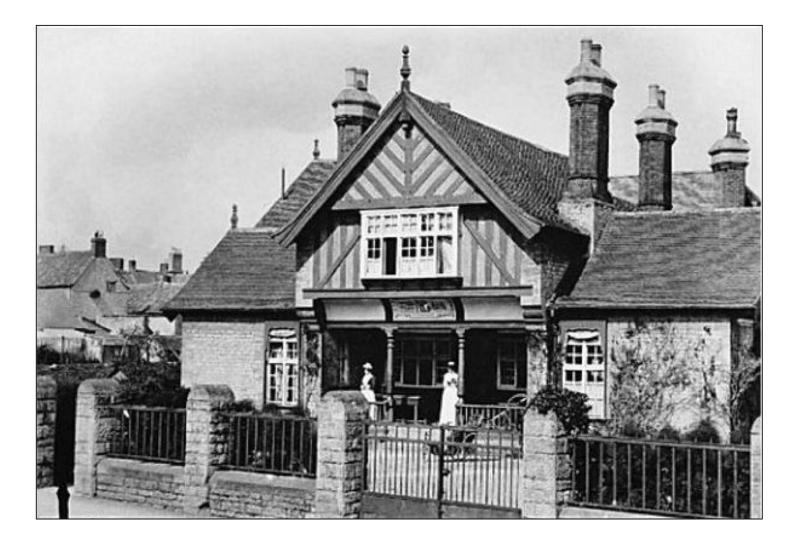
5 The entrance front as built, before 1912 and p before 1895	Andover 01264 347630 Cirencester 01285 771022 Exeter 01392 826185 Milton Keynes 01908 564660 w www.cotswoldarchaeology.co.uk e enquiries@cotswoldarchaeology.co.uk
	PROJECT TITLE Old memorial Hospital, Cirencester HBR
	ни на
	DRAWN BY DJB PROJECT NO. 6008 FIGURE NO.
	CHECKED BY LM DATE 26-08-2016 APPROVED BY PD SCALE@A4 NA 5

- 3.2 Despite a symmetrical entrance front, the general appearance is also irregular, in a deliberately romantic Tudor style (Fig. 5). The original core of the building was constructed in even, shallow courses of roughly-squared Cotswold stone, except for the centre bay on the entrance front, which was an open loggia at the ground floor when first built. The loggia had two elaborately-profiled wooden columns. The first-floor was timber-framed, close-studded, with large, straight down-braces, and a central oriel window, and was topped with a gable with a king-post and many flanking raked struts. It was topped with a bossed vase finial, and simple barge boards.

- 3.9 In 1895 a %day room and private sitting room+ for the matron was added to the building. It is not stated where this was (Clews 1988, from where the historical information that follows was taken). It may have been the occasion for the addition of the upper storey to the south-east corner. This does not appear on Fig. 5, but the addition of an upper floor is shown on another photo taken before the additions of 1913 (Fig. 6). A verandah was added to the south side in 1912 (Annual Report and Balance Sheet 1912), and this is shown on the photograph (also still visible on Figure 7). The only substantial expenditure noted in this period (apart from the operating theatre) is for the for matroncs day room and private sitting room, a considerable sum of £420. It appears inescapable that this is the date of this alteration, but this means that Fig. 5 would pre-date 1895, and Fig 6 must be 1912 or early 1913.

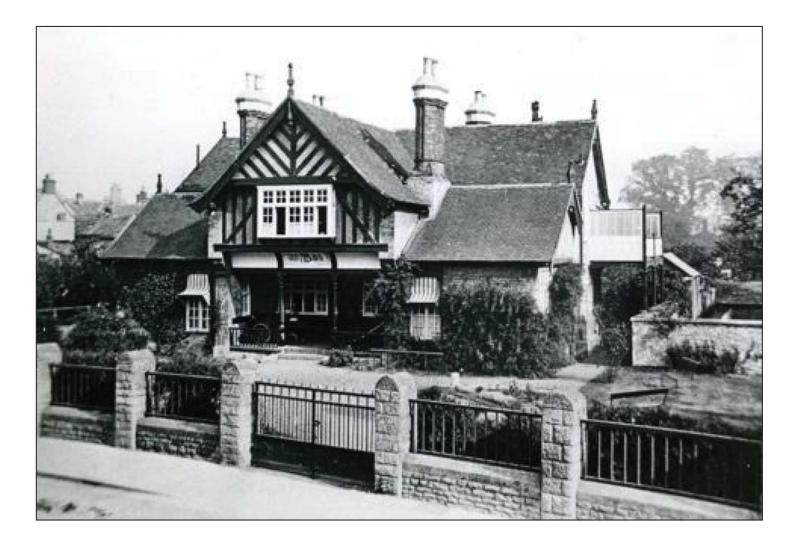
6 The entrance front in 1912	Andover 01264 347630 Cirencester 01285 771022 Exeter 01392 826185 Milton Keynes 01908 564660 w www.cotswoldarchaeology.co.uk e enquiries@cotswoldarchaeology.co.uk
	PROJECT TITLE Old memorial Hospital, Cirencester HBR
	FIGURE TITLE Historic photograph
	DRAWN BY DJB PROJECT NO. 6008 FIGURE NO. CHECKED BY LM DATE 26-08-2016 APPROVED BY PD SCALE@A4 NA 6

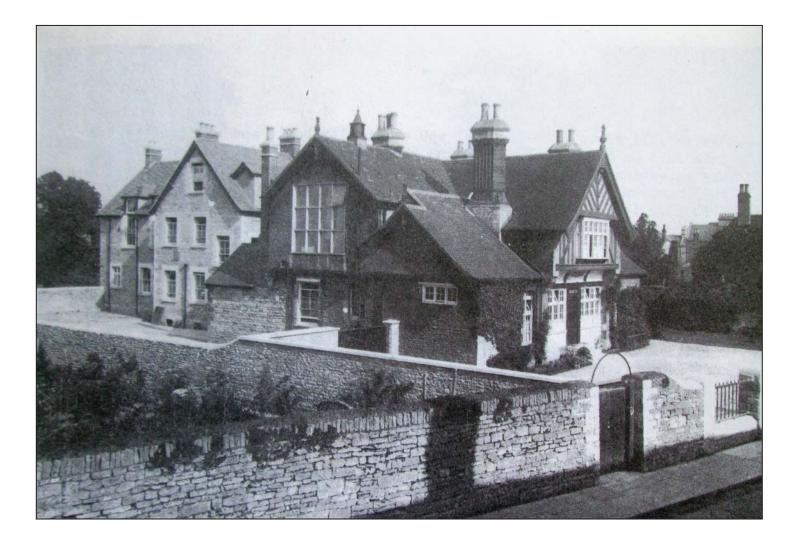
9	The hospital from the north-west after the additions of 1913	Andover 01264 347630 Cirencester 01285 771022 Exeter 01392 826185 Milton Keynes 01908 564660 w www.cotswoldarchaeology.co.uk e enquiries@cotswoldarchaeology.co.uk
		PROJECT TITLE Old memorial Hospital, Cirencester HBR
		FIGURE TITLE Historic photograph
		DRAWN BY DJB PROJECT NO. 6008 FIGURE NO. CHECKED BY LM DATE 26-08-2016 APPROVED BY PD SCALE@A4 NA 9

- 3.5 The side bays of the entrance front were originally single-storeyed, with gables to north and south. There is a strong possibility that the gables were timber-framed. They certainly seem to have been rendered and projected slightly (Figs 7 and 9).

- 3.12 In 1902, £500 was spent on a %ew operating room+. This must have been the room on the first-floor lit by the large window in the northern gable (Fig. 9). Early 20thcentury operating rooms were usually naturally lit with large windows, north-facing if possible, like artistsqstudios. It is possible, given the fact that the southern end of this range was at first of only one storey, that the new operating theatre was provided by actually adding a floor to this section, so that the original design might

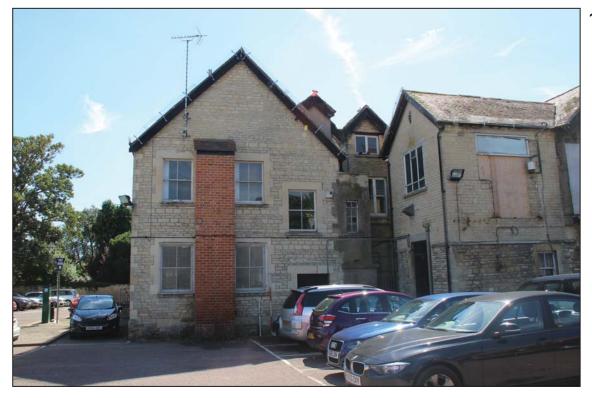
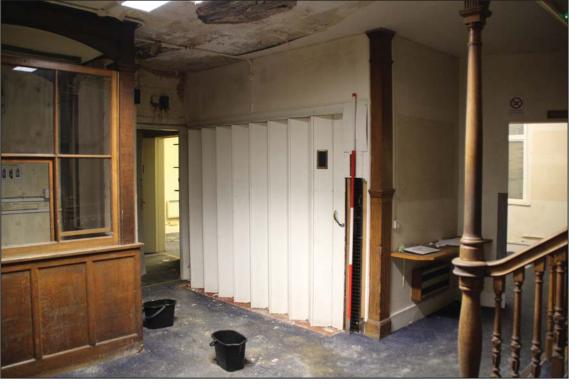
- 10 The east end of the north elevation of the hospital. The 1875 rear wing is just visible in the centre. The lower part of the block on the right and the gable on the left are the 1913 additions. The upper floor on the right is post-1948. Cf Fig. 9 (scale 2m)
- 11 The Bannatyne memorial lift on the ground floor looking north-east (scale 2m)

- 3.16 The work essentially comprised the addition of a T-shaped block added to the west side, and a small, single-storey extension to the north-east corner of the main block of 1875 (Fig. 7 and 9). Much of this survives, although the upright of the T, on the east, has been demolished (Figure 10)

- 3.39 The addition of the upper floor to the 1913 extension, east of the operating room, also belongs to this period (Fig. 10).
- 3.40 At a date after the photograph in Fig. 15, and therefore later than the inserted ground-floor just described, the single-storey flanking rooms on the west elevation were given flat-roofed upper floors. Oddly, given the use of machine-cut masonry in the 1940s work, this masonry is much more vernacular, being similar to the 1913 work, but still easily distinguishable from the 1875 masonry, showing that the gables were replaced (supporting, incidentally, the view that they were probably timber-framed). The date is unknown, but is likely to be in the 1950s.

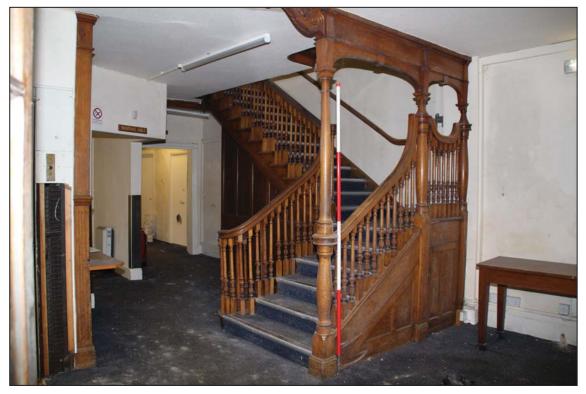
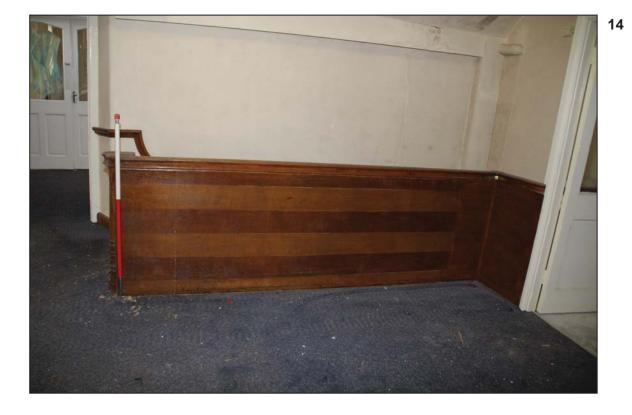
- 13 The foot of the Bannatyne memorial staircase in the former loggia, now entrance hall, looking south-east (scale 2m)
- 14 The landing balustrade on the first floor (scale 1m)

- 3.22 Both features still remain in largely original and good condition, although the run of landing balusters on the first floor has been replaced by plain, hardwood planking under the handrail (Fig. 14). Balusters still survive at the west end, over the lower flight, but backed with boarding. There is a fine curtail at the foot (Fig. 13).

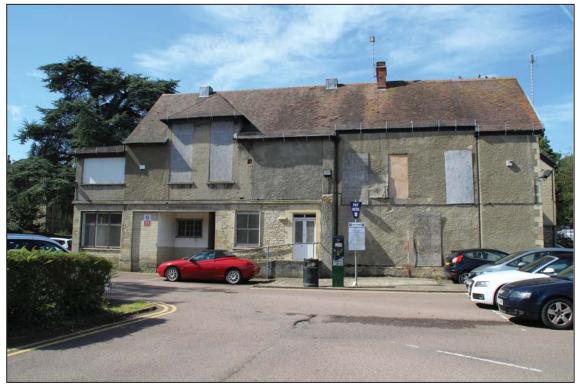
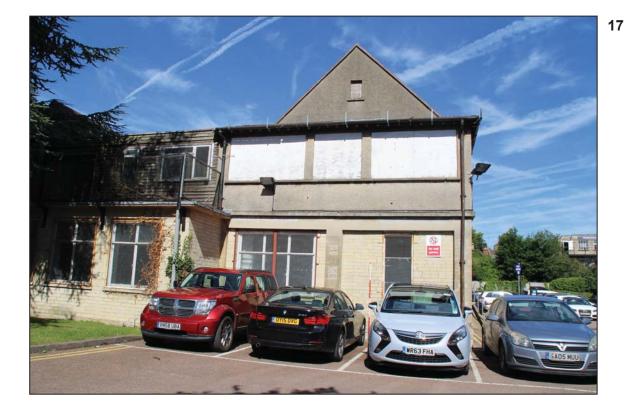
16	The east elevation of the hospital, 1913 and 1938 and later (scale 2m)	Andover 01264 347630 Cirencester 01285 771022 Exeter 01392 826185 Milton Keynes 01908 564660 w www.cotswoldarchaeology.co.uk e enquiries@cotswoldarchaeology.co.uk
17	The sun lounge at the southern end of the eastern ward of 1938, over an open ground floor, later infilled	Old memorial Hospital, Cirencester HBR
	(scale 2m)	FIGURE TITLE Photographs
		DRAWN BY DJB PROJECT NO. 6008 FIGURE NO. CHECKED BY LM DATE 26-08-2016 16 & 17 APPROVED BY PD SCALE@A4 NA 16 & 17

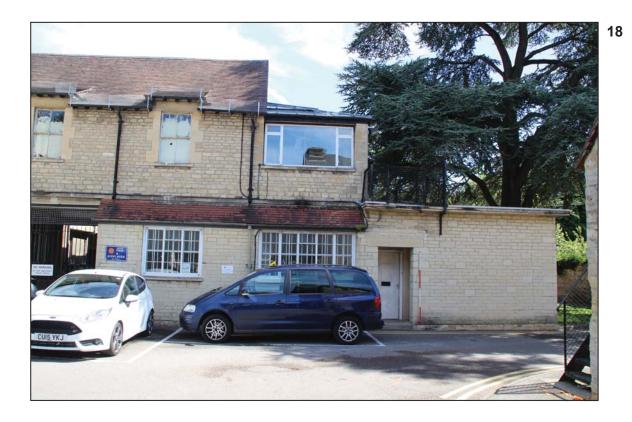
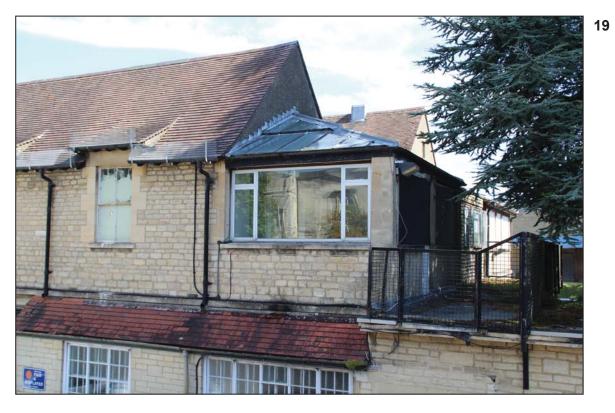
- 18 The west elevation of the western ward of 1938, first-floor sun lounge on right, later ground floor alterations (scale 2m)
- 19 The sun lounges (with a more recent weather-boarded inset), looking east

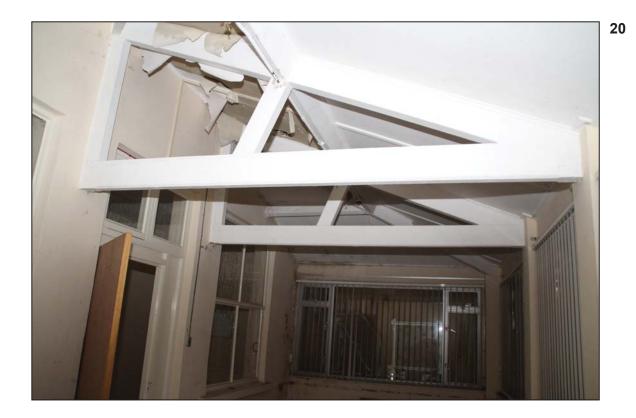
20 The interior of the western 1938 sun lounge	Andover 01264 347630 Cirencester 01285 771022 Exeter 01392 826185 Milton Keynes 01908 564660 w www.cotswoldarchaeology.co.uk e enquiries@cotswoldarchaeology.co.uk
	Old memorial Hospital, Cirencester HBR
	FIGURE TITLE Photograph
	DRAWN BY DJB PROJECT NO. 6008 FIGURE NO. CHECKED BY LM DATE 26-08-2016 APPROVED BY PD SCALE@A4 NA 20

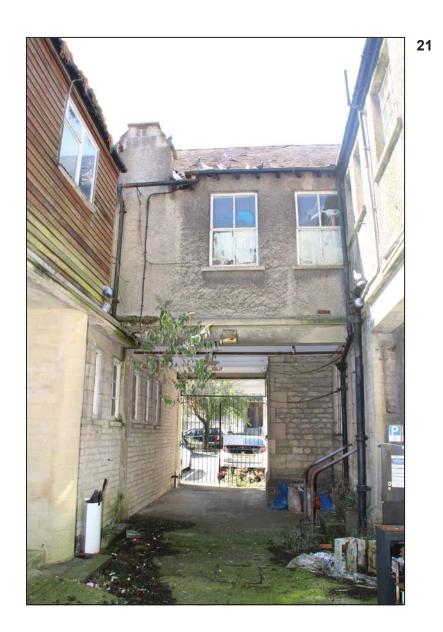
21 The western ward of 1938 spanning the open ground floor, looking west. The later post-1948 masonry infill between the piers can be seen on the left (cf Fig. 17) and the altered bay (lower right)	Andover 01264 347630 Cirencester 01285 771022 Exeter 01392 826185 Milton Keynes 01908 564660 w www.cotswoldarchaeology.co.uk e enquiries@cotswoldarchaeology.co.uk e enquiries@cotswoldarchaeology.co.uk HBR				
	FIGURE TITLE Photograph				
	DRAWN BY DJB PROJECT NO. 6008 FIGURE NO. CHECKED BY LM DATE 26-08-2016 APPROVED BY PD SCALE@A4 NA 21

- 3.32 As might be expected, the southern side of the 1875-1913 blocks was modified to provide access to these new wards. A corridor was built from the top of the Bannatyne stair, with a new bridge across the re-entrant between the 1875 and 1913 blocks here (Figs 2 and 22). This had a flat roof. The small bay window of 1875 was replaced with a larger projection further west (Fig. 21).

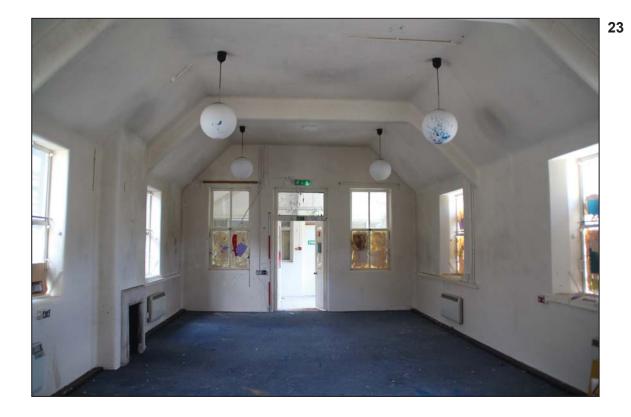
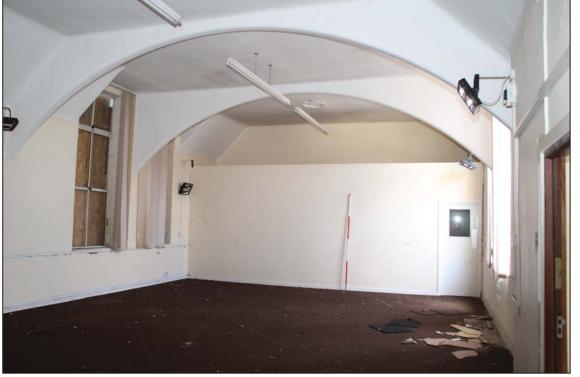
23	The interior of the western 1938 ward, looking south (scale 2m)

24 The interior of the eastern 1938 ward, looking south. The southern end has been partitioned off at a later date to make a corridor (scale 2m)

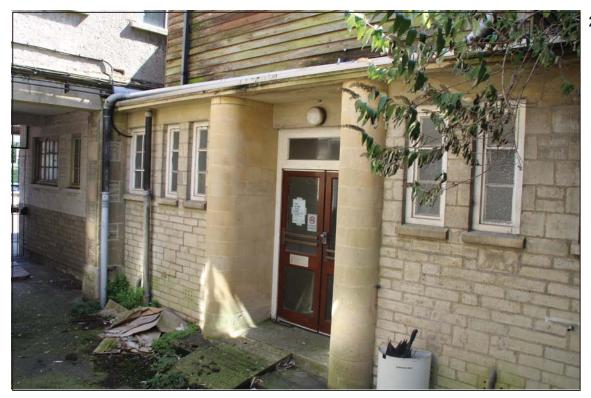
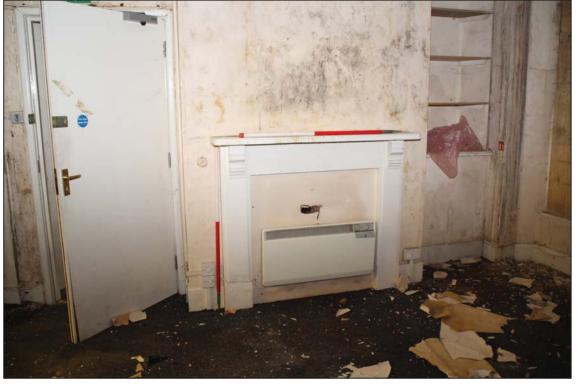
25	The portal of the door into the added ground floor under the 1938 wards, looking south-east	Andover 01264 347630 Cirencester 01285 771022 Exeter 01392 826185 Milton Keynes 01908 564660 w www.cotswoldarchaeology.co.uk e enquiries@cotswoldarchaeology.co.uk
26	The fireplace in the north-west ground floor room, looking south-east (scales 1m)	PROJECT TITLE Old memorial Hospital, Cirencester HBR
		PIGURE TITLE Photographs
		DRAWN BY DJB PROJECT NO. 6008 FIGURE NO. CHECKED BY LM DATE 26-08-2016 25 & 26 APPROVED BY PD SCALE@A4 NA 25 & 26

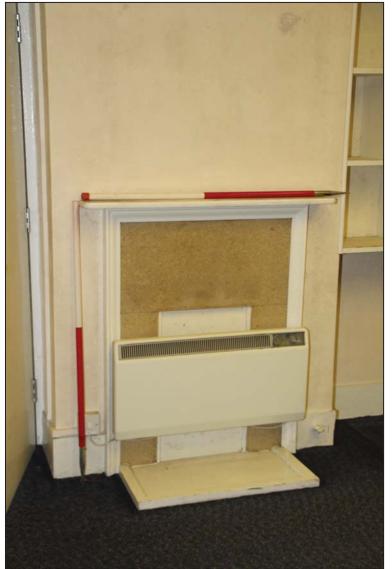
27 The fireplace in the room east of the north-west room ground floor room, looking south (scales 1m)	Andover 01264 347630 Cirencester 01285 771022 Exter 01392 826185 Million Keynes 01908 564660 www.cotswoldarchaeology.co.uk e enquiries@cotswoldarchaeology.co.uk e Million Keynes 01908 564660 www.cotswoldarchaeology.co.uk e Million Keynes 01908 564660 www.cotswoldarchaeology.co.uk	
	FIGURE TITLE Photograph DRAWN BY DJB PROJECT NO. 6008 FIGURE NO. CHECKED BY LM DATE 26-08-2016 APPROVED BY PD SCALE@A4 NA 27

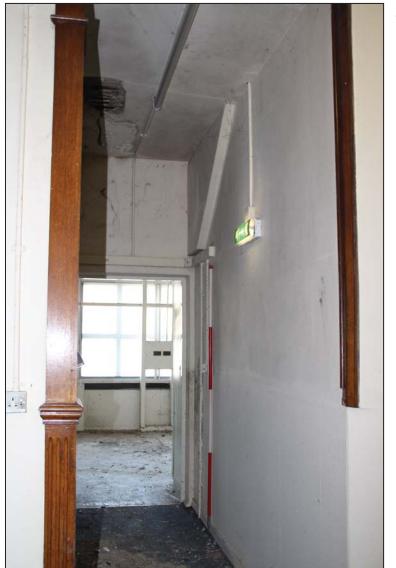
28	The corridor from the first floor landing and the lift to the operating room, looking north, note trace of stair top centre (scale 2m)	Andover 01264 347630 Cirencester 01285 771022 Exeter 01392 826185 Milton Keynes 01390 564660 www.cotswoldarchaeology.co.uk e enquiries@cotswoldarchaeology.co.uk PROJECT TITLE Old memorial Hospital, Cirencester HBR
		PIGURE TITLE Photograph DRAWN BY DJB PROJECT NO. 6008 FIGURE NO.
		CHECKED BY LM DATE 26-08-2016 APPROVED BY PD SCALE@A4 NA 28

- 3.44 The lift replaced the original stair on the ground floor, but in the corridor on the first floor that the lift opens into, and which leads to the operating room, there is a trace of a stair that led into the attic of the central bay. This rose from the equivalent point to the one below, but the lower flight was longer as the east wall on this floor was located further east. It turned at a landing, and a shorter flight continued up into the roof (Fig. 28).

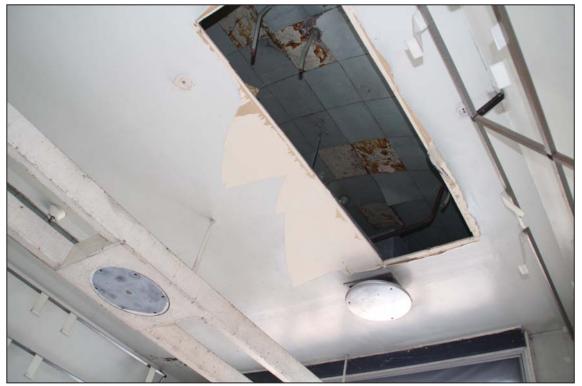
29 The plaster barrel-vaulted ceiling of the 1902 operating room above the modern suspended ceiling	Cotswold Archaeology www.cotswoldarchaeology.co.uk e enquiries@cotswoldarchaeology.co.uk
	Old memorial Hospital, Cirencester HBR
	HOURE TITLE Photograph
	DRAWN BY DJB PROJECT NO. 6008 FIGURE NO. CHECKED BY LM DATE 26-08-2016 APPROVED BY PD SCALE@A4 NA 29

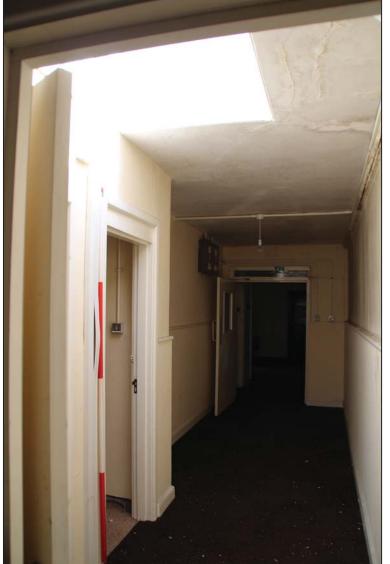
30	The top-lit link to the 1875 rear range. The room on the left is in the link, the corridor runs through the 1875 range and the 1913 block is through the door at the rear.	Cirencester 01285 771022 Exeter 01392 826185 Milton Keynes 01908 564660 www.cotswoldarchaeology.co.uk e enquiries@cotswoldarchaeology.co.uk PROJECT TITLE Old memorial Hospital, Cirencester HBR
		FIGURE TITLE Photograph DRAWN BY DJB PROJECT NO. 6008 FIGURE NO. CHECKED BY LM DATE 26-08-2016 APPROVED BY PD SCALE@A4 NA 30

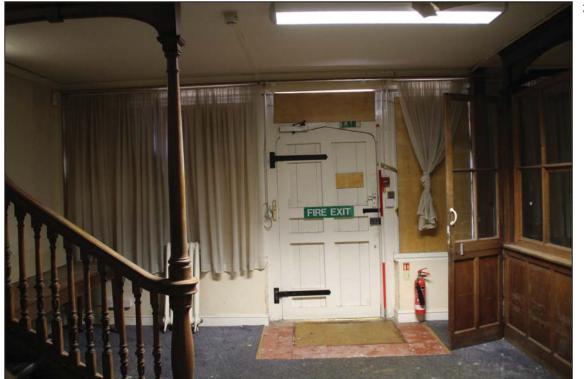
31 The interior of the front door in the entrance hall (scale 2m)	Andover 01264 347630 Cirencester 01285 771022 Exeter 01392 826185 Milton Keynes 01908 564660 w www.cotswoldarchaeology.co.uk e enquiries@cotswoldarchaeology.co.uk
	PROJECT ITTLE Old memorial Hospital, Cirencester HBR
	FIGURE TITLE Photograph
	DRAWN BY DJB PROJECT NO. 6008 FIGURE NO.
	CHECKED BY LM DATE 26-08-2016 APPROVED BY PD SCALE@A4 NA 31

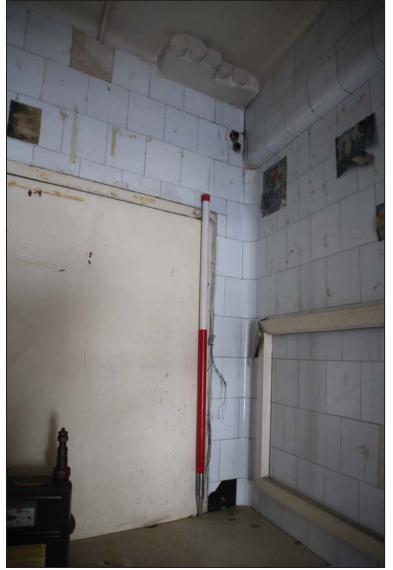
34	Complex all-over tiling in a 1913 room added to the south side of the original building (scale 1m)	Andover 01264 347630 Cirencester 01285 771022 Exeter 01392 826185 Milton Keynes 01908 564660 w www.cotswoldarchaeology.co.uk e enquiries@cotswoldarchaeology.co.uk PROJECT TITLE Old memorial Hospital, Cirencester				
		HBR FIGURE TITLE Photogr DRAWN BY CHECKED BY APPROVED BY	DJB	PROJECT NO. DATE SCALE@A4	6008 26-08-2016 NA	FIGURE NO.

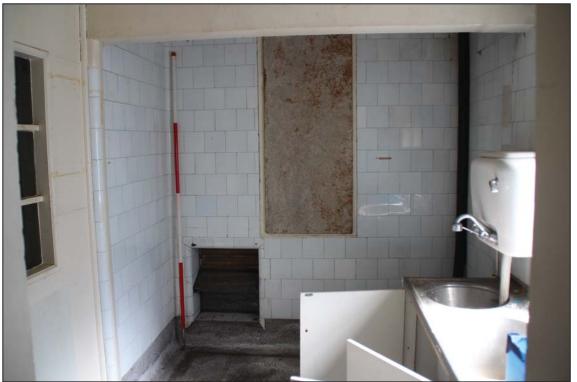
35	Complex all-over tiling in a 1913 room added to the south side of the original building, south of that in Fig. 34 (scale 2m)	Andover 01264 347630 Cirencester 01285 771022 Exeter 01392 826185 Milton Keynes 01908 564660 w www.cotswoldarchaeology.co.uk e enquiries@cotswoldarchaeology.co.uk PROJECT TITLE Old memorial Hospital, Cirencester
		HBR FIGURE TITLE Photograph DRAWN BY DJB PROJECT NO. 6008 FIGURE NO. CHECKED BY LM DATE 26-08-2016 35

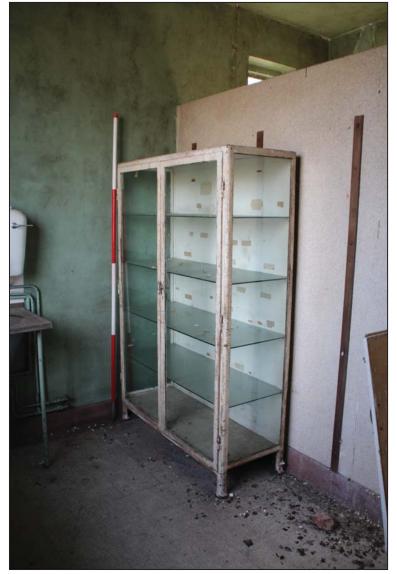
36	The metal-framed glass cabinet made by Edwards Surgical Supplies, in the room next to the operating theatre (scale 2m)	Cirencester 01285 771022 Exeter 01392 826185 Milton Keynes 01908 564660 w www.cotswoldarchaeology.co.uk e enquiries@cotswoldarchaeology.co.uk
		Old memorial Hospital, Cirencester HBR
		FIGURE TITLE Photograph
		DRAWN BY DJB PROJECT NO. 6008 FIGURE NO. CHECKED BY LM DATE 26-08-2016 36 APPROVED BY PD SCALE@A4 NA 36

3.52 In the post-1948 room added to the east of the operating theatre, is a glass, galvanised steel-framed cabinet for surgical supplies. This is likely to date from the 1950s (Fig, 36). It was supplied by Edwards Surgical Supplies London W1, according to a stamped plate screwed to the back-plate. The company was founded in 1900, and incorporated in 1951. As the plaque does not say % dd+, it may be that the cabinet can be dated pre-1951. Stylistically, a mid-century date would fit.
