LAND EAST OF  
LEAFIELD ROAD  
FAIRFORD

# ARCHAEOLOGY & HERITAGE ASSESSMENT

Written by:	BS
Checked by:	HCS
Date:	April 2017
Ref:	GLEE21132_AHA
Revision:	Draft

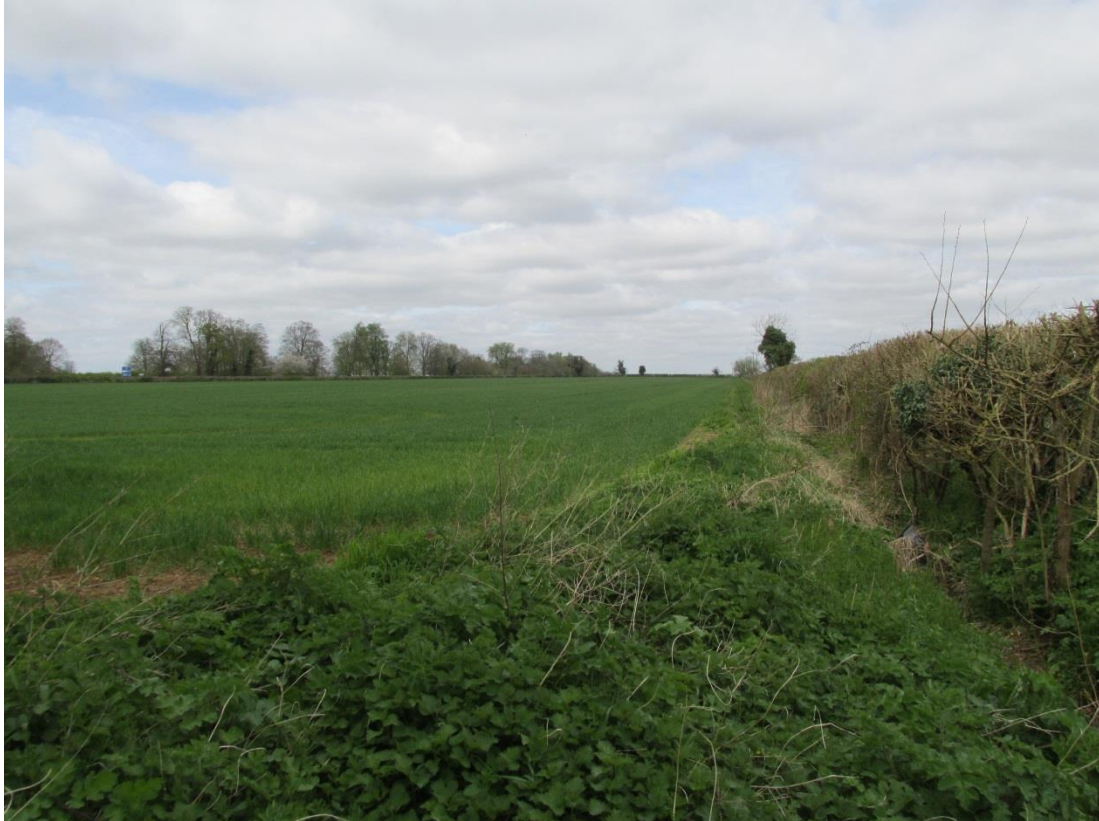
4.32. The site was visited in April 2017 to check for any heritage assets on or close to site and the relationship of the site to nearby designated heritage assets. Current land use was also considered. The site consists of a single field which was under an immature cereal crop when visited. The site's boundaries are defined by hedgerows with ditches (Plate 1). Further fields lie north and east of the site.

*Plate 1: View north west across site from its south eastern corner*

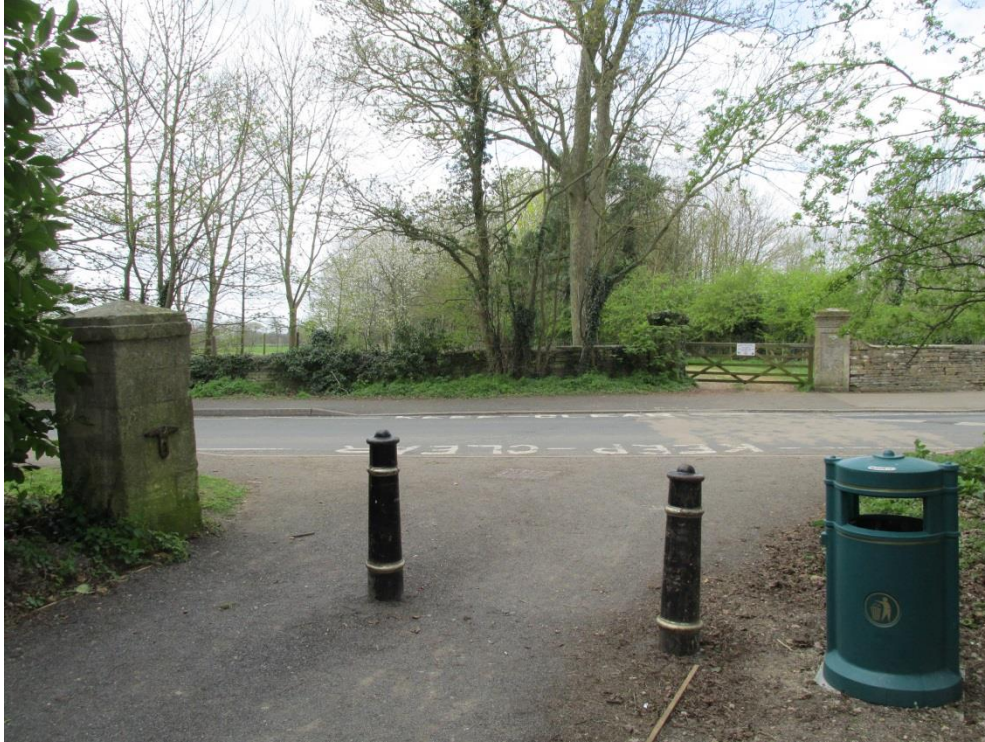
*Plate 2: Fairford Park gate posts on Leafield Road, south of site*

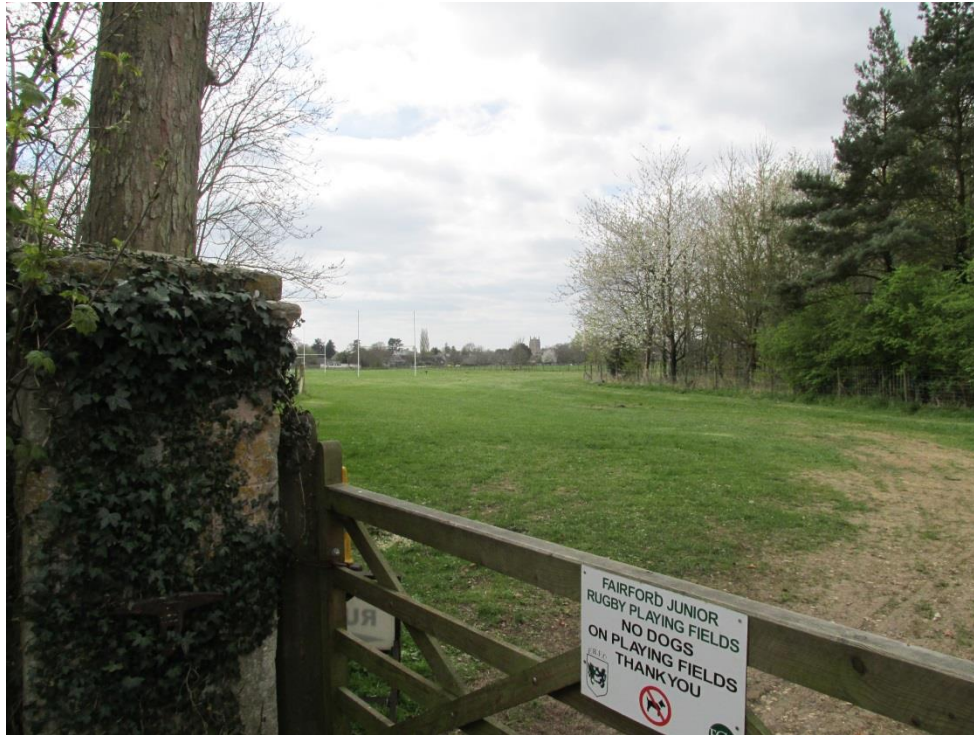
- 4.33. To the south of the site, a relatively recent estate of two storey and gable roofed houses is screened from the site by a belt of woodland which corresponds to that evident on the Tithe and later maps. Between the woodland and houses, a hard surfaced track echoes one shown on historic maps and reflects a route into Fairford Park. Stone gate posts remain at the junction with Leafield Road (Plate 2).
- 4.34. The gate posts lie in the north eastern tip of the Fairford Conservation Area as does open land west of Leafield Road. This is now in use as rugby pitches and has a strong edge of trees and other vegetation. There is no view of St Mary's Church from the site itself, but the tower can be seen from just south of the site (Plate 3).

*Plate 3: View south west towards Fairford from south of site*

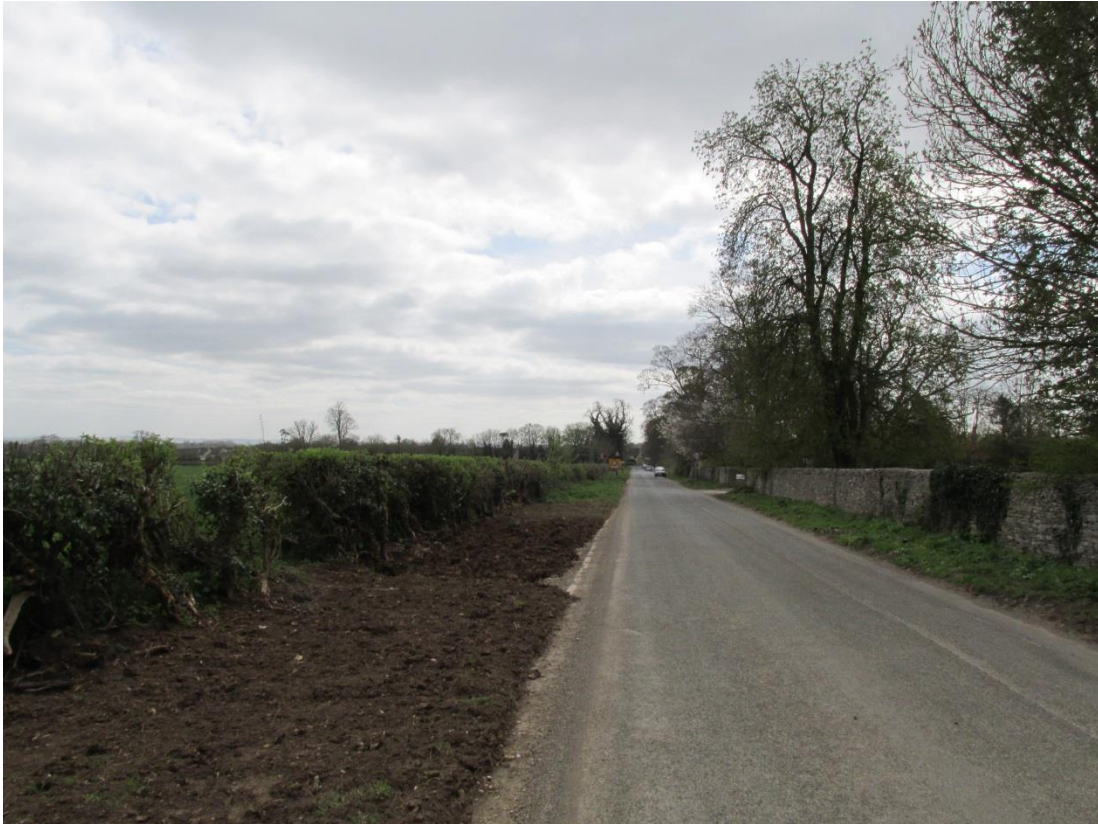
4.36. North of the school area which has a low stone wall and pavement adjacent to Leafield Road itself, a circa 1.5m high stone wall marks the edge of the former park (Plate 4). North of the school is a pasture field with large trees creating a parkland type appearance, albeit obscured by the wall. The field north of this is in arable cultivation. A number of large trees line the eastern side of Leafield Road. There is no view to the obelisk from the site and it was originally placed as the focus for views west of Leafield Road.

*Plate 4: View south along Leafield Road*
