**Management
Asbestos Survey
Report**

**Moreton in Marsh Area Centre
High Street
Moreton in Marsh
GL56 0AX**

**Cotswold District Council
Council Offices
Trinity Road
Cirencester
GL7 1PX**

Ledbury Surveys Ltd

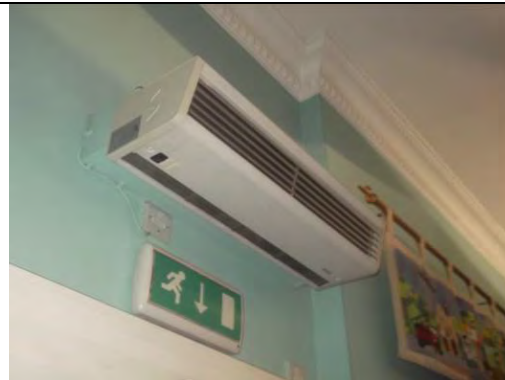
Modern non ACM heater

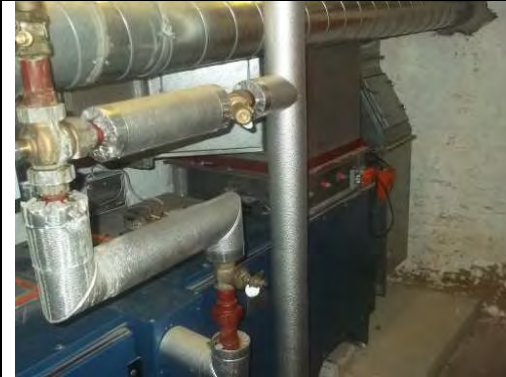
General view of Plant Room. Presumed asbestos gaskets, ropes and seals to plant
Chrysotile

It is recommended that the Presumed items are labelled and monitored in accordance with CAR 2012

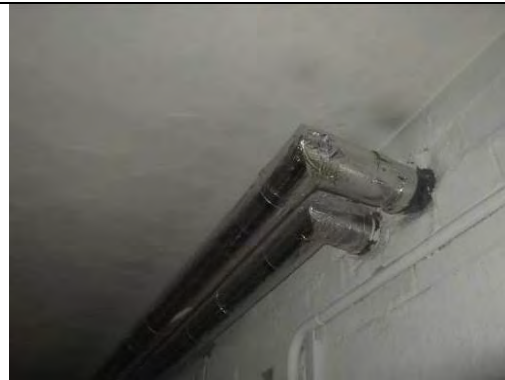
Plastered ceiling and foil wrapped MMMF non ACM lagging to pipes

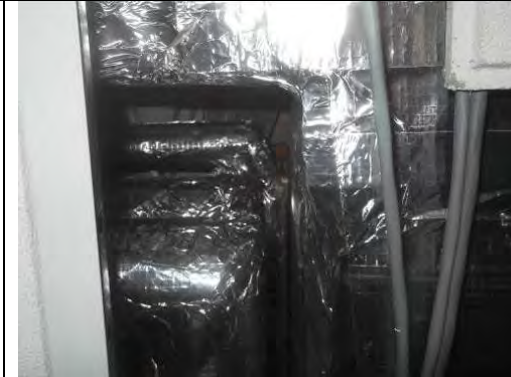
Modern non ACM lagged pipes

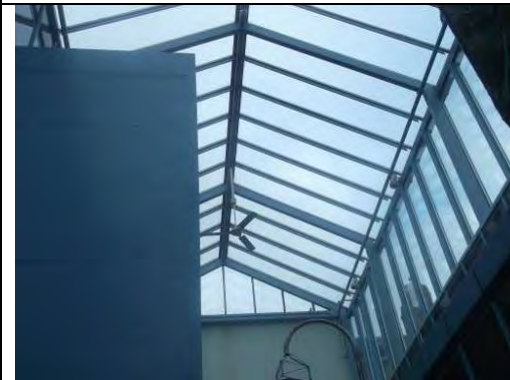
Modern non ACM glass roof lights

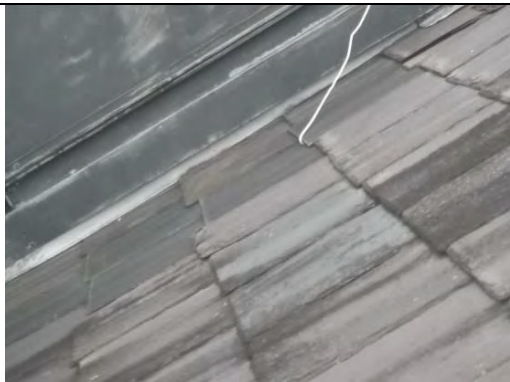
Strongly Presumed cement roof slates intermixed with natural slates

Chrysotile

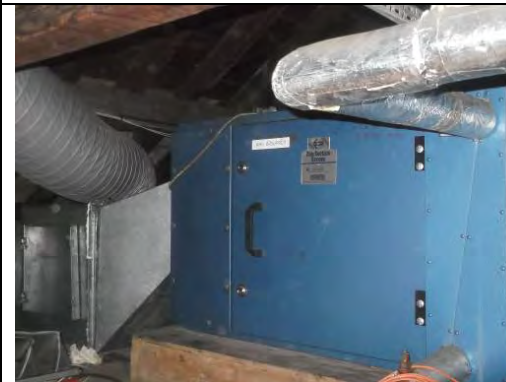
Presumed asbestos gasket, ropes and seals to plant

Chrysotile

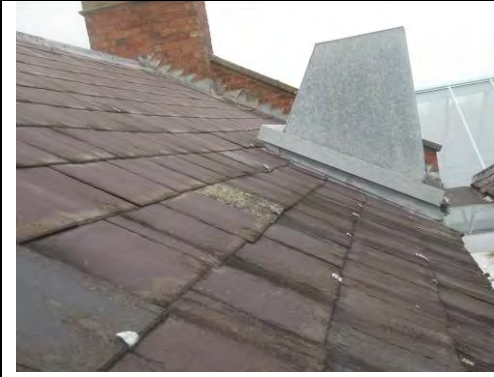
Strongly Presumed cement roof slates
intermixed with natural slates
Chrysotile
