**Management  
Asbestos Survey  
Report**

**Cotswold District Council  
Council Offices  
Trinity Road  
Cirencester  
Gloucestershire  
GL7 1PX**

Trinity Road Offices  
Trinity Road  
Cirencester

**On Behalf of Cotswold District Council**

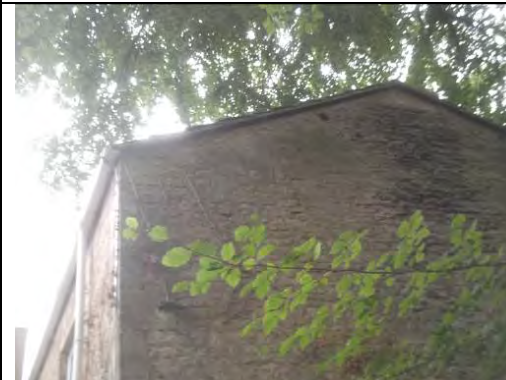
Cement under clocking to roof  
VS to CDCOTR/1  
**Chrysotile**

It is recommended that the proven and presumed items are labelled and monitored in accordance with CAR 2012

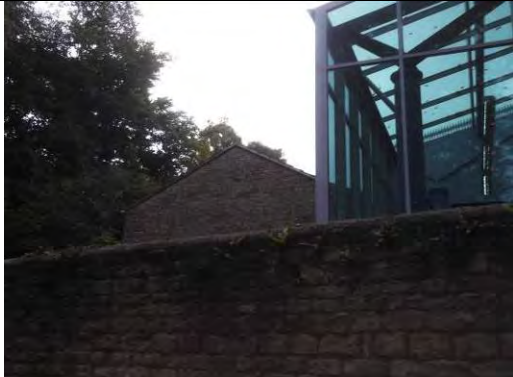
Cement under cladding to roof  
VS to CDCOTR/1  
**Chrysotile**

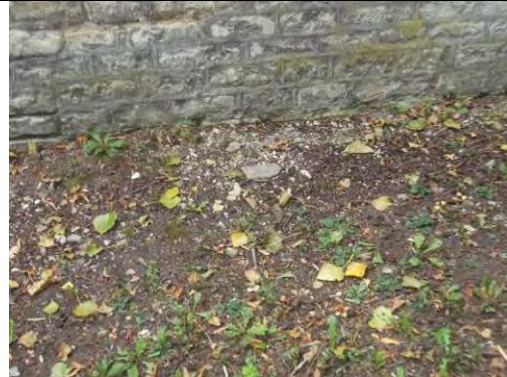
Asbestos cement debris within Garden.  
**Removed**

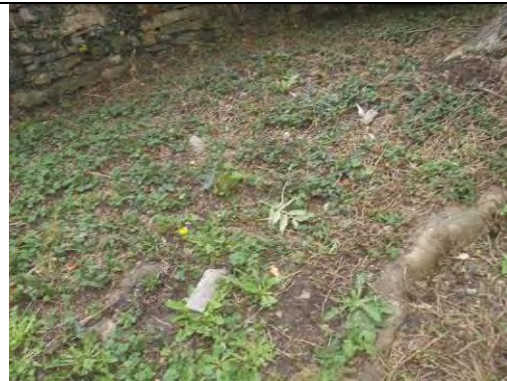
Asbestos cement debris within Garden  
**Removed**

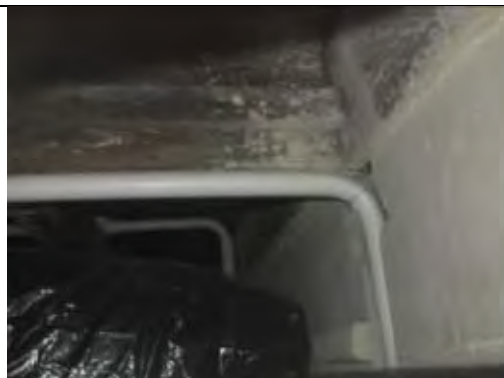
MMM insulation within plastic wrap above suspended ceiling tiles

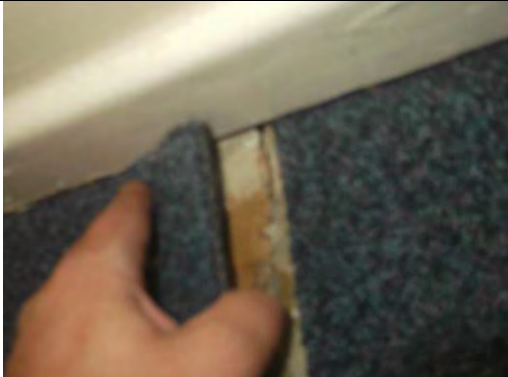
Carpet on concrete

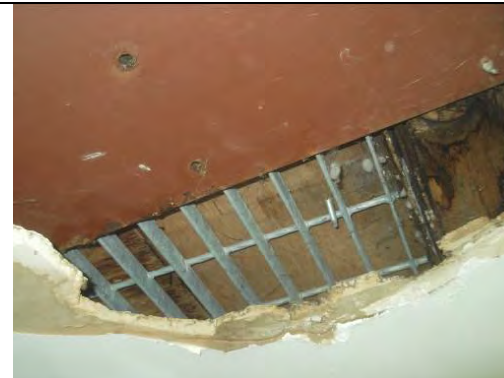
Landing. Painted plastered ceiling with original roof walkway over boarded above

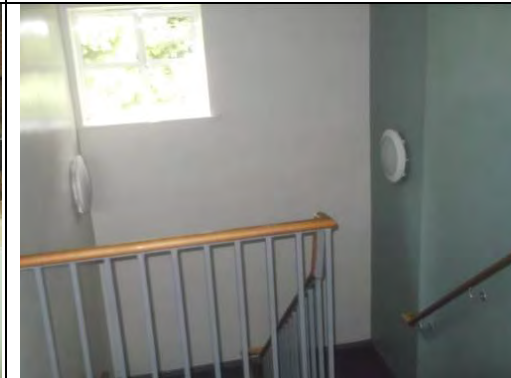
General view of Stairwell

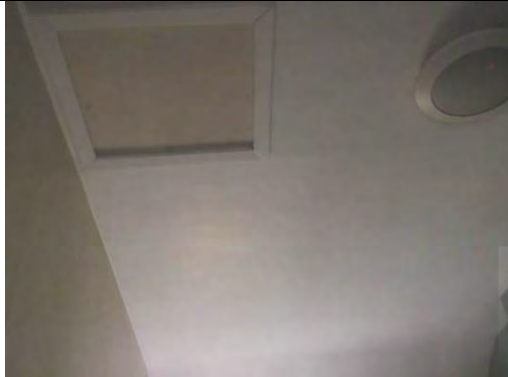
Painted plasterboard ceiling

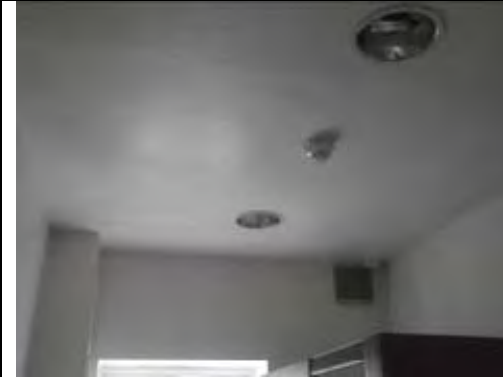
Painted plasterboard ceiling and painted plastered walls

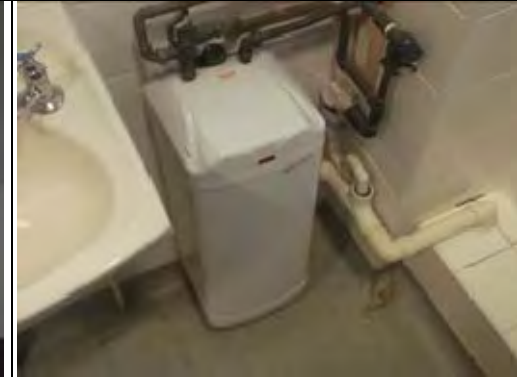
Modern non ACM water heater

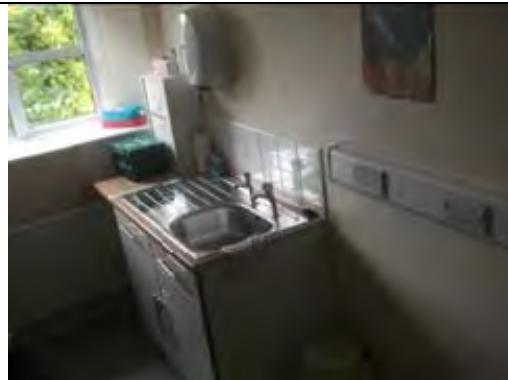
General view of First Aid Room. Modern non ACM kitchen unit

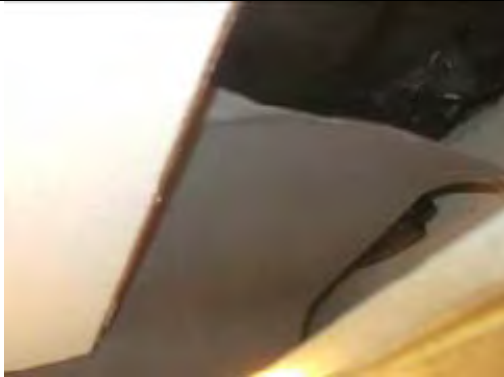
General view above suspended ceiling

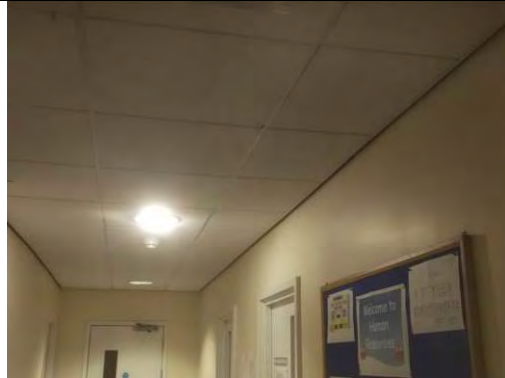
General view of Corridor

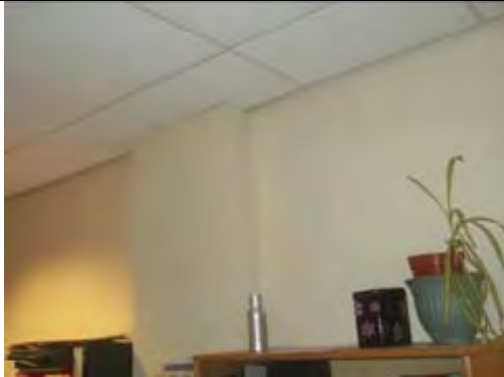
Painted plastered walls

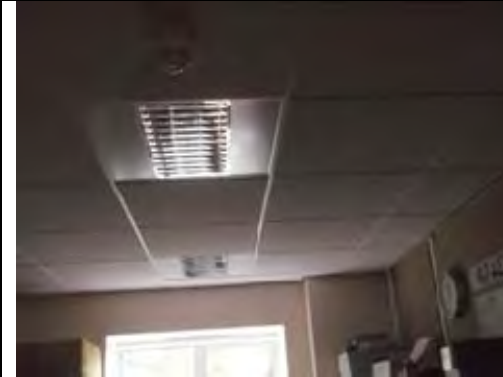
Modern non ACM ceiling tiles

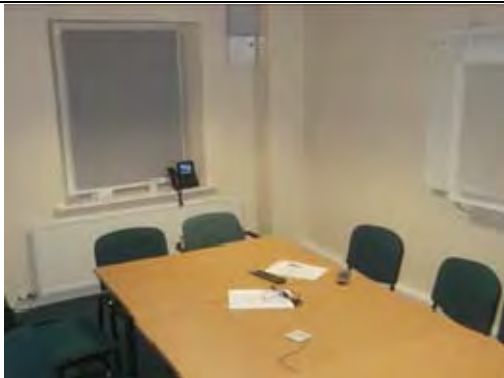
General view of 1.47A

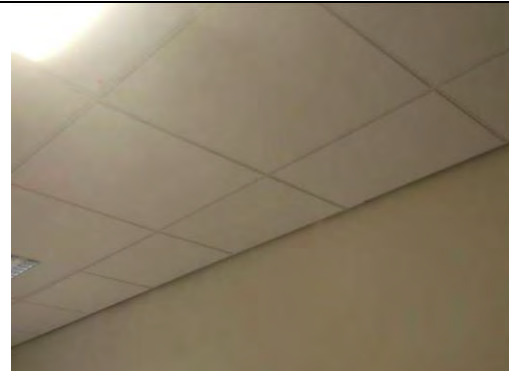
Modern non ACM suspended ceiling tiles and painted plastered wall

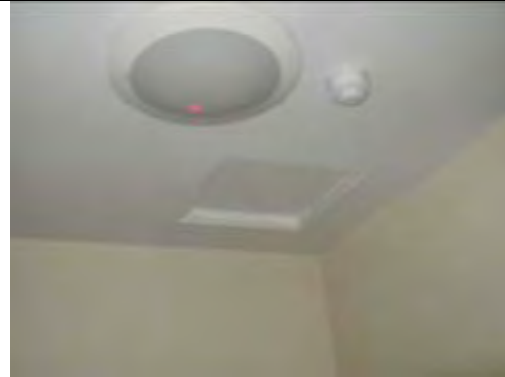
Painted plastered walls and painted plasterboard ceiling

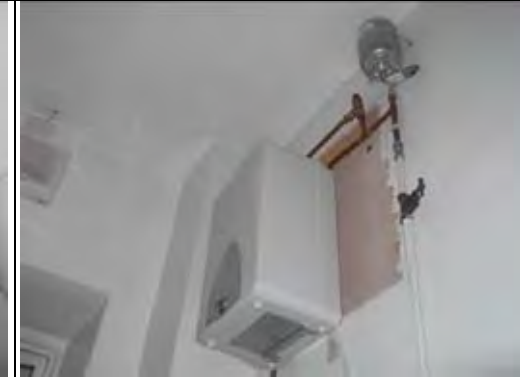
Modern non ACM water heater

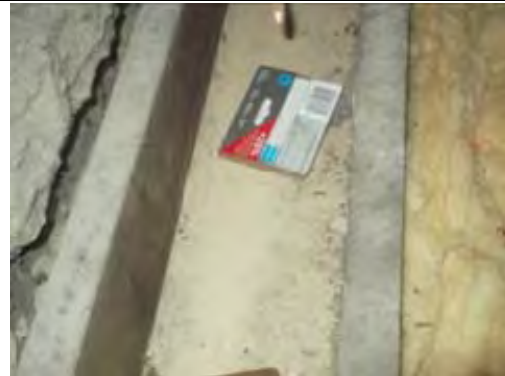
MMMFI insulation above plasterboard ceiling

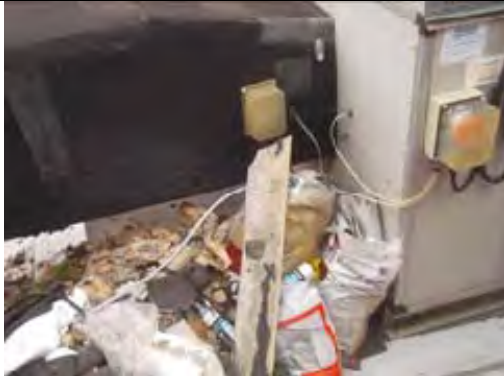
Asbestos cement debris. **Now removed**

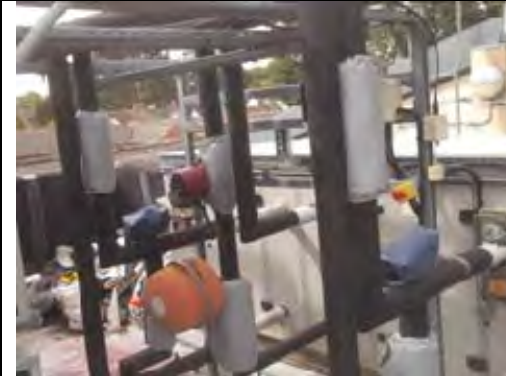
Modern non ACM pipe wrap to air plant

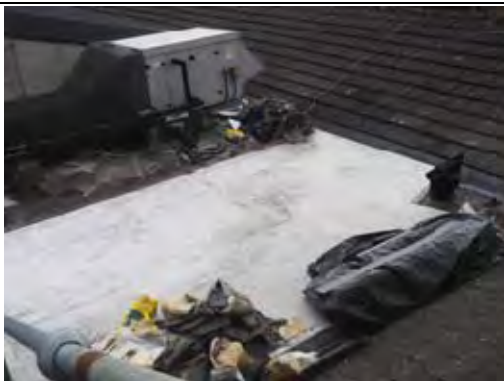
General view of roof. Insulation board debris  
CDCOTR/2  
**NADIS**

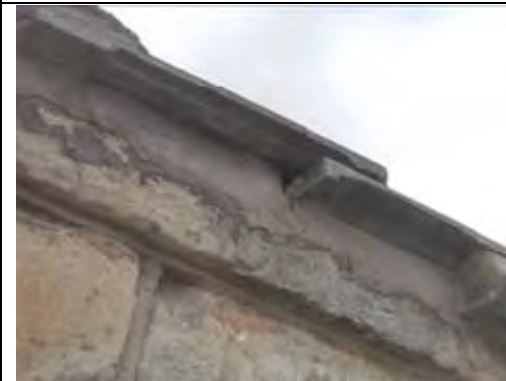
Concrete roof tiles

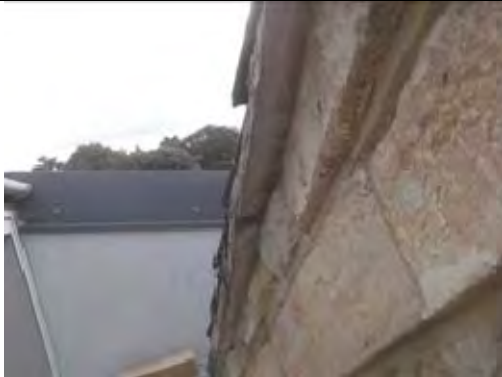
Cement under cloaking to roof  
CDCOTR/1  
**Chrysotile**

It is recommended that any removal of ACMs is undertaken by a licensed contractor and disposed of as Hazardous Waste in accordance with the Hazardous Waste (England) Regulations 2005. All of the remaining ACMs should be labelled and monitored on a regular basis.

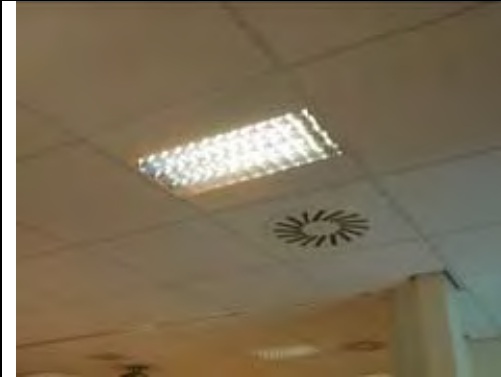
Modern non ACM suspended ceiling tiles

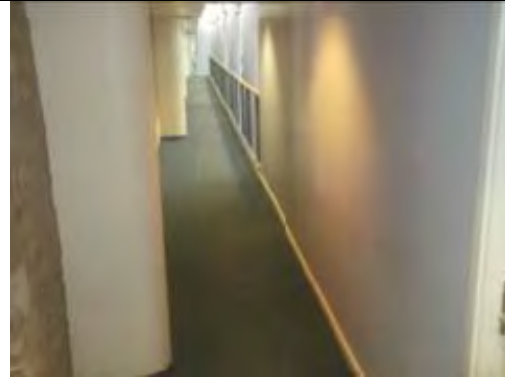
General view of Corridor

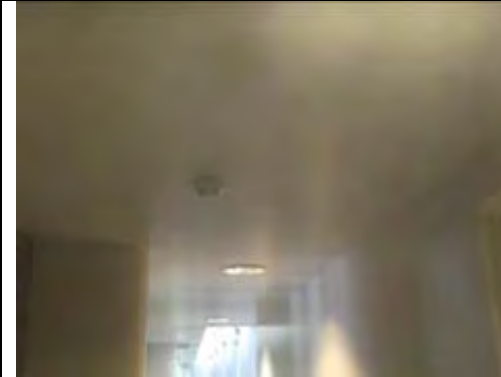
Painted plastered ceiling and walls

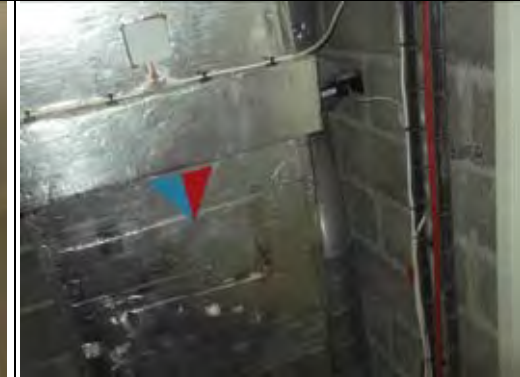
General view of Plant Room with modern non ACM insulation to plant

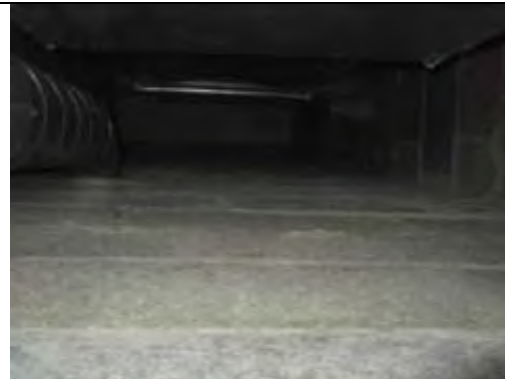
Modern non ACM plant

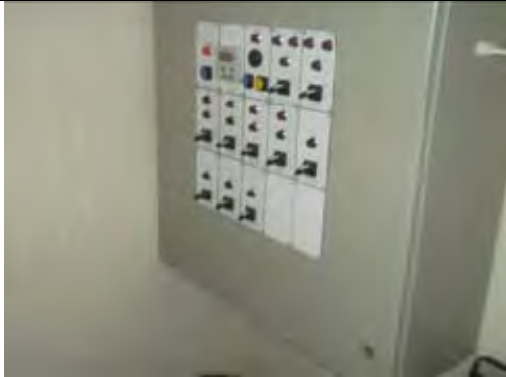
Modern non ACM electrics

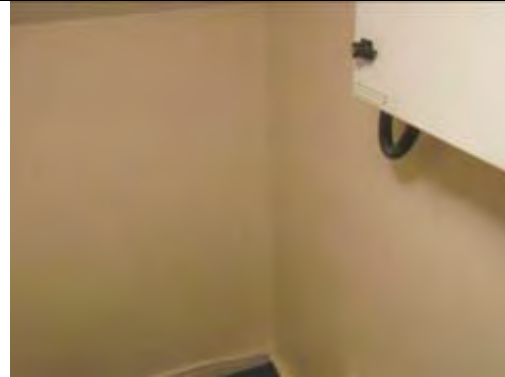
Painted plastered walls

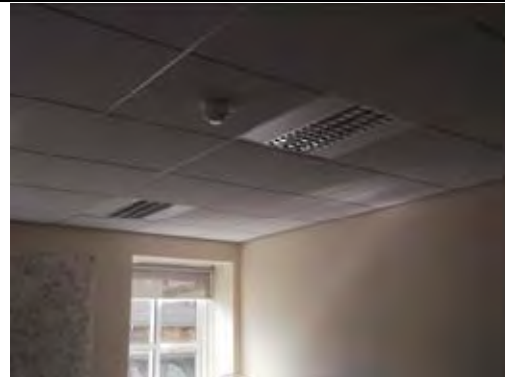
Modern non ACM suspended ceiling tiles and painted plastered walls and painted plasterboard walls

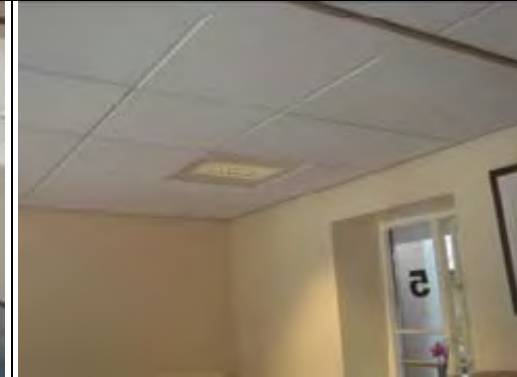
Modern non ACM suspended ceiling tiles and painted plastered and plasterboard walls

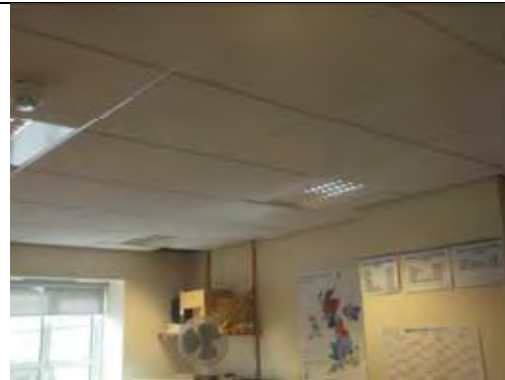
Modern non ACM suspended ceiling tiles and painted plastered and plasterboard walls

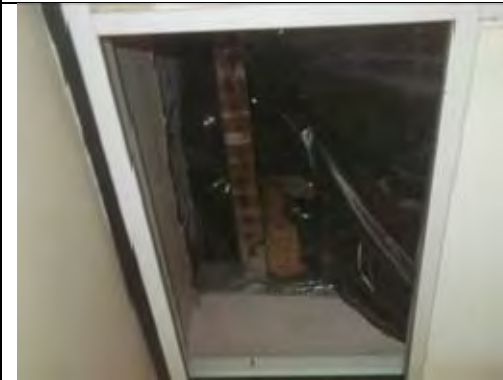
General view above suspended ceiling

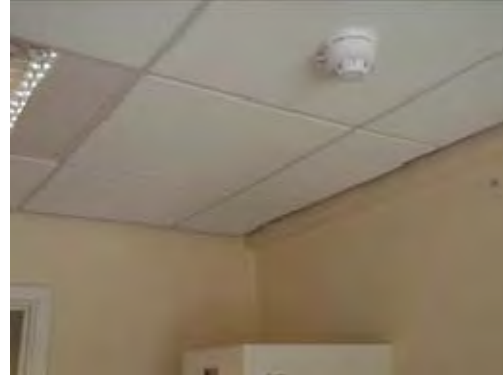
Modern non ACM suspended ceiling tiles

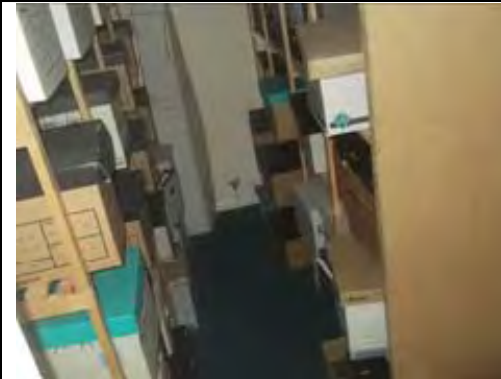
General view of Store

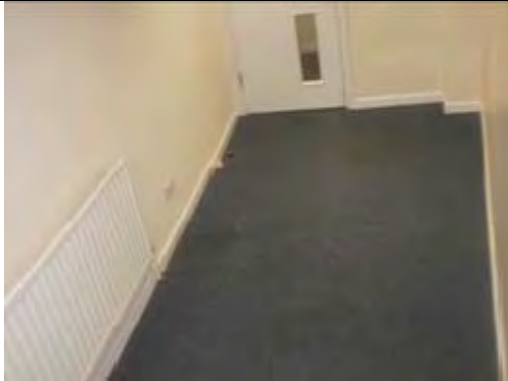
General view of Corridor

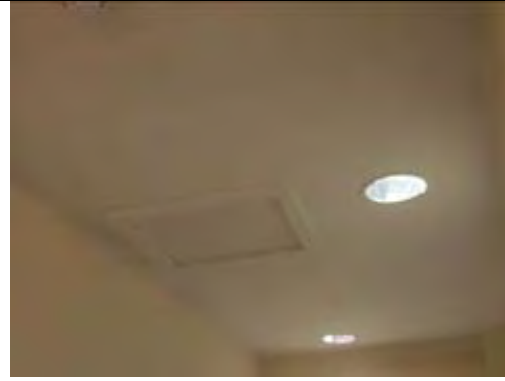
Painted plasterboard walls and ceiling

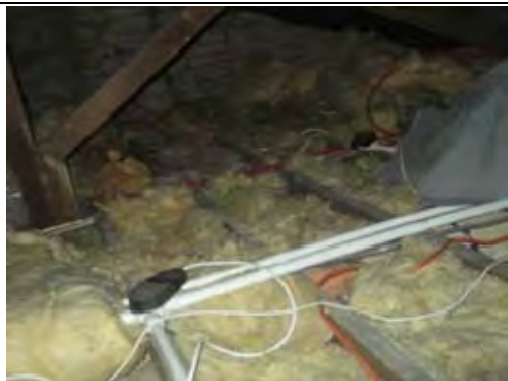
General view within Loft Space with MMMF insulation

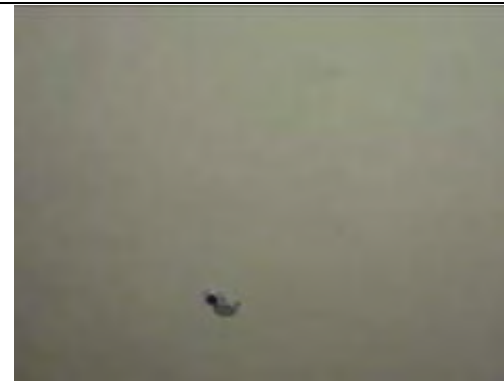
Painted plasterboard ceiling

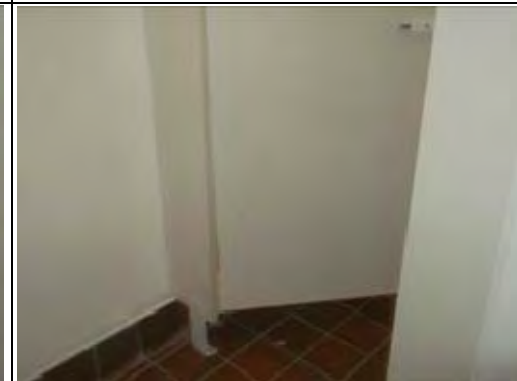
General view of Ladies Toilets

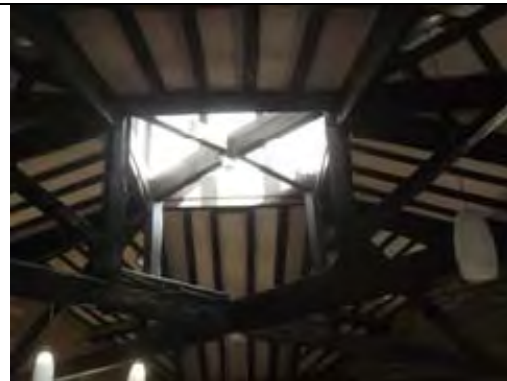
Painted plasterboard lining panels and stone walls

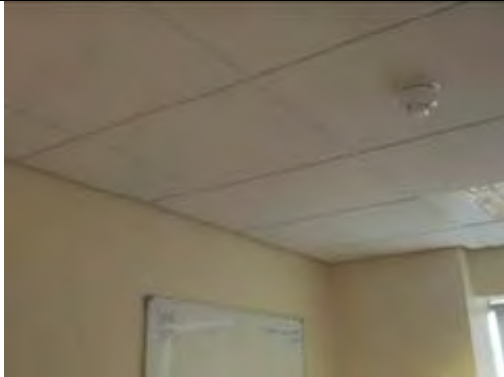
Modern non ACM suspended ceiling

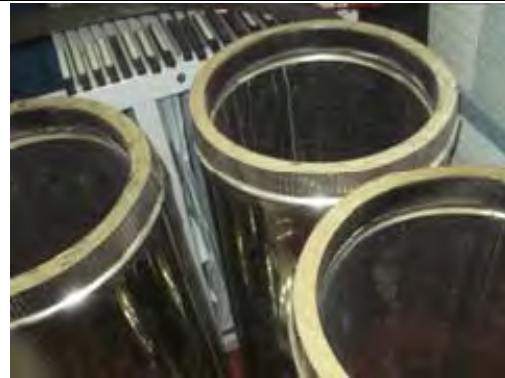
Modern non ACM twin walled flues

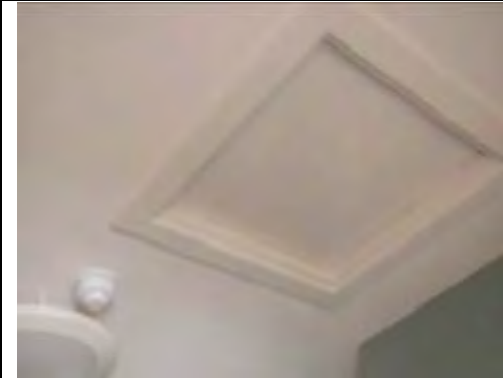
Painted plasterboard ceiling

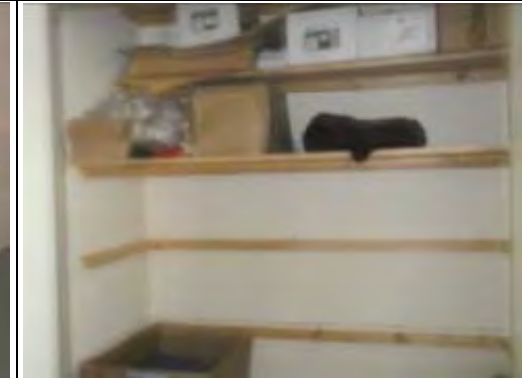
Painted plastered walls

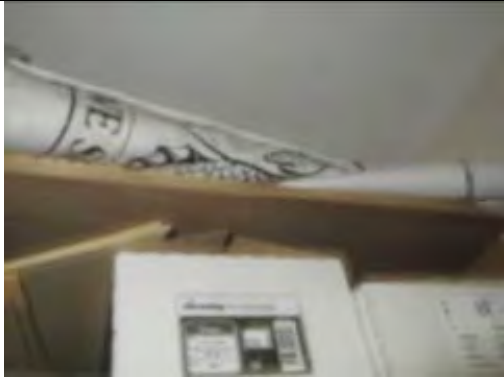
Painted plasterboard ceiling

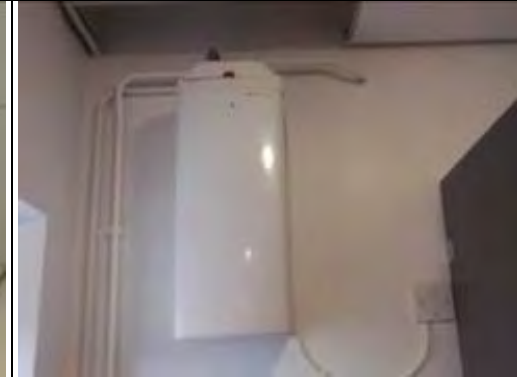
Modern non ACM water heater

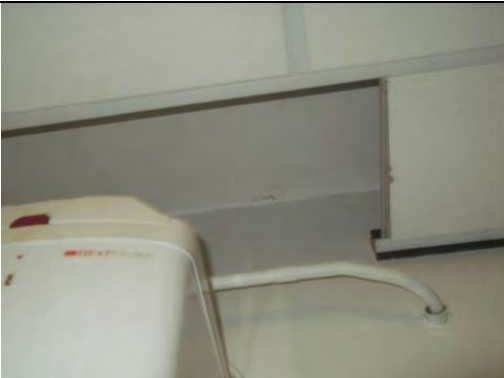
Modern non ACM ceiling tiles

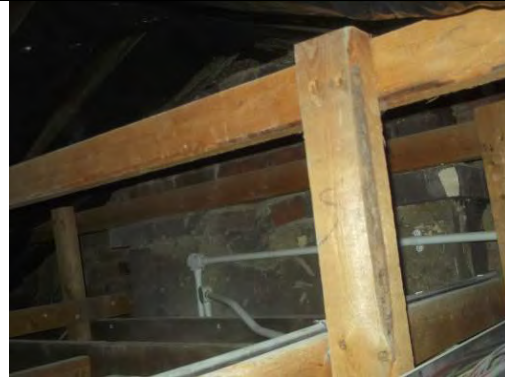
General view above suspended ceiling tiles

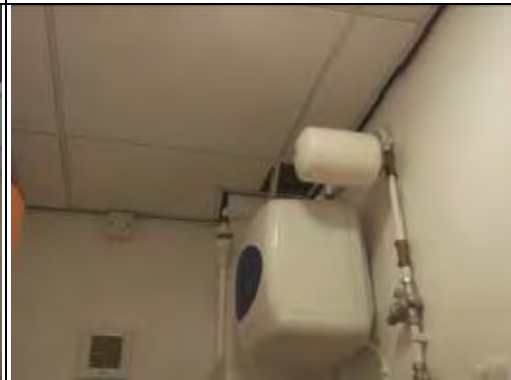
General view of Gents WC with modern non ACM electric water heater

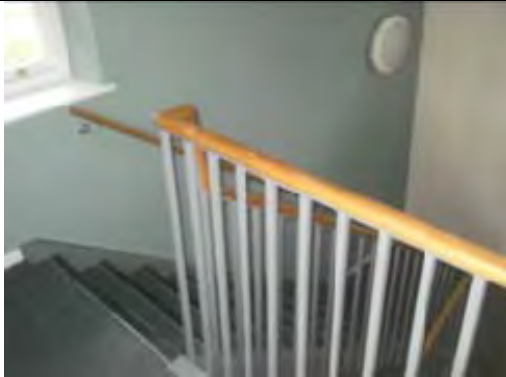
General view of Stairwell

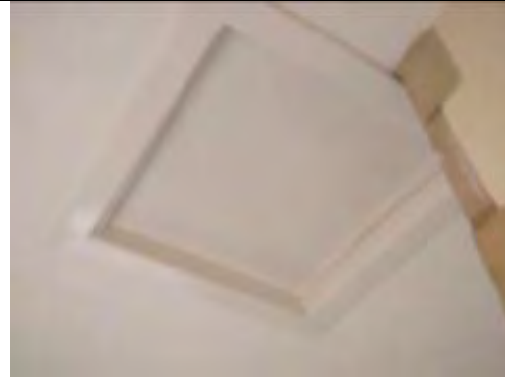
Painted plasterboard ceiling and timber loft hatch

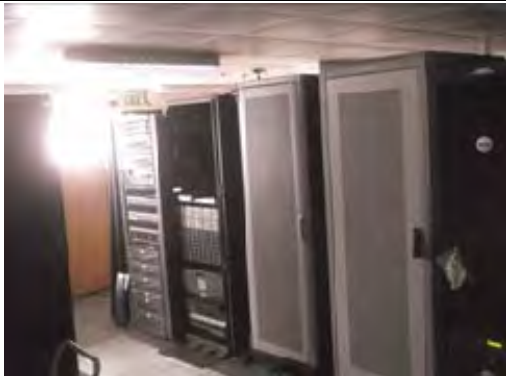
General view of 1.67  
Server Room

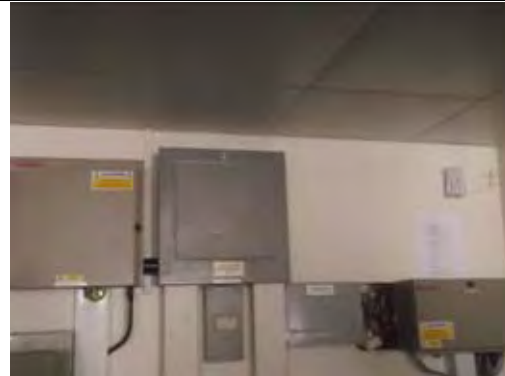
Modern non ACM suspended ceiling tiles and modern non ACM electrics

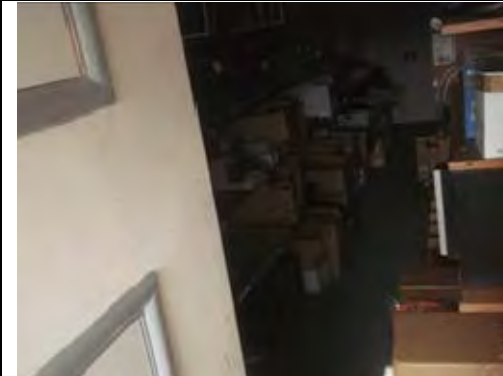
General view of Store

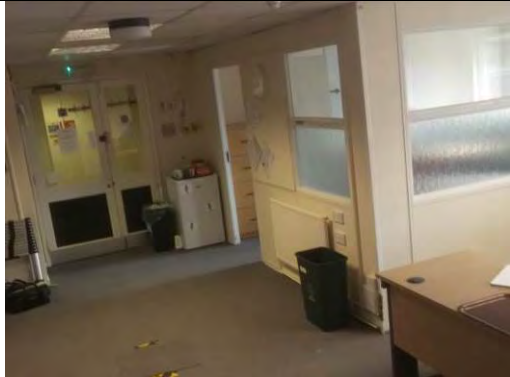
General view of 1.66 and 1.65

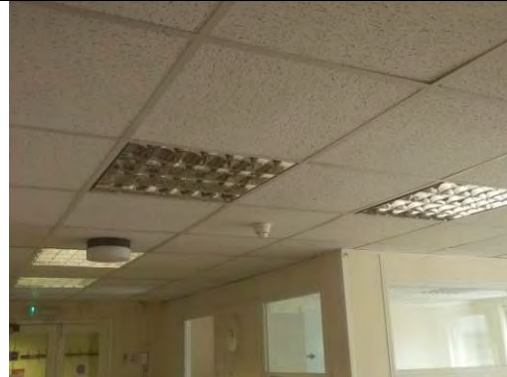
Modern non ACM suspended ceiling tiles and painted plasterboard walls and painted plaster walls

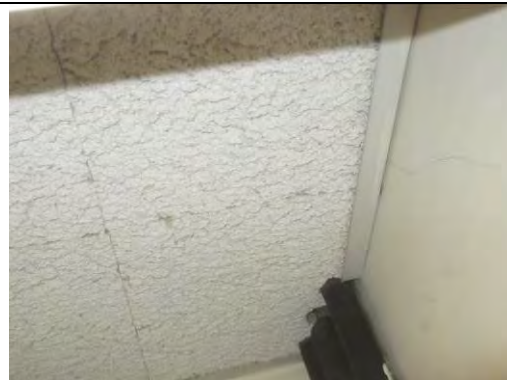
Older style non ACM ceiling

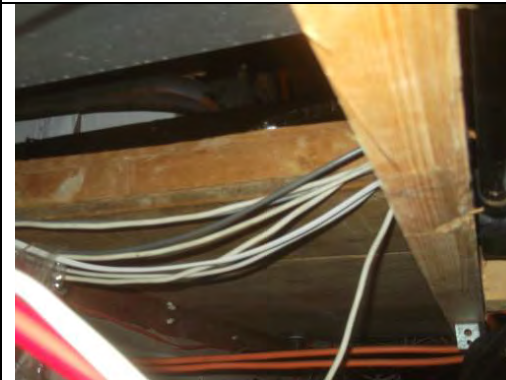
General view above suspended ceiling

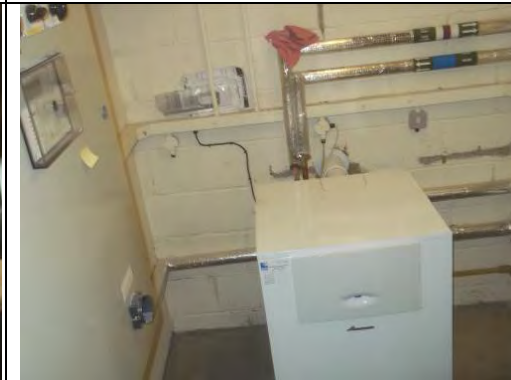
General view of 1.69 Boiler Room with modern non ACM boiler

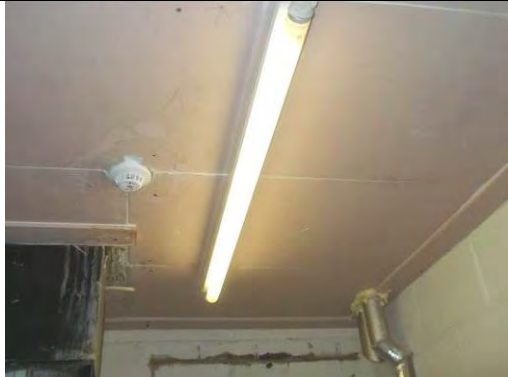
Fire resistant plasterboard ceiling

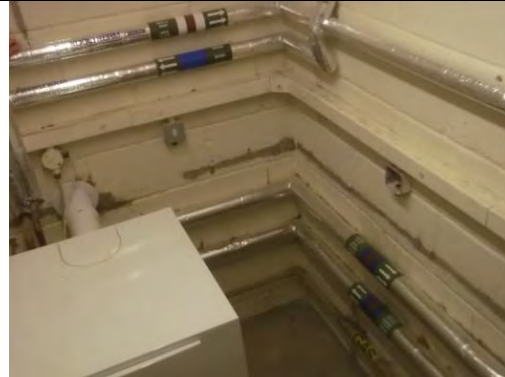
Foam and foil wrap to pipes. Non ACM

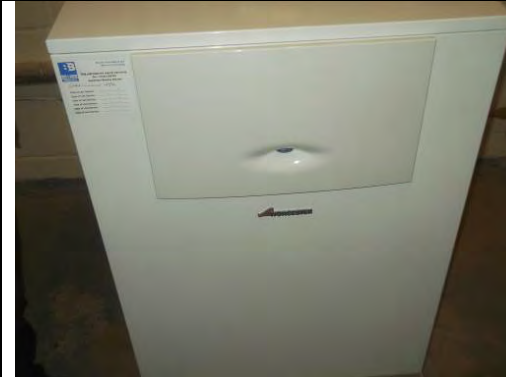
Non ACM boiler

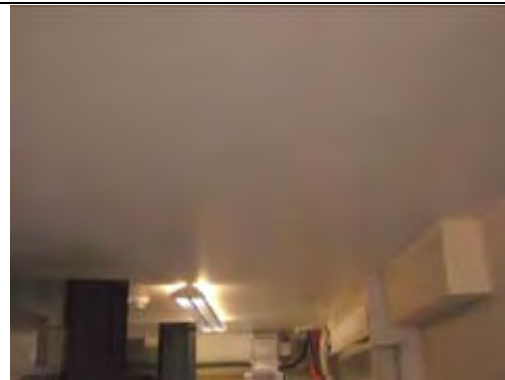
Painted plasterboard ceiling and painted plastered walls

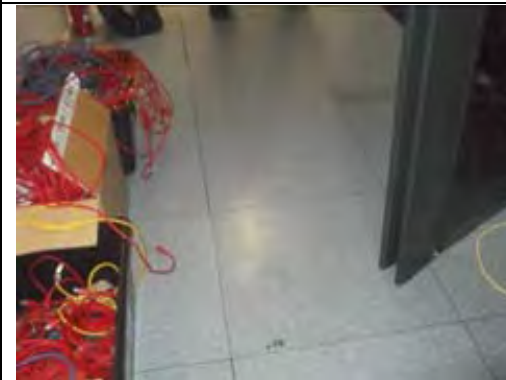
Modern non ACM timber suspended floor with non ACM antistatic flooring

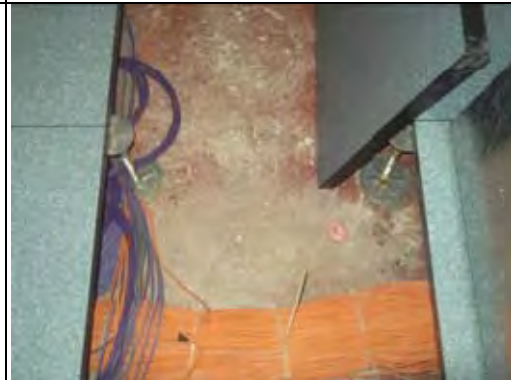
Concrete floor below suspended timber floor

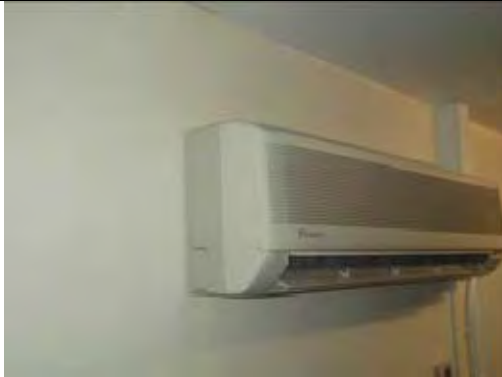
Modern non ACM air conditioning

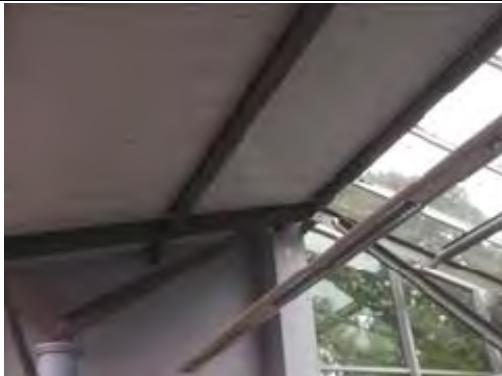
Insulated metal panels to roof

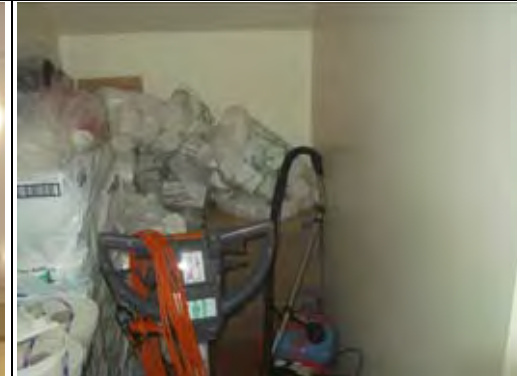
General view of Store

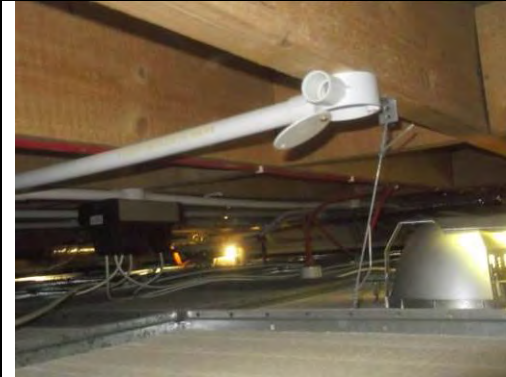
General view above suspended ceiling

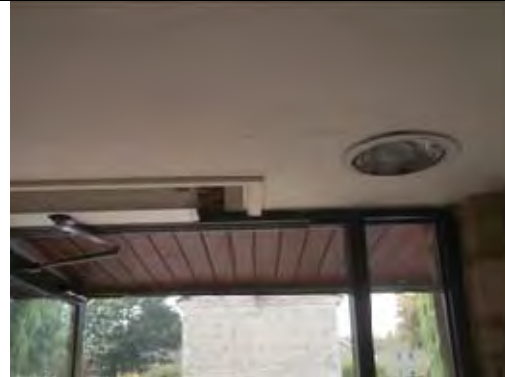
Painted plasterboard ceiling and timber ceiling

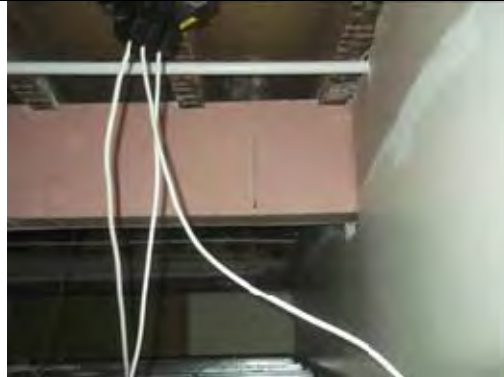
General view above suspended ceiling with modern non ACM fire resistant plasterboard to beam

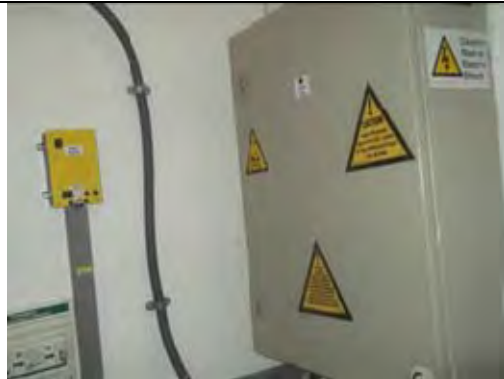
Modern non ACM electrics

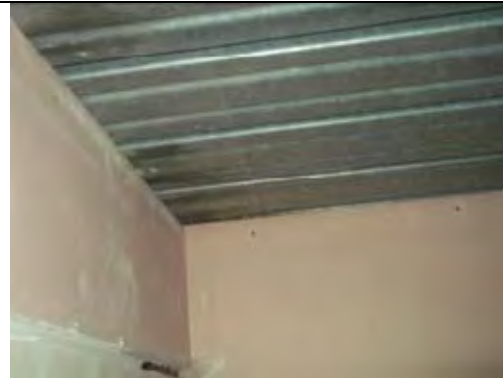
Metal profiled sheet to ceiling above  
suspended ceiling

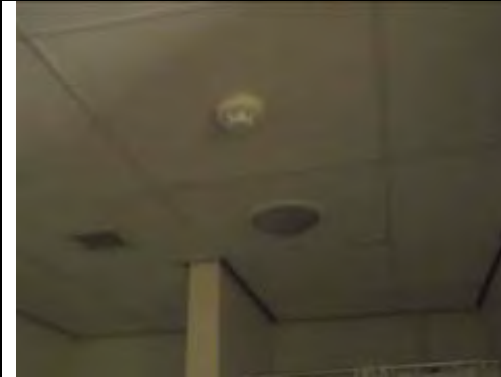
Modern non ACM suspended ceiling tiles

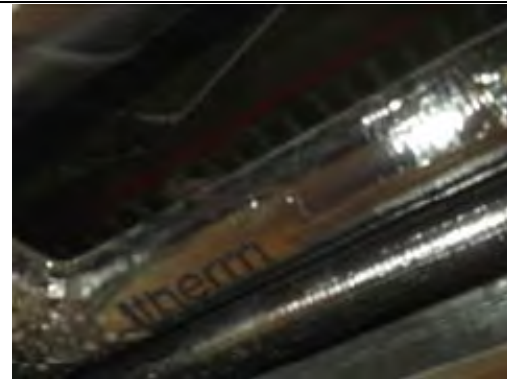
MMMF insulation to pipes with foil wrap

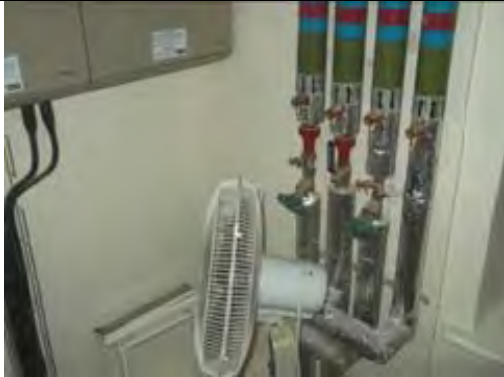
MMMMF and foil wrap to pipes. Non ACM

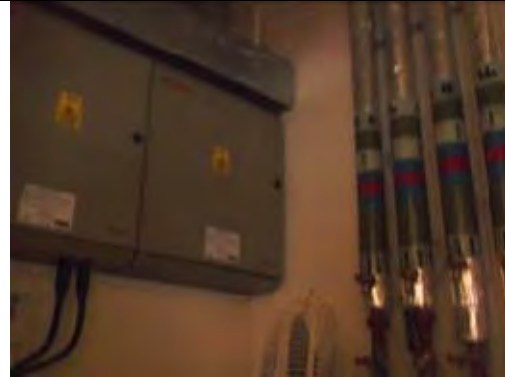
Modern non ACM electrics

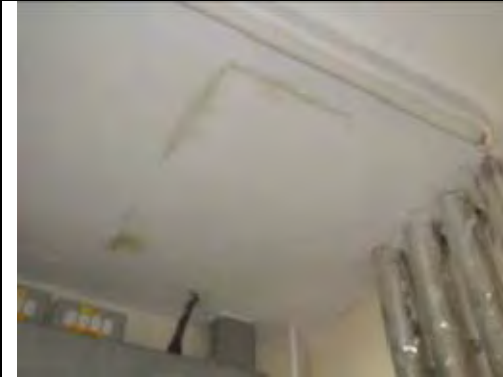
Painted plastered ceiling and non ACM lagged pipes

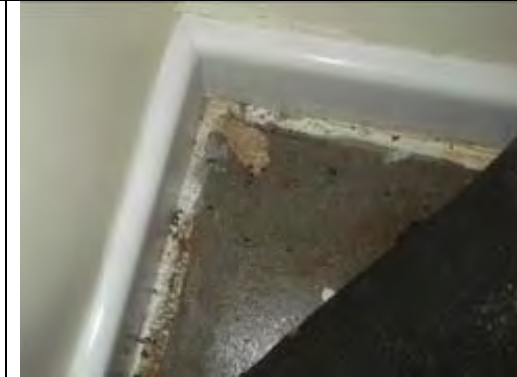
Carpet on concrete

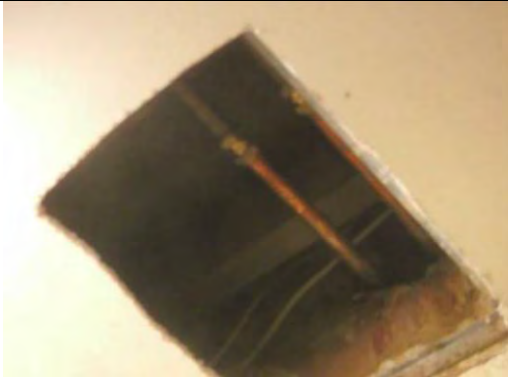
General view above ceiling

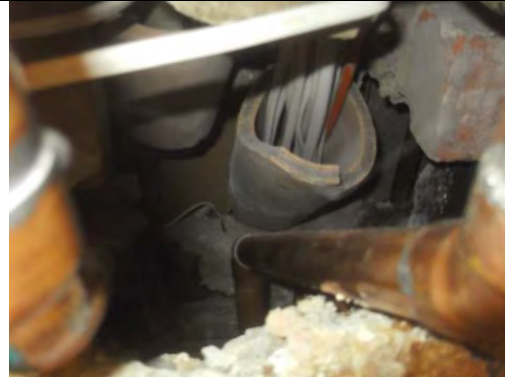
Non ACM pipes

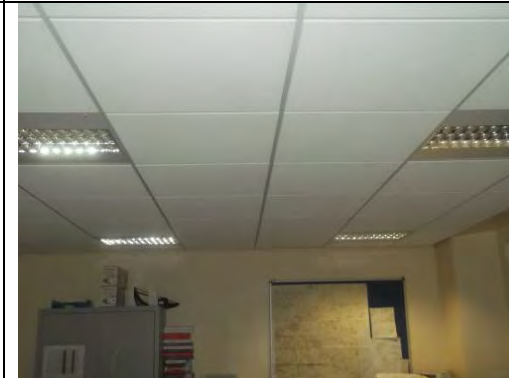
Modern non ACM suspended ceiling tiles

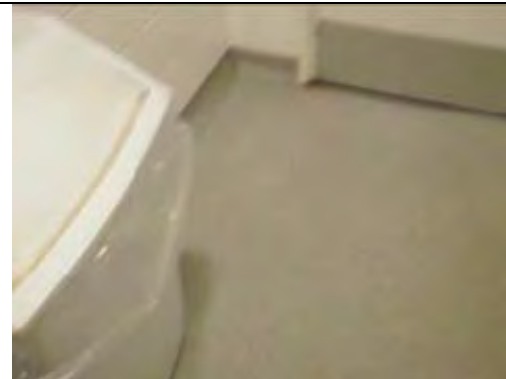
Modern non ACM flooring

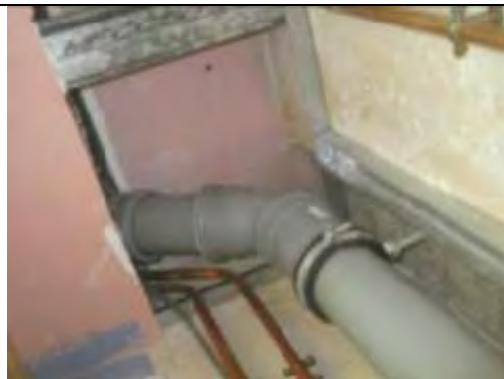
Plastic pipe. Non ACM

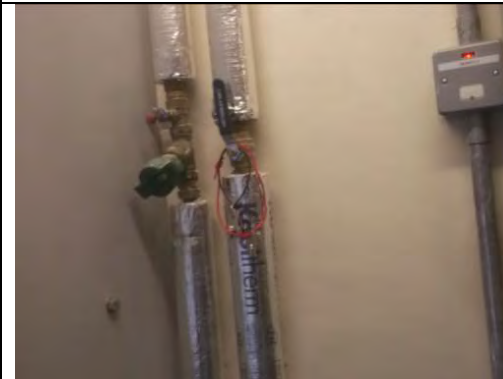
MMMMF insulation with foil wrap to pipes.  
Non ACM

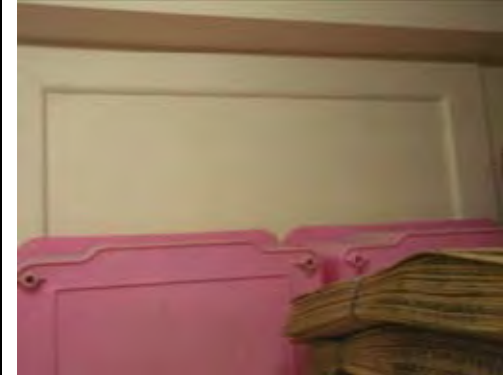
Non ACM panel to wall

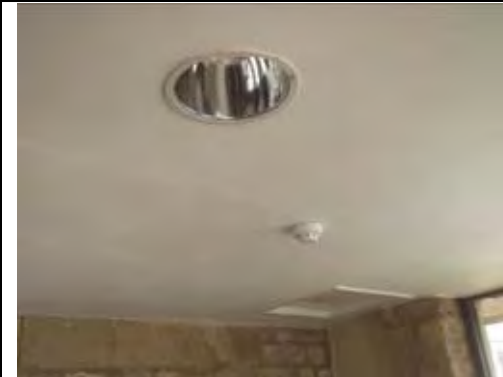
Painted plasterboard ceiling and stone walls

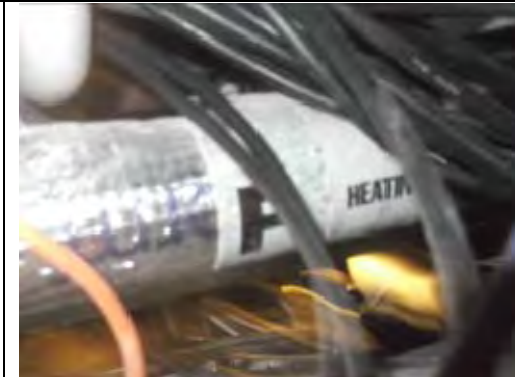
Modern non ACM heating pipes

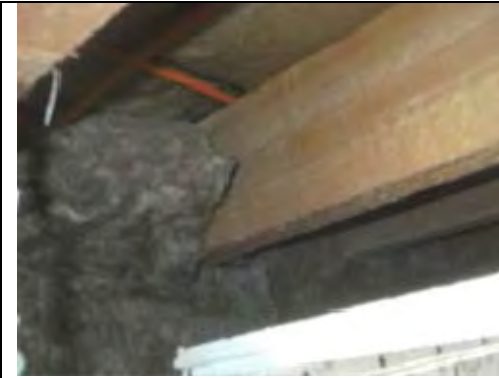
General view above suspended ceiling.  
MMMF insulation. Non ACM

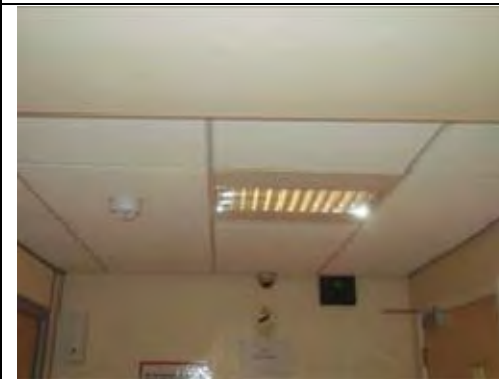
Modern non ACM suspended ceiling tiles and  
painted plastered walls

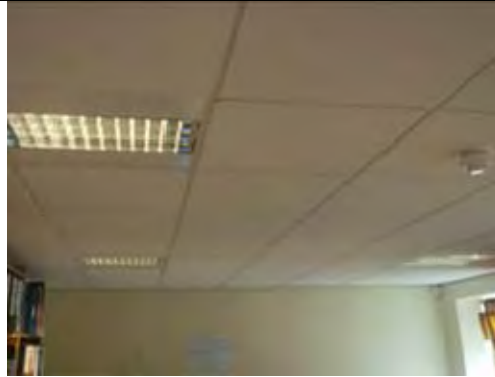
Modern non ACM suspended ceiling tiles and painted plastered walls

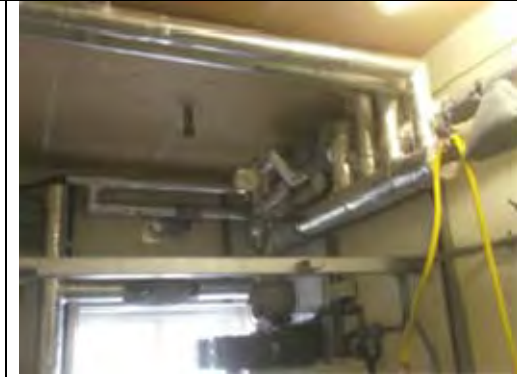
MMMFM and foil wrap to pipes. Non ACM

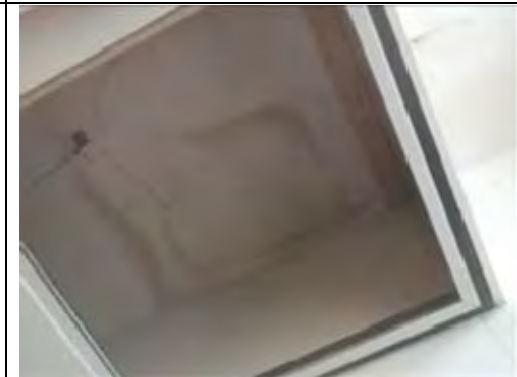
Painted plastered ceiling

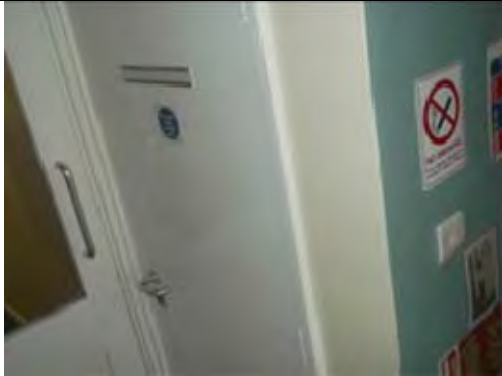
No Access to understairs cupboard

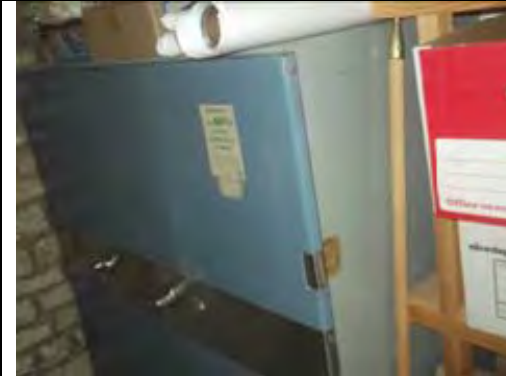
Presumed asbestos insulation board laminate  
to safe  
**Crocidolite**

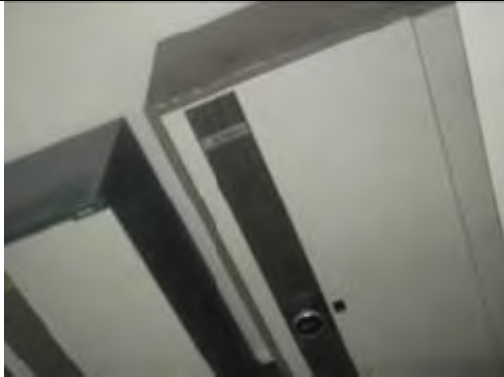
Presumed asbestos insulation board laminate to safes in corridor Opposite 0.25 / 26  
**Crocidolite**

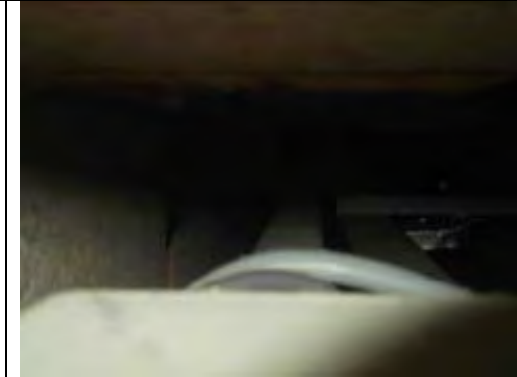
Concrete block lined shaft

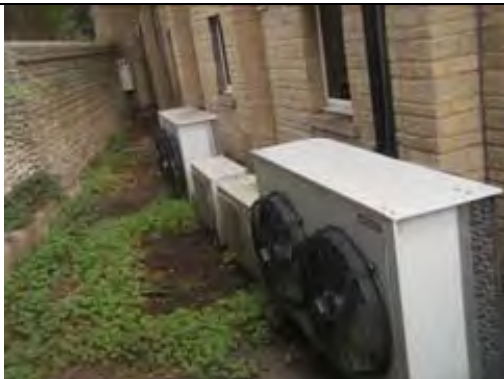
Modern non ACM air conditioning

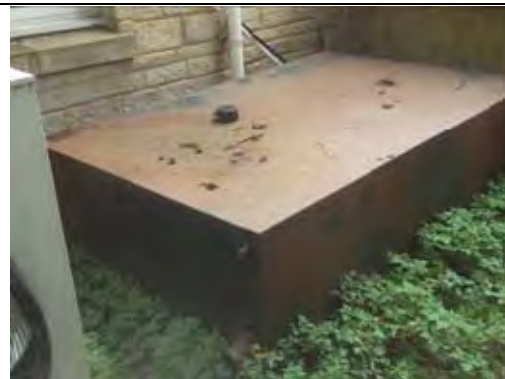
Modern non ACM tank

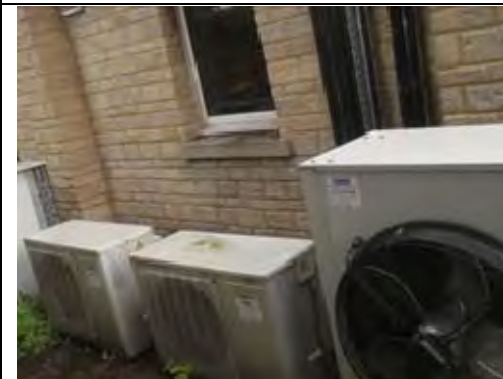
Modern non ACM air conditioning units

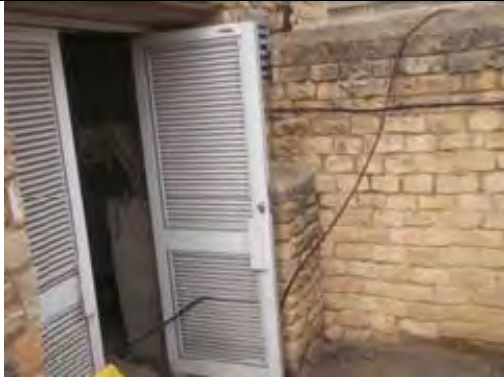
General view of Boiler Room Entrance

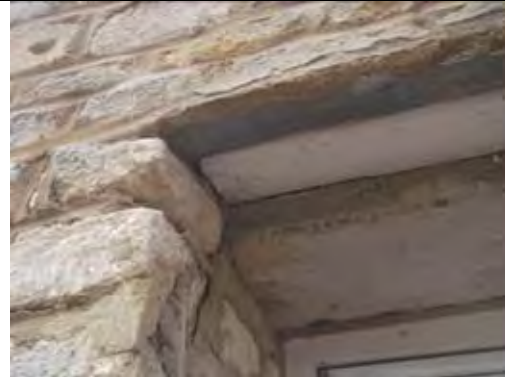
Concrete lintel and timber header to doorway

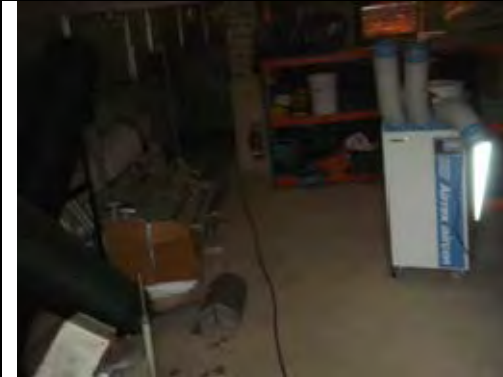
General view of Boiler Room

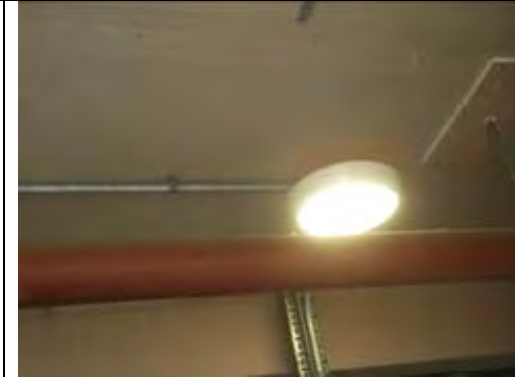
Painted plastered ceiling

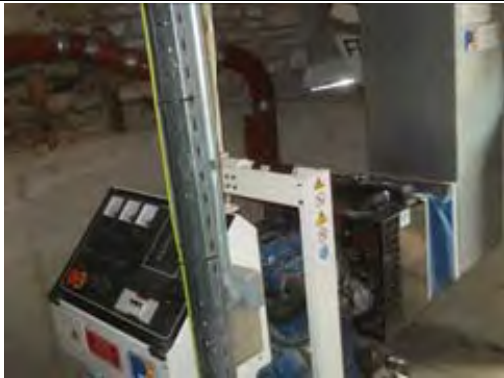
Modern non ACM boiler and exhaust

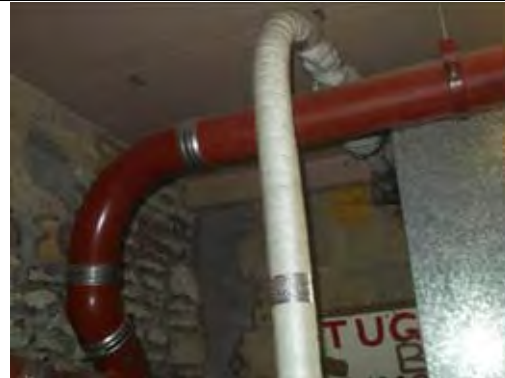
Modern non ACM wrap to exhaust pipes

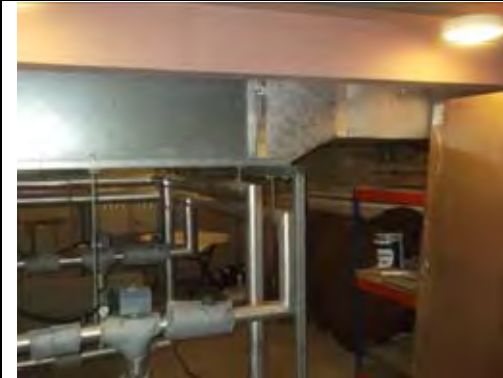
General view of Boiler Room

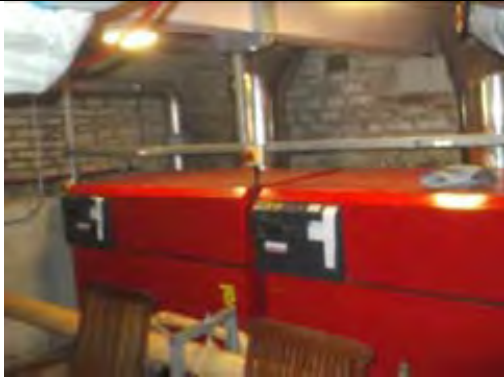
General view of Boiler Room with modern non ACM Boilers
