**Management  
Asbestos Survey  
Report**

**Cotswold District Council  
Council Offices  
Trinity Road  
Cirencester  
Gloucestershire  
GL7 1PX**

Trinity Road Offices  
Trinity Road  
Cirencester

**On Behalf of Cotswold District Council**

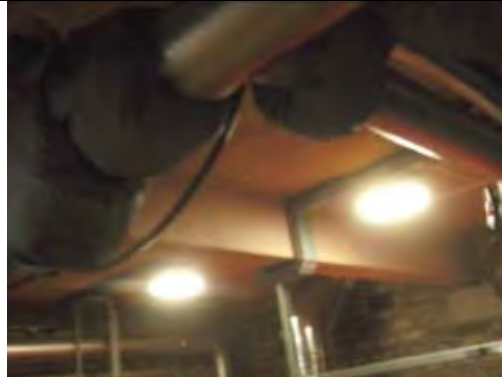
Modern non ACM pipes
