Management Asbestos Survey Report

**44 Black Jack Street
Cirencester
GL7 2AA**

**Cotswold District Council
Council Offices
Trinity Road
Cirencester
Gloucestershire
GL7 1PX**

Management Survey

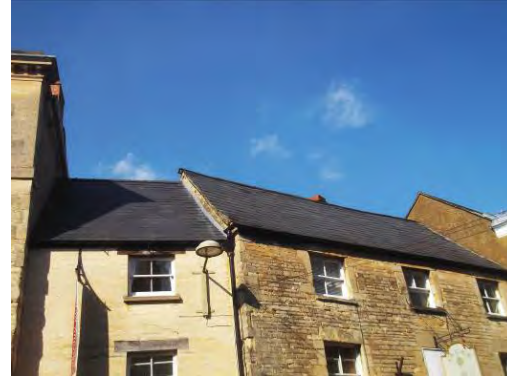
The property was found to be a natural stone building with a pitched tiled roof. The roof tiles were found to be natural slate. The under cloaking to the verge edge of the roof was Strongly Presumed to be asbestos cement.

Stone walls and non ACM roof tiles

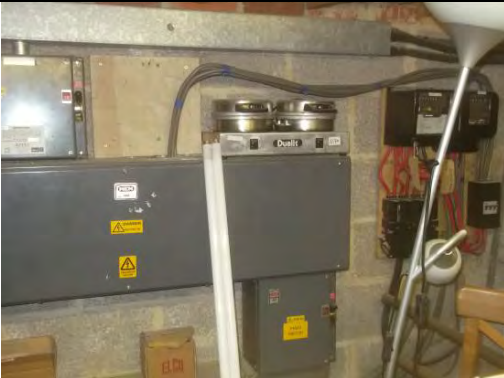
Modern non ACM electrics

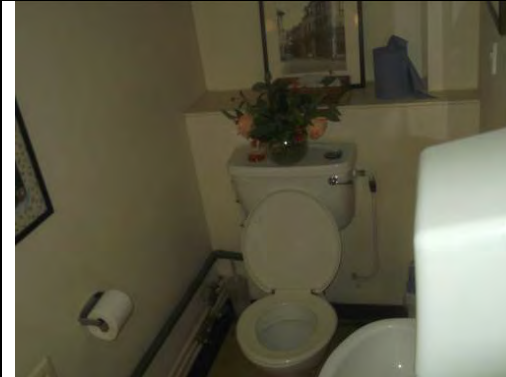
General view of WC. Modern non ACM toilet suite

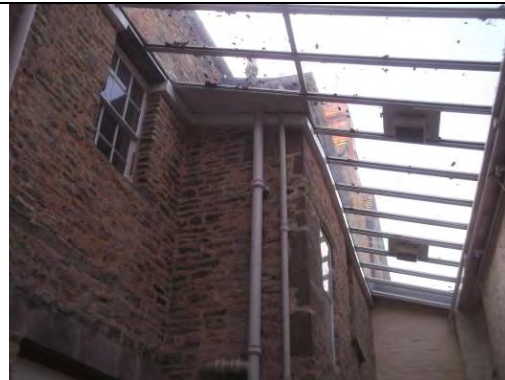
Stone walls and glass roof lights

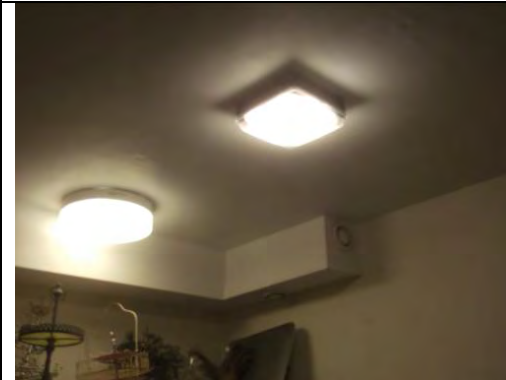
Painted plastered ceiling and non ACM boxwork

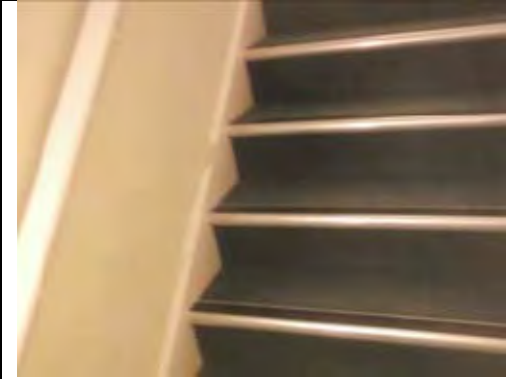
General view of Stairwell. Non ACM stair nosings

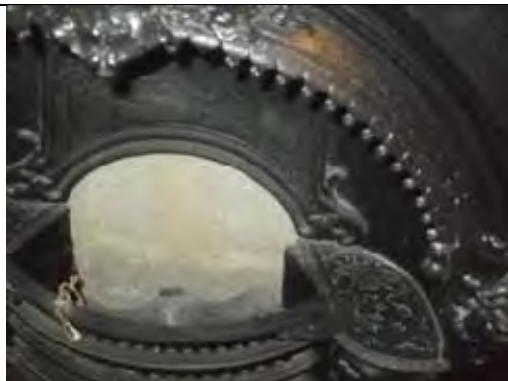
Non ACM fireplace

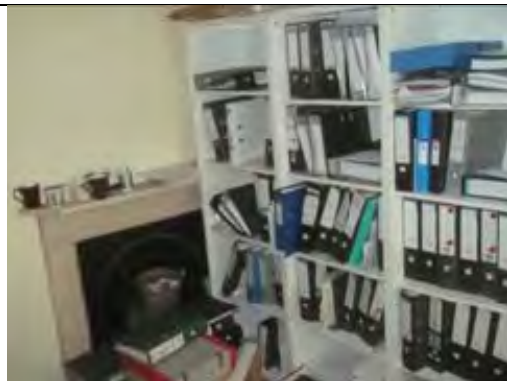
General view of Room 1

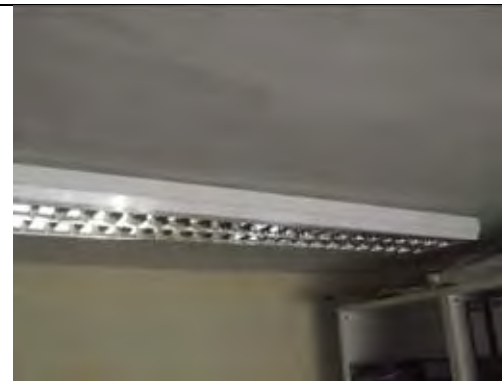
Painted plastered walls and ceiling

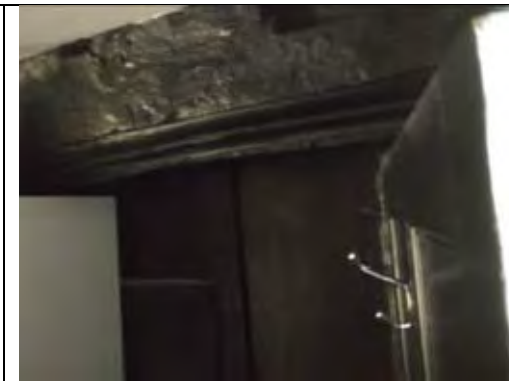
Timber paneling to cupboard beneath stairs

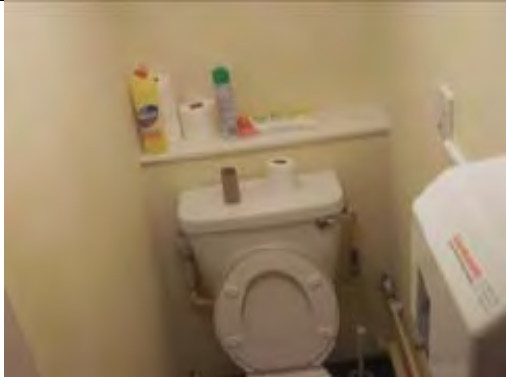
General view of WC

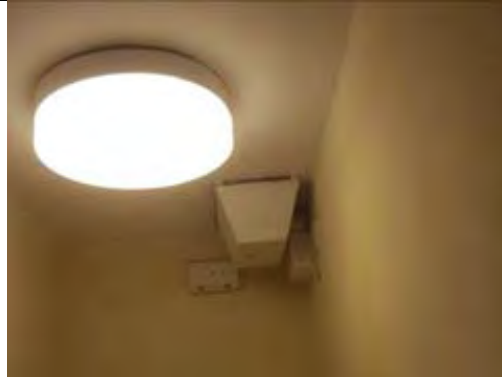
Painted plastered walls and painted plasterboard ceiling

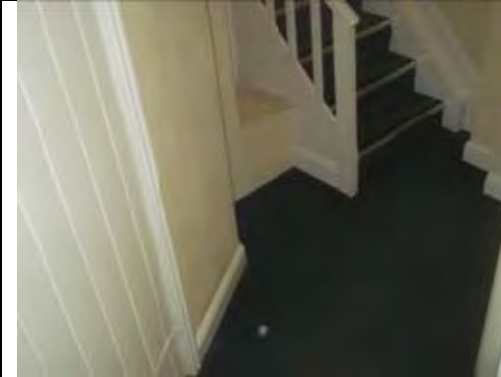
General view of Stairs leading to Room 3 with modern non ACM stair nosing

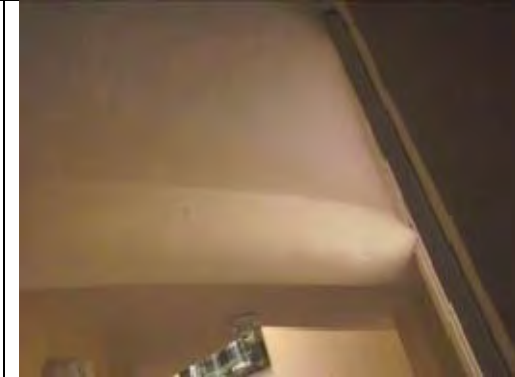
Painted plastered walls

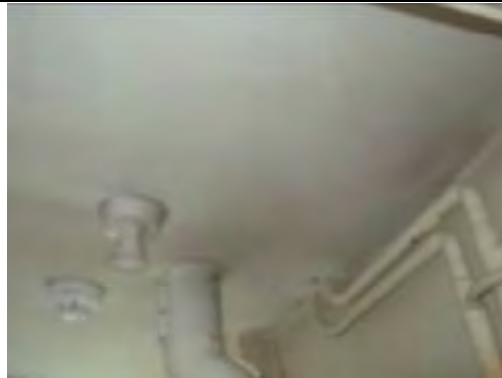
Painted plastered ceiling

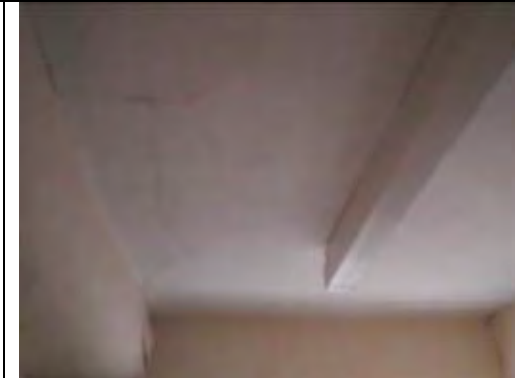
Painted plastered walls and painted plasterboard ceiling

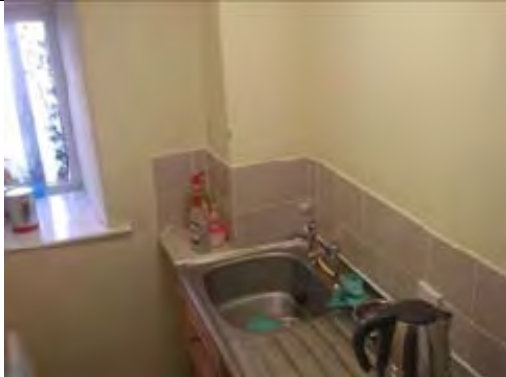
General view of Tea Room

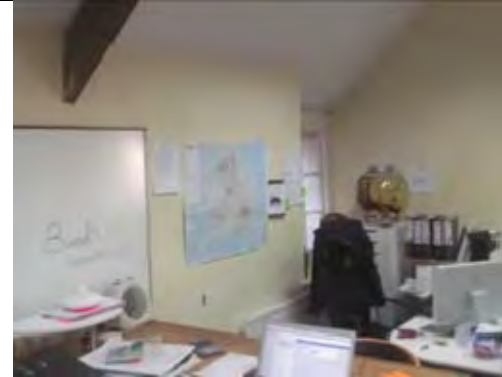
General view of Room 3

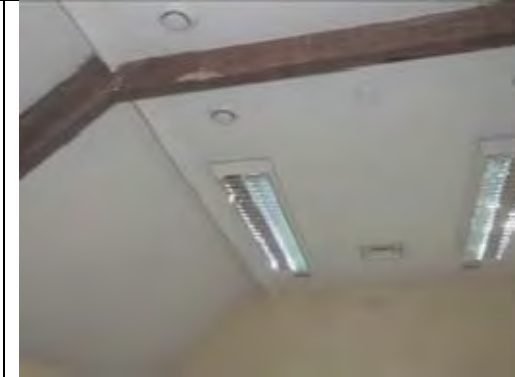
Painted plasterboard ceiling

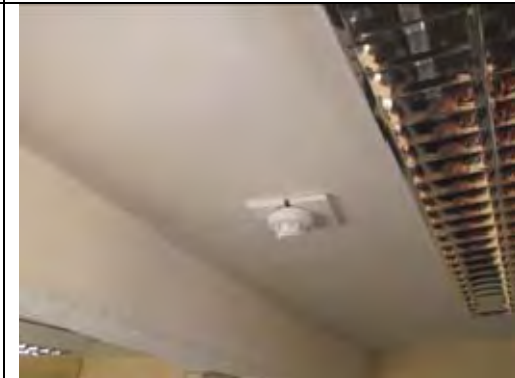
Painted plastered walls and painted plasterboard ceiling

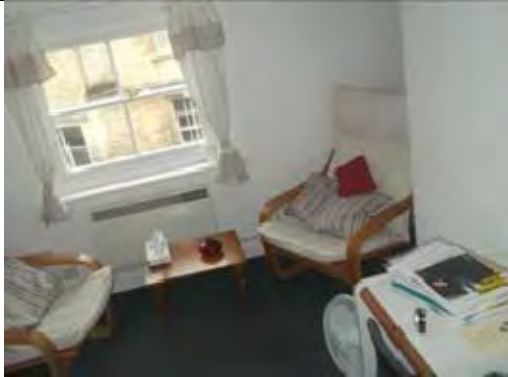
General view of Room 7

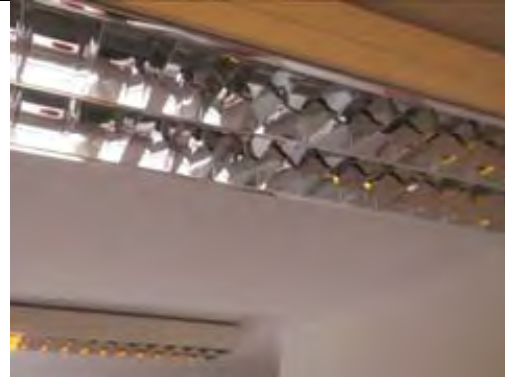
Painted plasterboard ceiling

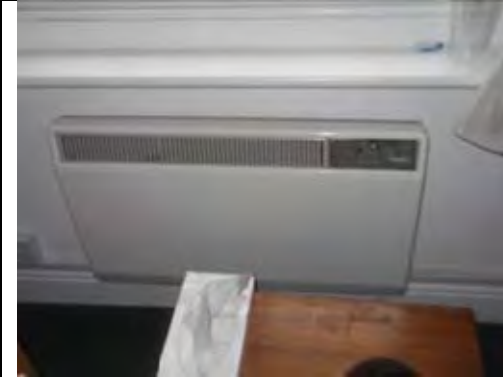
Modern non ACM electric heater

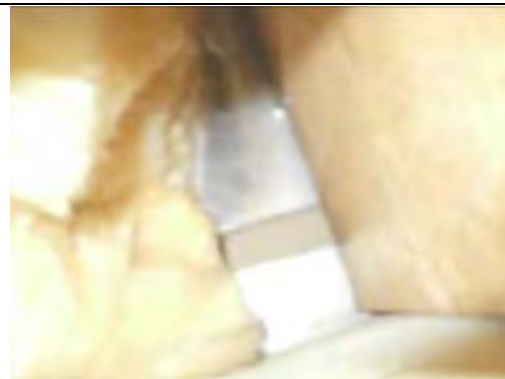
MMMF non ACM insulation

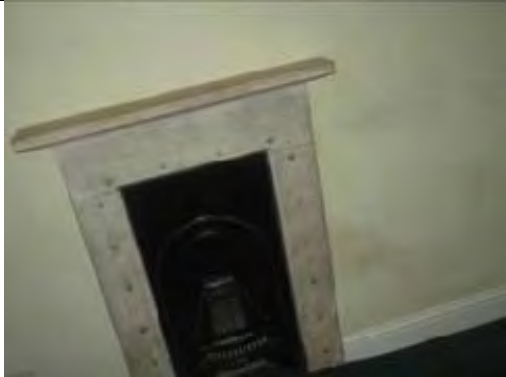
Non ACM fireplace

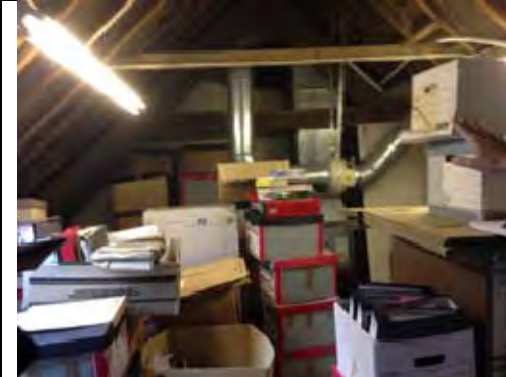
General view of Room 6

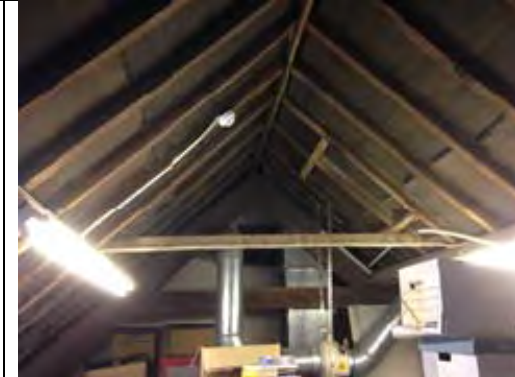
Non ACM lining to roof

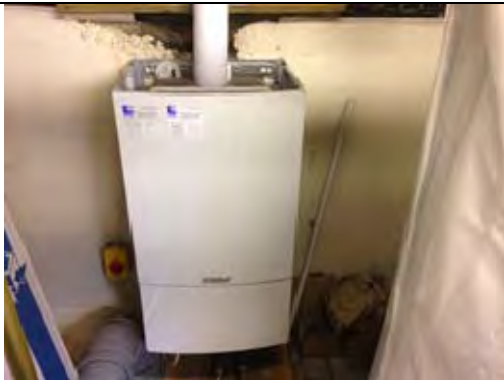
Modern non ACM boiler

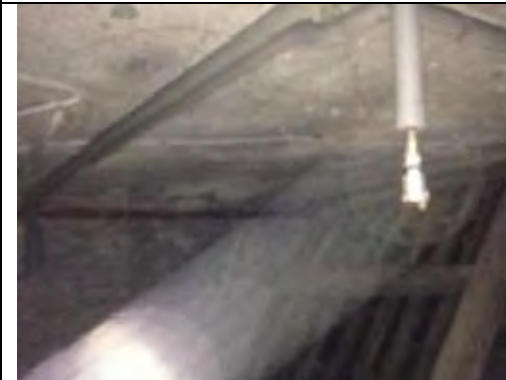
General view of Loft Space and non ACM roof

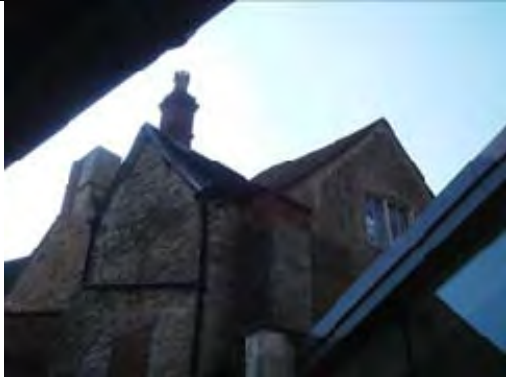
Presumed asbestos cement undercloaking to
verge edge of roof

Chrysotile
