## **Management Asbestos Survey Report**

**Abberley House  
Park Street  
Cirencester  
GL7 2BX**

**Cotswold District Council  
Council Offices  
Trinity Road  
Cirencester  
GL7 1PX**

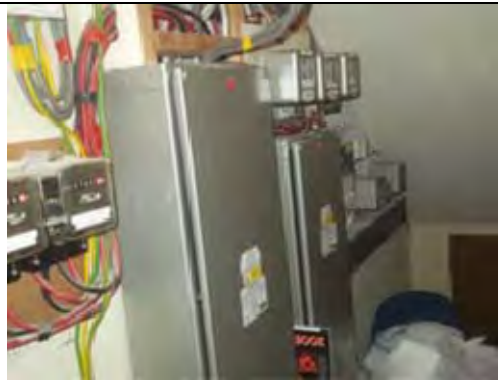
Presumed asbestos flash guards, ropes and seals to electrics

**Chrysotile**

It is recommended that the proven and presumed items are labelled and monitored in accordance with CAR 2012

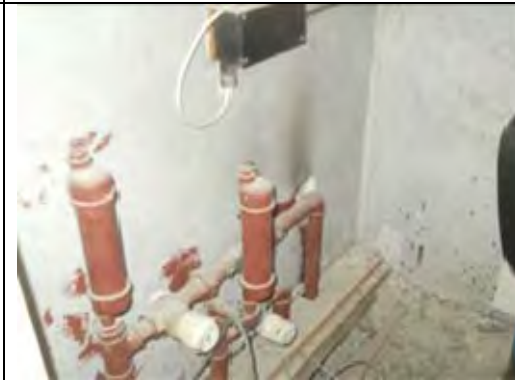
Non ACM heating pipes

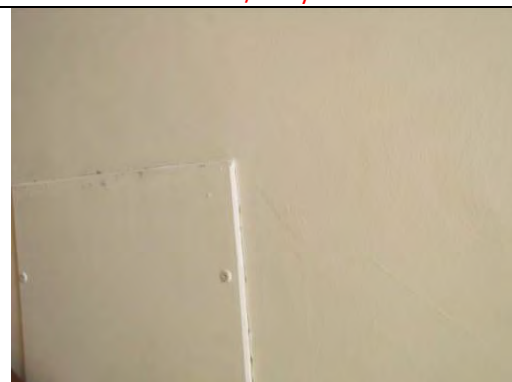
No ACM panel to wall

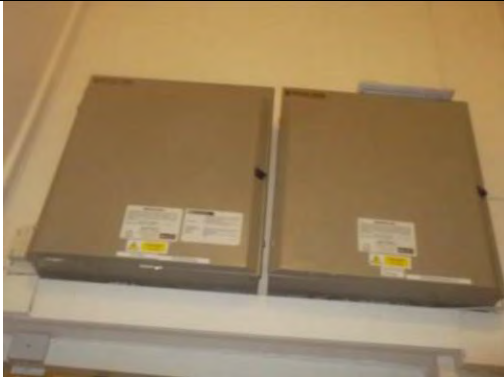
Presumed asbestos flash guards, ropes and seals to electricians  
**Chrysotile**

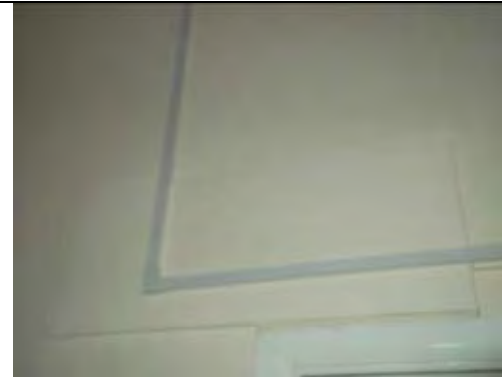
Insulation board above door  
AHC/8  
NADIS

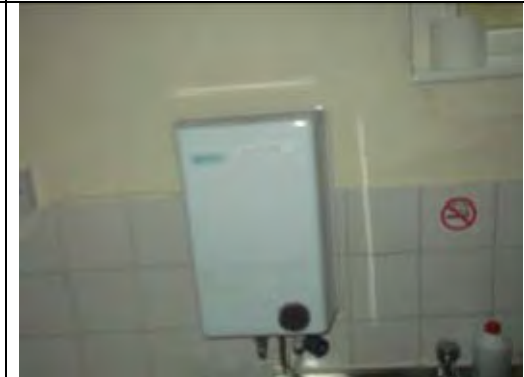
Modern non ACM water heater

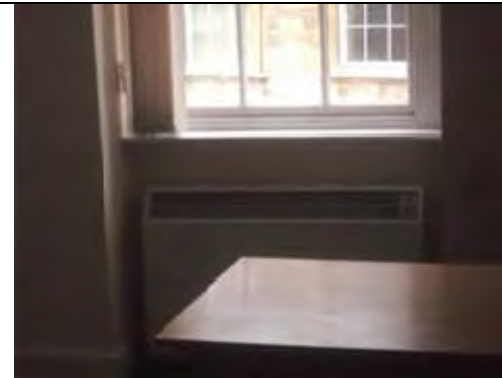
Presumed asbestos insulation board, ropes  
and seals to heater and board behind  
Crocidolite

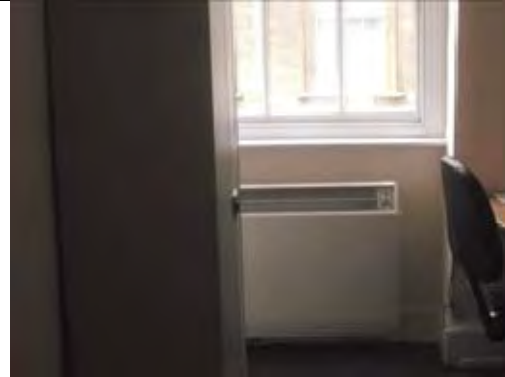
Presumed asbestos insulation board, ropes and seals to heater and board behind  
**Crocidolite**

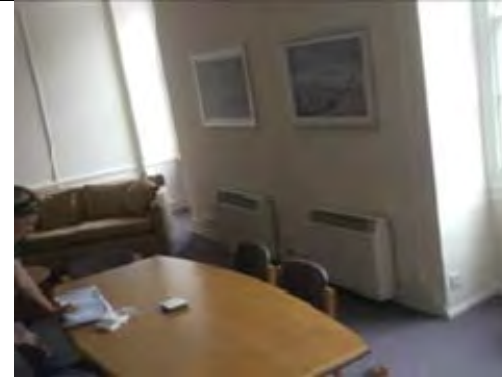
General view of Office 3/4  
Textured coating to ceiling AHC/10  
**Chrysotile**

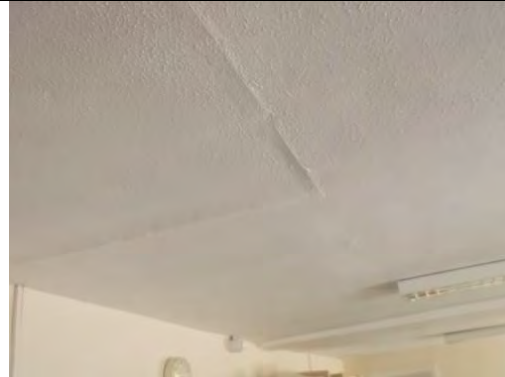
Textured coating to ceiling  
AHC/3  
**Chrysotile**

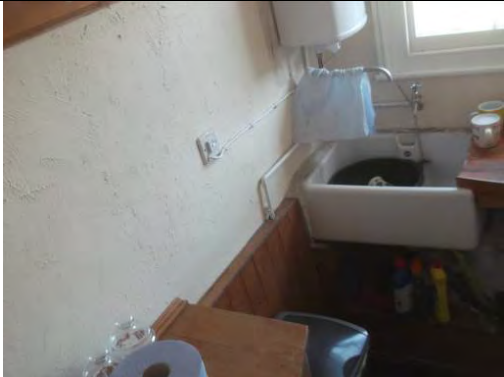
General view of Kitchen. Textured coating to walls  
AHC/4  
NADIS

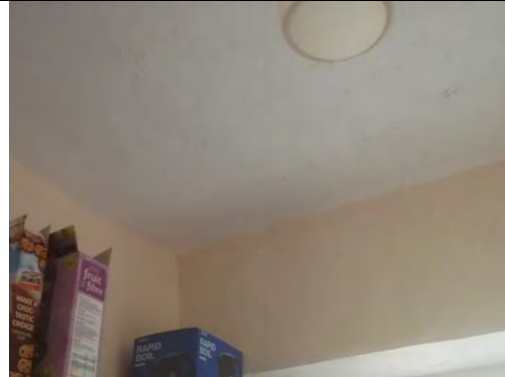
Textured coating to ceiling  
AHC/4  
NADIS

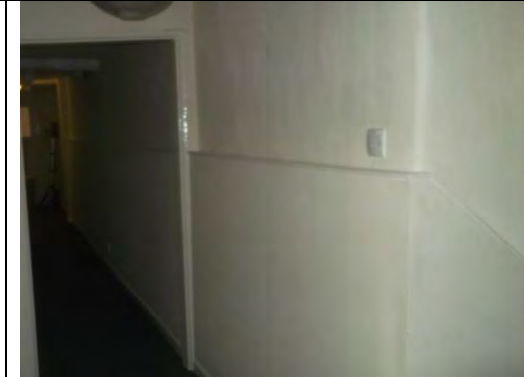
Insulation board to corridor  
AHC/5  
NADIS

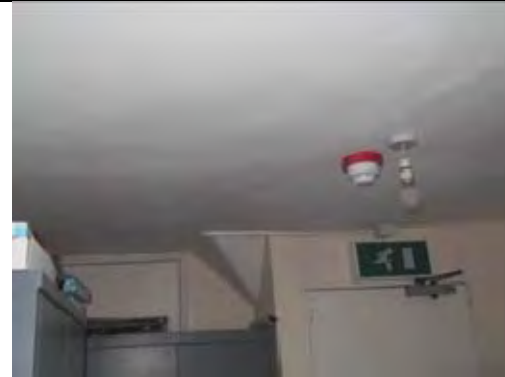
Painted plastered walls and ceiling and non ACM insulation board to door  
AHC/6  
NADIS

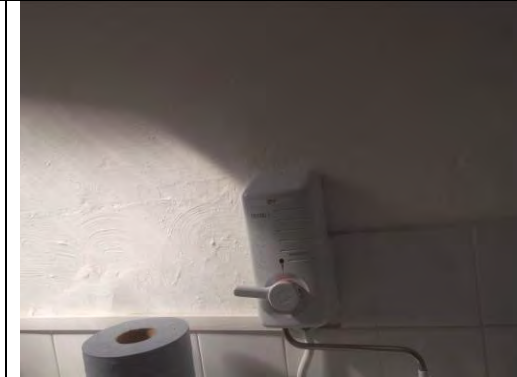
Textured coating to wall  
AHC/7  
NADIS

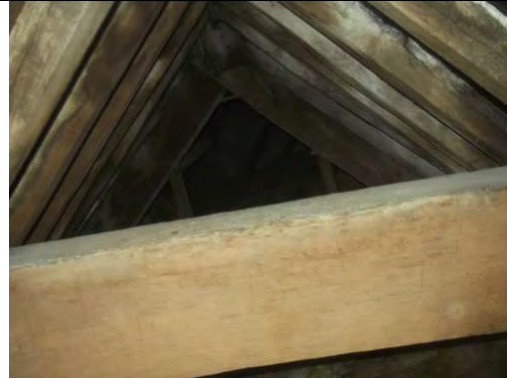
Timber construction to roof

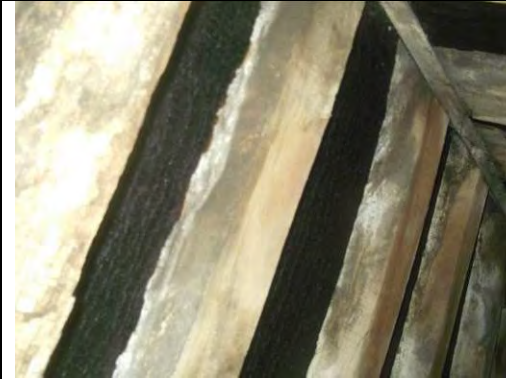
Non ACM roofing felt

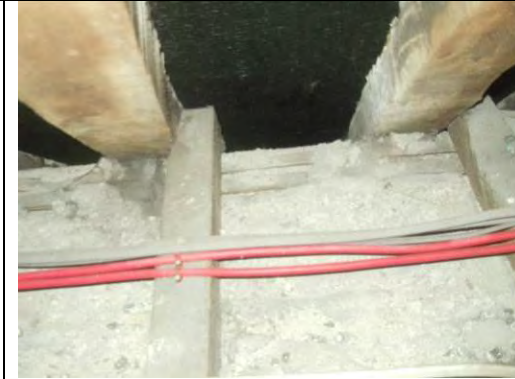
Loft floor with lathe and plaster ceiling below
