3.7 Public Realm

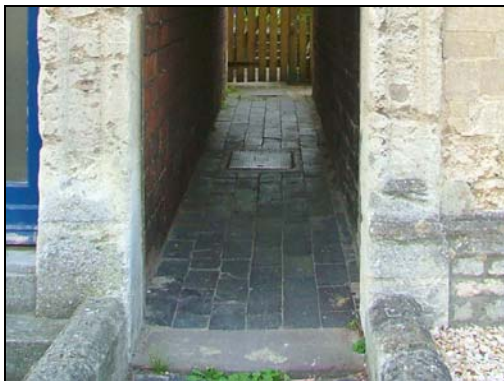
243

Generally the floorscape has a neutral impact on the special character and appearance of the Conservation Area although there is little floorscape which responds particularly well to its setting or enhances the public realm. Exceptions include Staffordshire blue paviours which can be found occasionally to private pedestrian routes between houses, and as thresholds to front gardens, often in combination with terracotta or blue clay edging bricks [183-185 & 243].

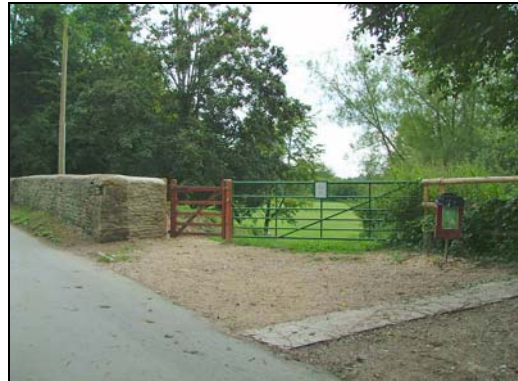
244

Informal areas of car parking, front gardens and pathways are often surfaced using hoggin, or similar gravel material [244 & 246]. The area of large concrete slabs at the southern end of Watermoor Road and its junction with Stepstairs Lane fails to enhance the quality of the space [249].

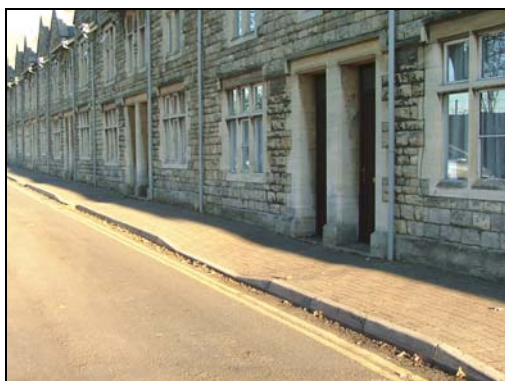
245

Floorscape in the Conservation Area consists predominantly of black tarmac to most public highways and pathways, often in combination with Pennant stone kerb setts. There are also a few areas where pathways are surfaced with small concrete paviours, for example, along the southern pavement to King's Street [245] and along Southgate Mews, linking Watermoor Road and the east end of Queen Street; these tend to compete with rather than enhance the textured stone and brick buildings they are intended to support.

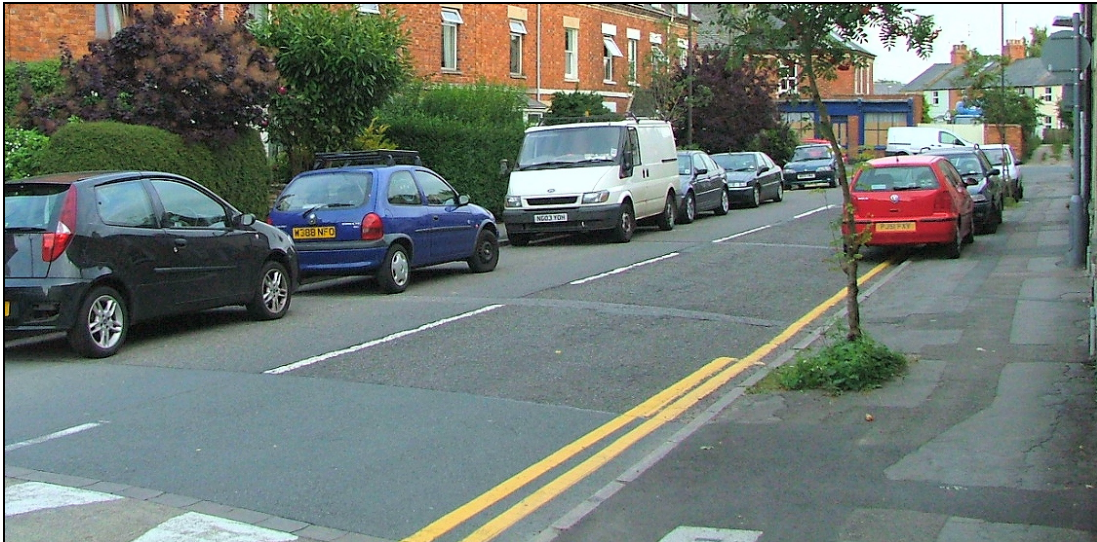
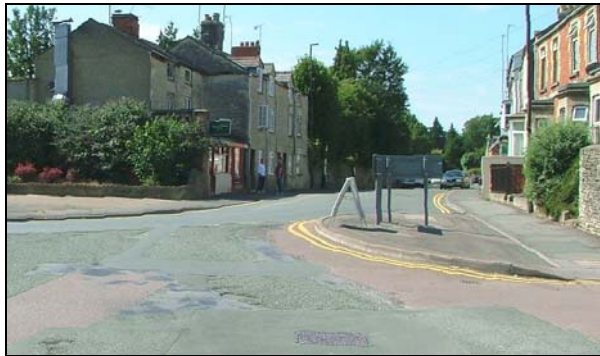
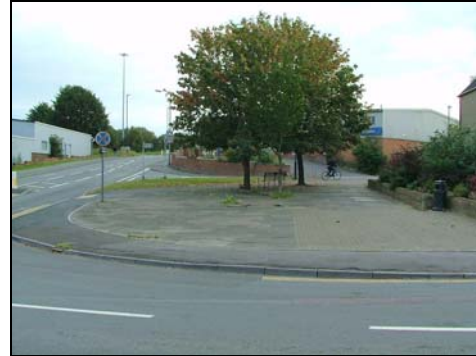
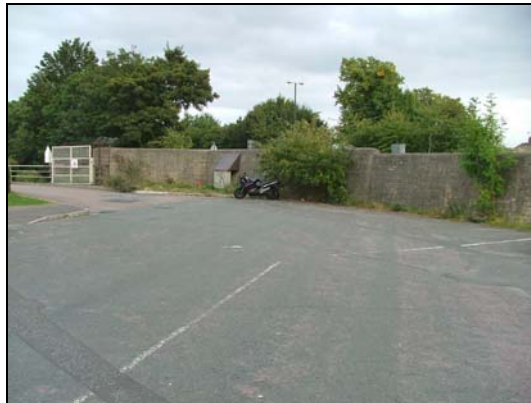
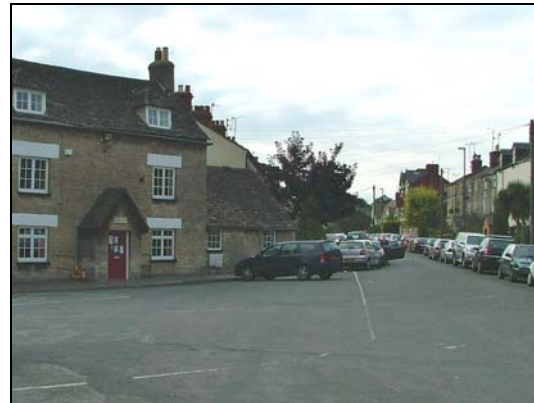
For the most part the use of black tarmac within the conservation area is not problematic. There are several areas, however, where the tarmac is patchy and in poor condition, and detracts from the conservation area's special architectural and historic interest [247-251].

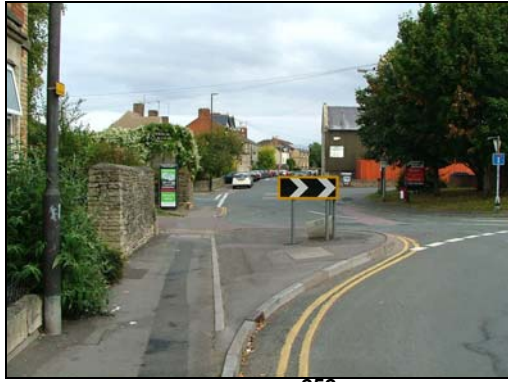
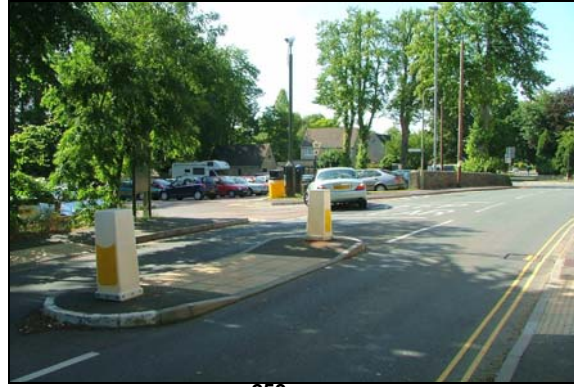
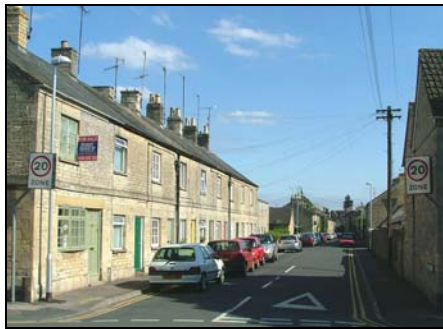
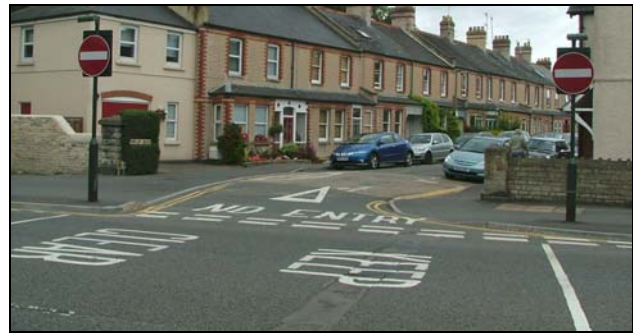
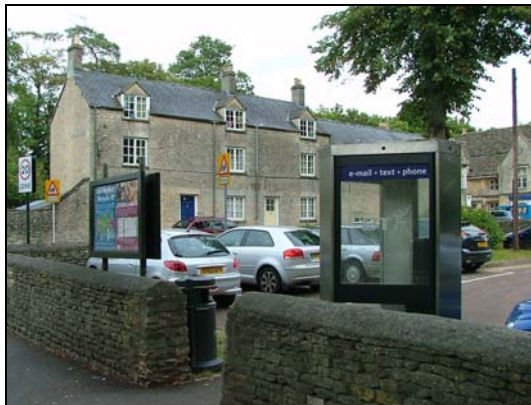
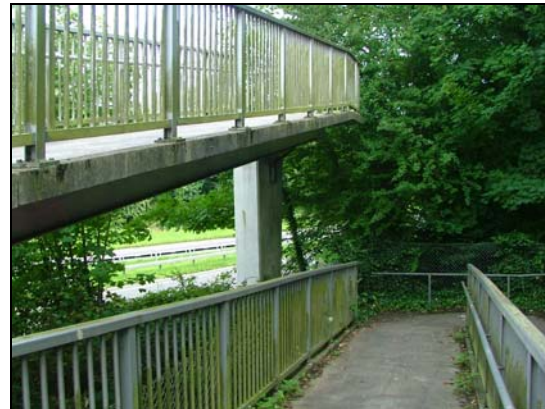
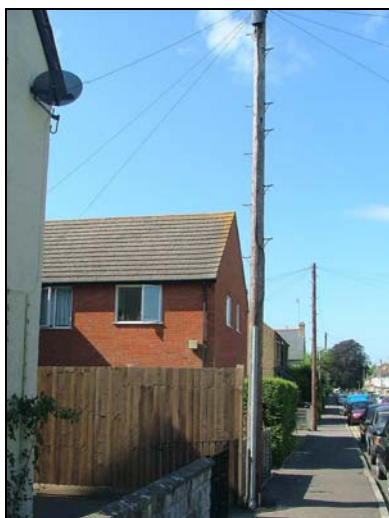
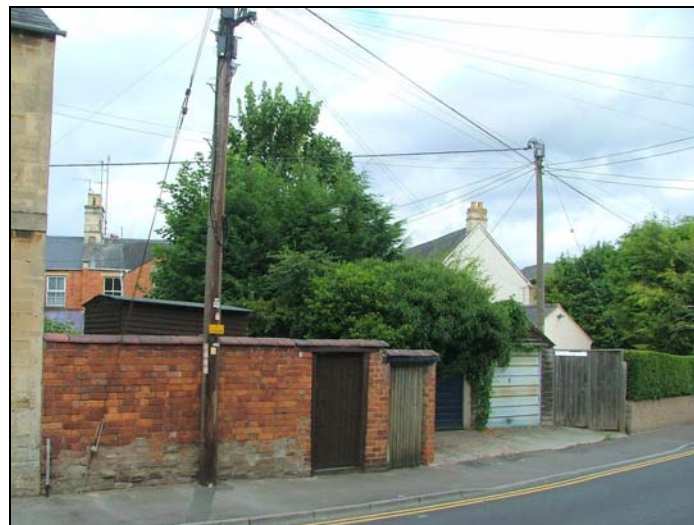
Parts of the Conservation Area also suffer from a clutter of traffic-related street furniture and road markings, as well as security measures such as CCTV cameras. In particular, too many traffic signs have an unduly dominant impact on the special historic and architectural character of the area. Examples include the junction at the southern end of Watermoor Road [252], the junction of Purley Road with London Road [255] and the Beeches car park and environs [253 & 256]. Telegraph poles and wires add a further element of visual clutter to several parts of the area, including Chester Street [254 & 259] and Purley Road [258].

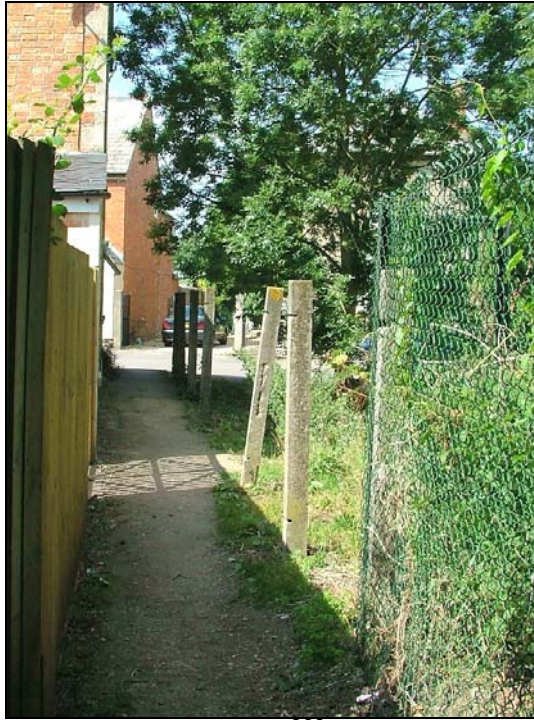
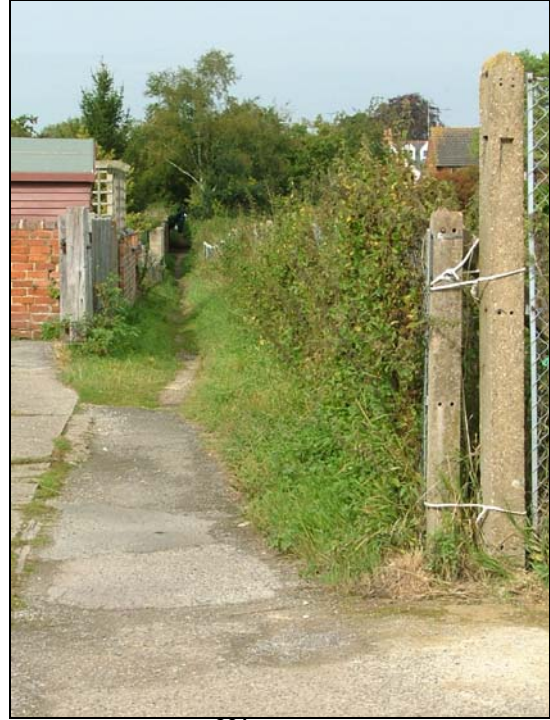
Some barriers and boundaries treatments are in need of enhancement; for example, public pathways bordered by poorly-maintained post and chain fencing whose unkempt appearance fails to enhance the special qualities of the area [260-61], and unpainted, galvanised aluminium barriers terminating pedestrian exits from public places such as schools, are often poorly designed and maintained [262-64].

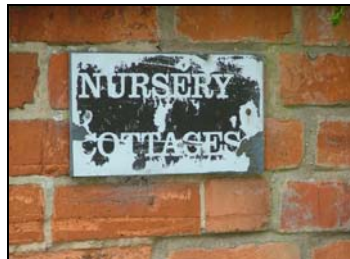
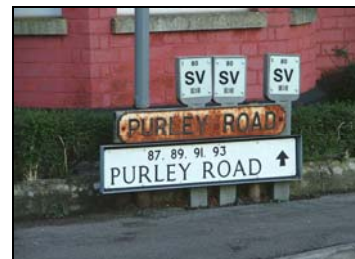
Enamel road and property names in various forms create attractive detail in the Conservation Area [242] although some are in poor condition, and/or are barely legible [265-67]. Lighting is mostly limited to concrete lamp standards which have a neutral impact on the special architectural and historic character of the Conservation Area.

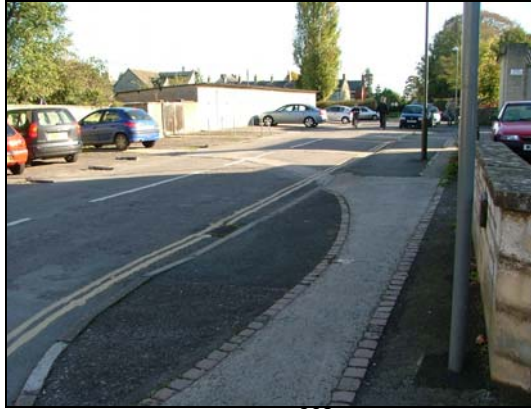
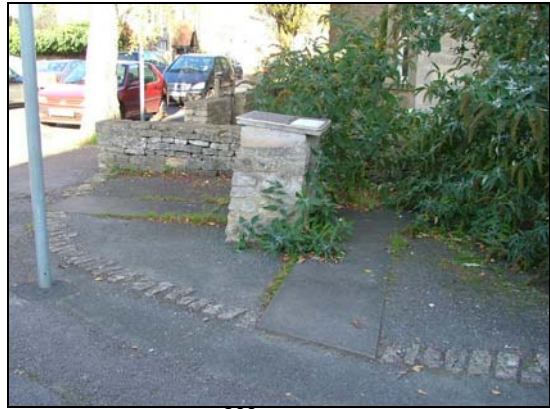
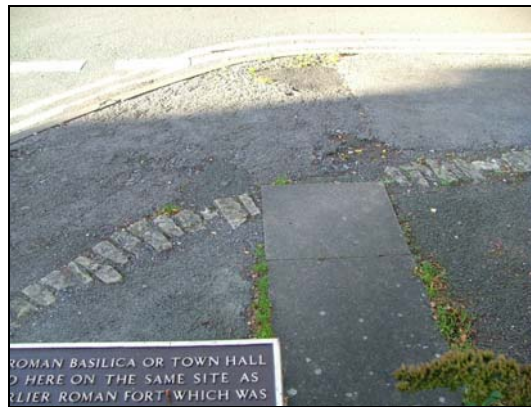
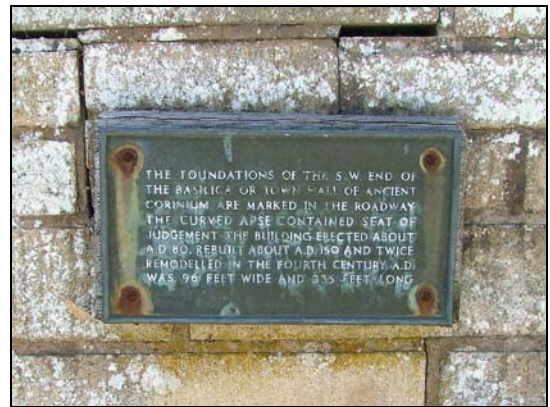
Interpretation of the area is especially weak and poorly maintained, most notably at the northern entrance to St Michael's Park where the outline of the Roman basilica is marked out in artificial materials and accompanied by signage which is barely apparent and badly maintained, the whole within a space dominated by parking and punctuated by galvanised traffic bollards [268-71].

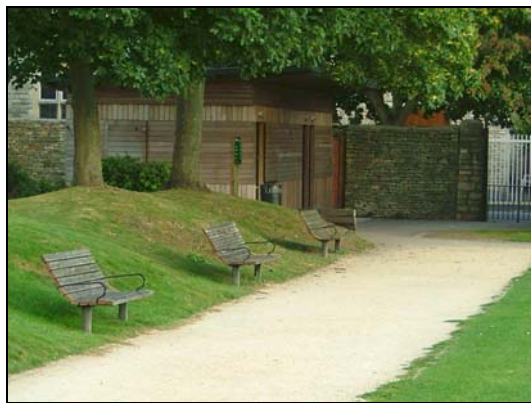
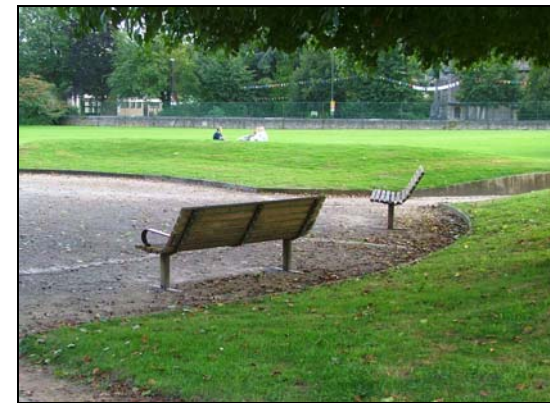
Seating provision is limited but there are a handful of benches, mostly located in St Michael's Park, which combine practicality with robust modern design [272-73].
