**Management
Asbestos Survey
Report**

**Moreton in Marsh Area Centre
High Street
Moreton in Marsh
GL56 0AX**

**Cotswold District Council
Council Offices
Trinity Road
Cirencester
GL7 1PX**

Ledbury Surveys Ltd

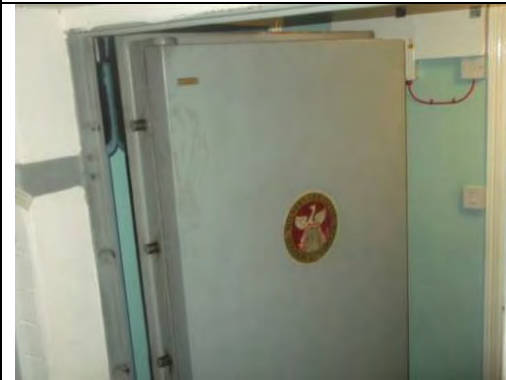
Internally the Reception Area was found to have painted plastered walls, painted plasterboard walls and a painted plasterboard ceiling. The Safe within the cupboard under the stairs is Presumed to have an asbestos insulation board steel laminate infill. The air plant throughout the site is Presumed to contain asbestos gaskets, ropes and seals. The insulation board to the door within the Plant Room was found to be proven no ACM. The Strong Room door is Presumed to contain an asbestos insulation board steel laminate.

Presumed asbestos insulation board laminate to safe
Crocidolite

It is recommended that the Presumed items are labelled and monitored in accordance with CAR 2012

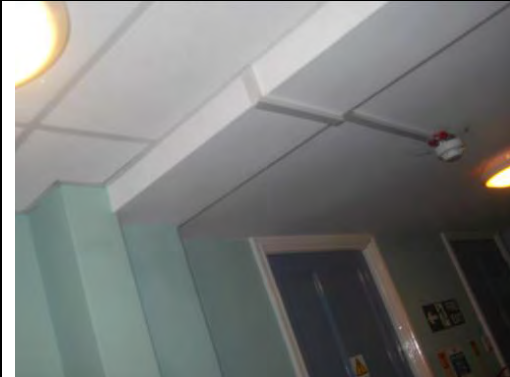
Painted plastered walls and modern non ACM suspended ceiling tiles

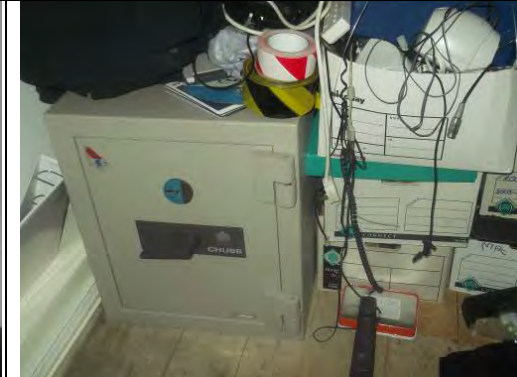
Presumed asbestos insulation board
laminate to safe
Crocidolite

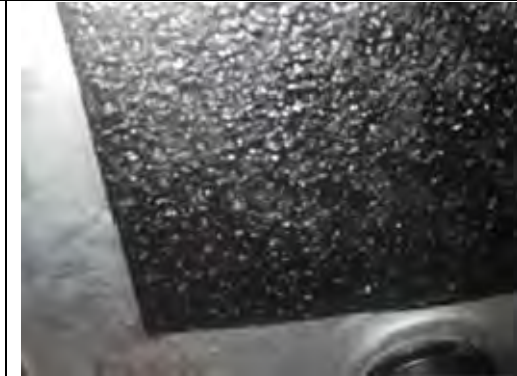
Sink pad
MAOM/4
NADIS

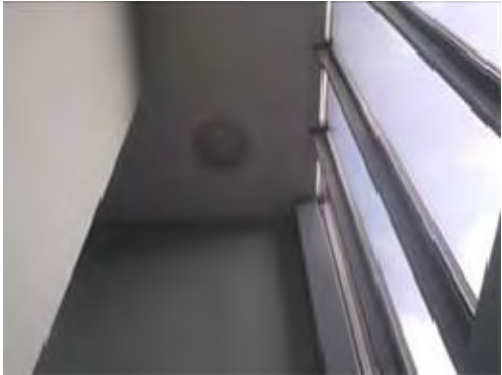
<p>General view of Back Stairs. Proven non ACM stair nosings</p>	<p>Fire proof paint to steel MAOM/7 NADIS</p>
