**Management  
Asbestos Survey  
Report**

**Cotswold District Council  
Council Offices  
Trinity Road  
Cirencester  
Gloucestershire  
GL7 1PX**

Trinity Road Offices  
Trinity Road  
Cirencester

**On Behalf of Cotswold District Council**

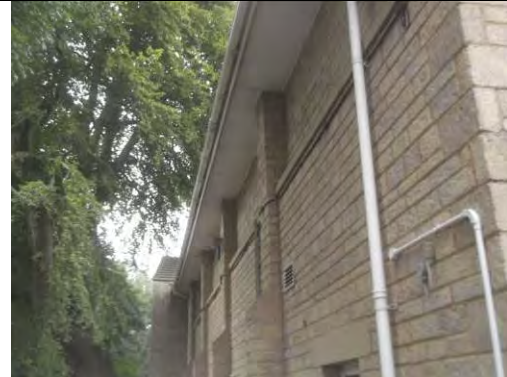
Soffit boards  
VS to CDCOTR/5  
**NADIS**

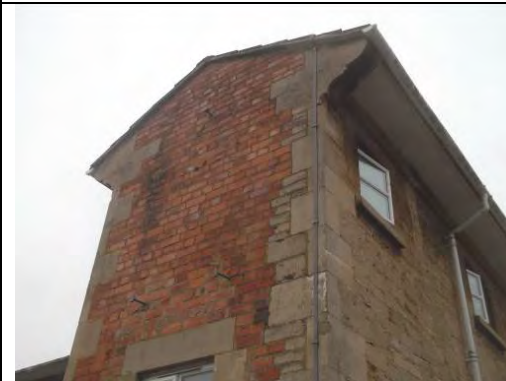
Insulation board soffits  
VS- CDOTR/5  
**NADIS**

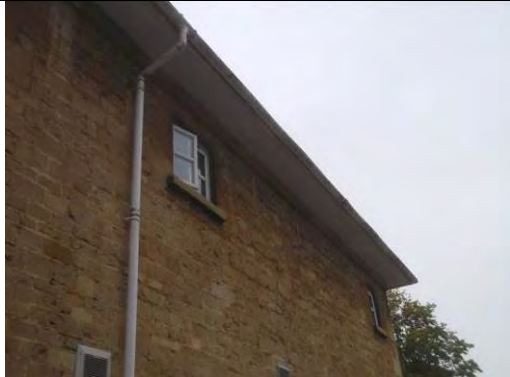
Soffit boards  
VS- CDOTR/5  
NADIS

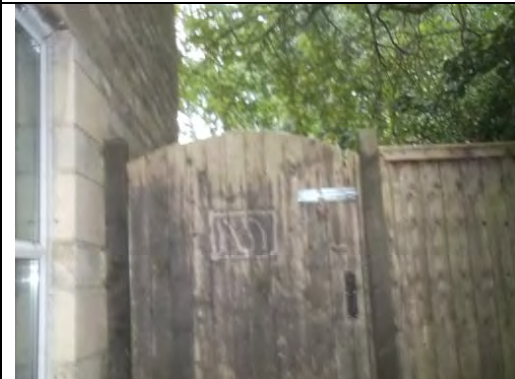
No access through gate

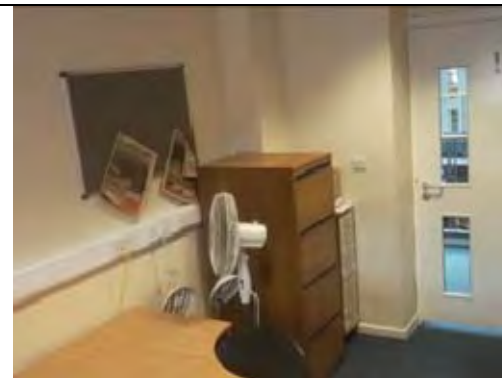
General view of 1.22

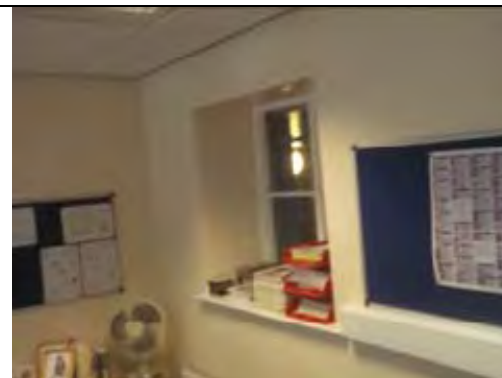
General view of 1.24

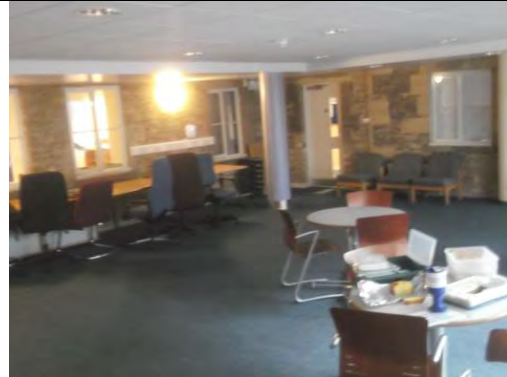
General view of Open Plan Area

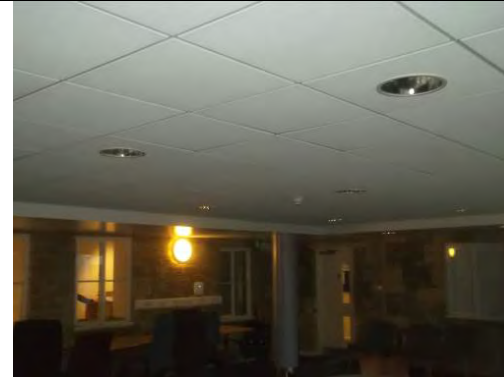
Modern non ACM suspended ceiling tiles

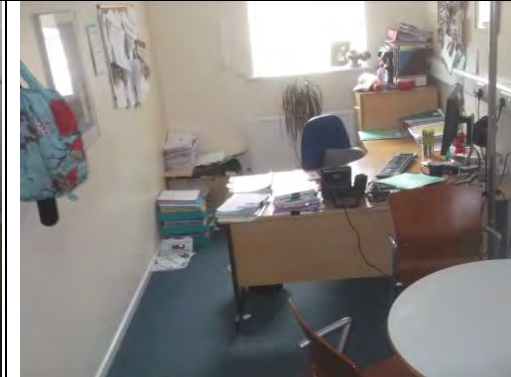
General view of 1.49

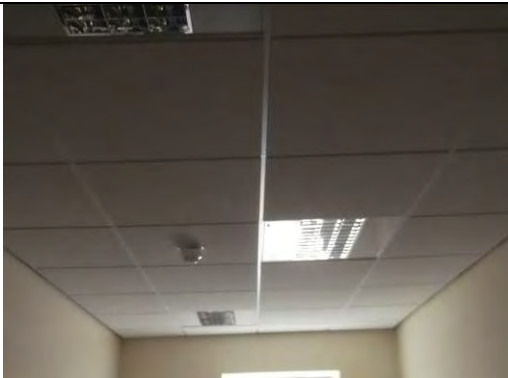
Modern non ACM suspended ceiling tiles

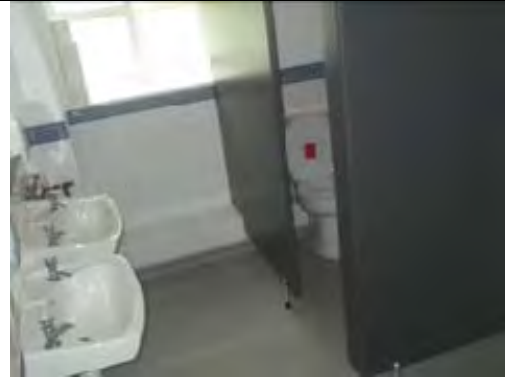
General view of Gents Toilets

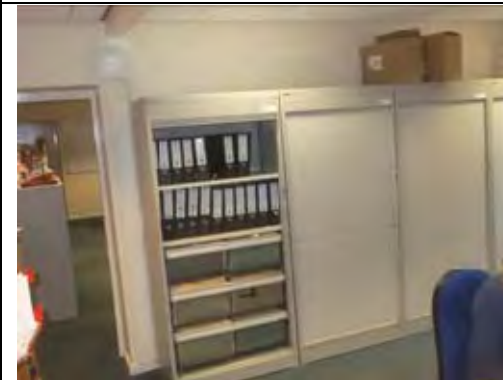
General view of 1.31

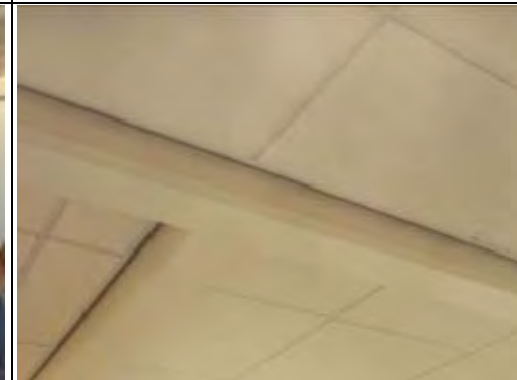
Modern non ACM suspended ceiling tiles

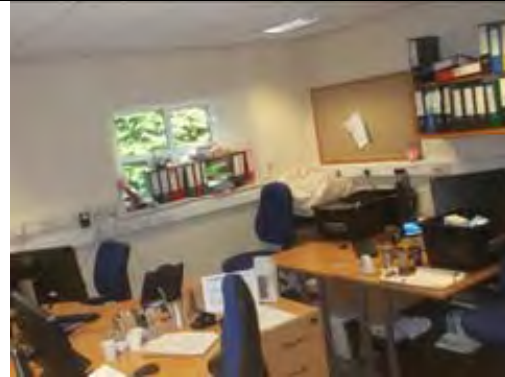
General view of 1.32

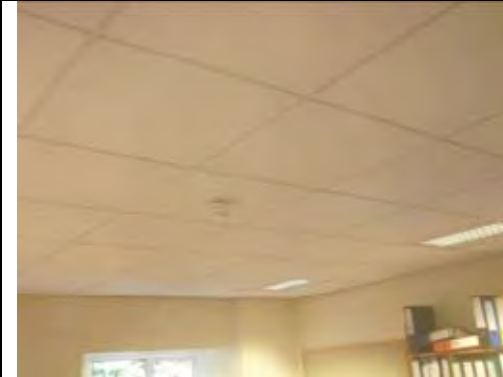
Modern non ACM suspended ceiling tiles and painted plastered walls

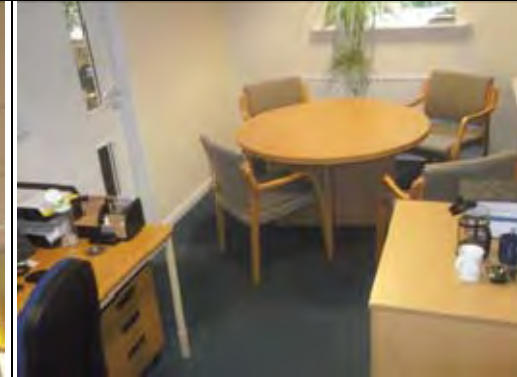
General view of 1.33

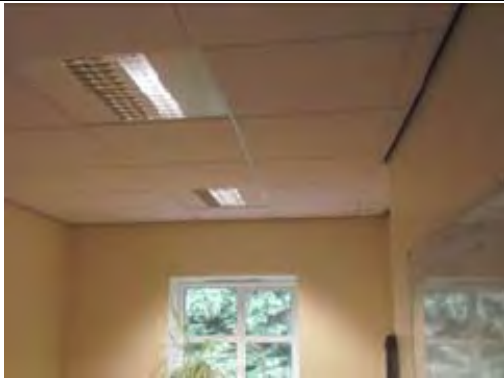
Modern non ACM suspended ceiling tiles and painted plastered walls

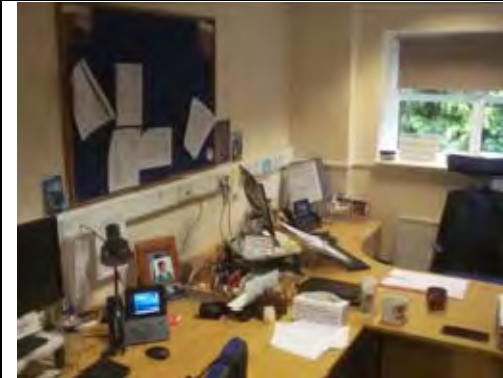
General view of 1.34

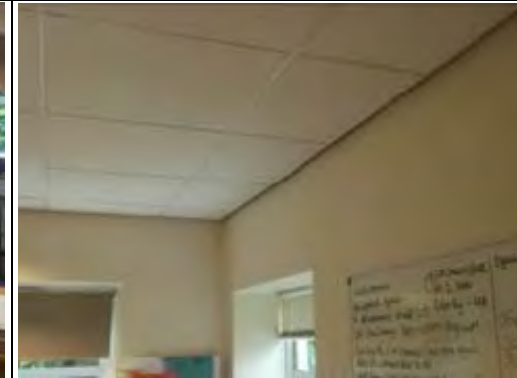
Modern non ACM suspended ceiling tiles

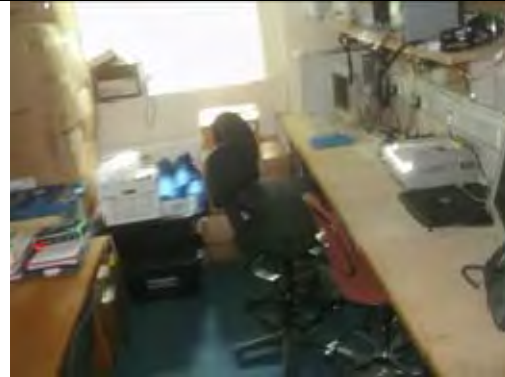
General view of 1.41

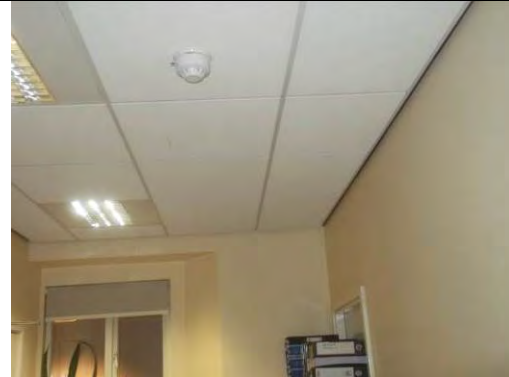
Modern non ACM suspended ceiling tiles

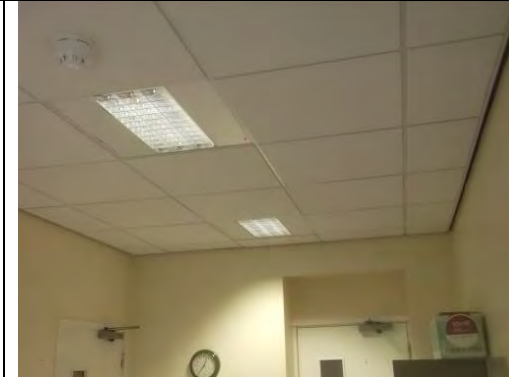
Modern non ACM suspended ceiling tiles

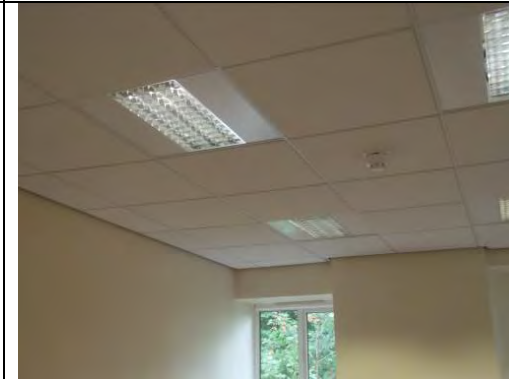
Modern non ACM suspended ceiling tiles

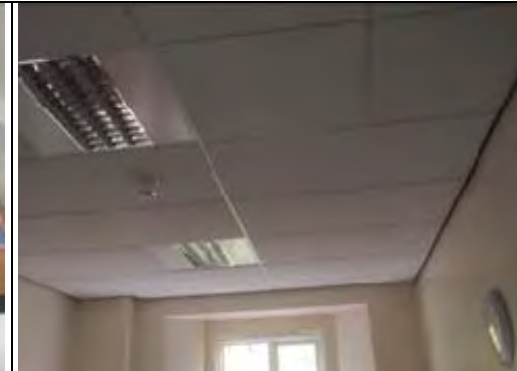
Modern non ACM suspended ceiling tiles

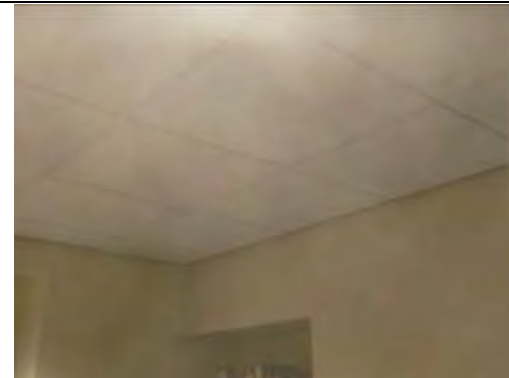
Modern non ACM suspended ceiling tiles

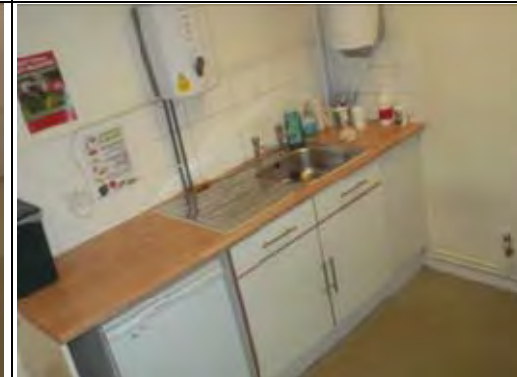
Modern non ACM kitchen units

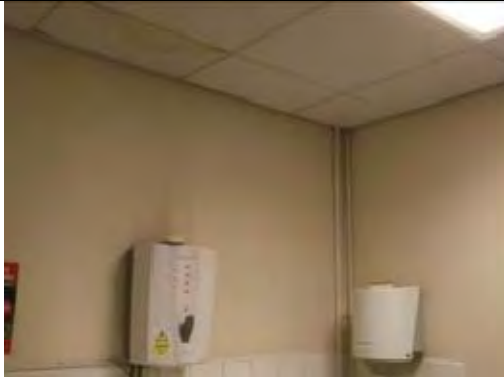
Modern non ACM suspended ceiling tiles

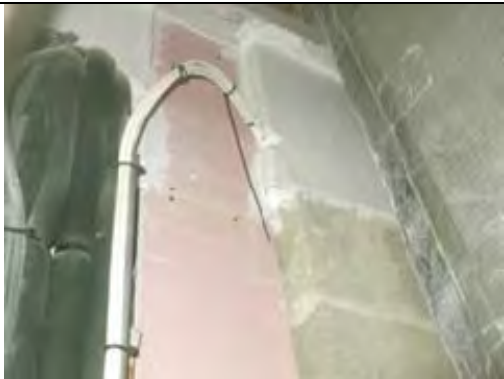
Fire resistant plasterboard

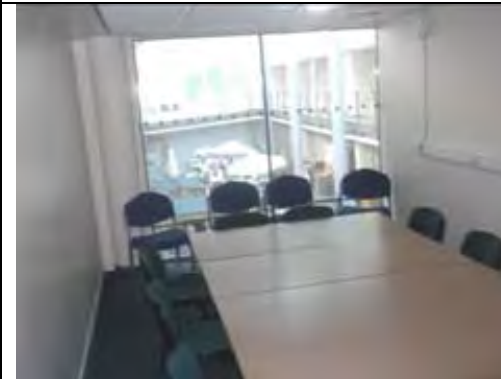
General view of 1.46

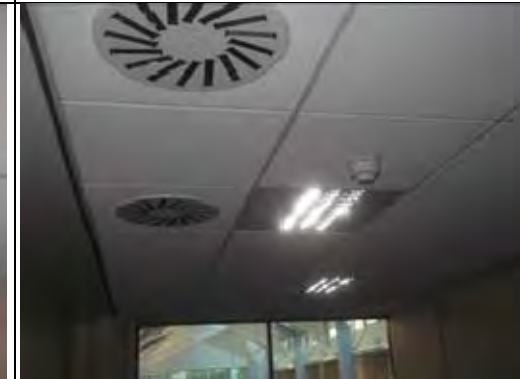
Modern non ACM suspended ceiling tiles

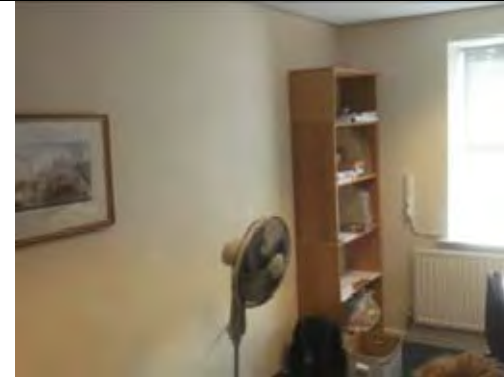
General view of 1.80

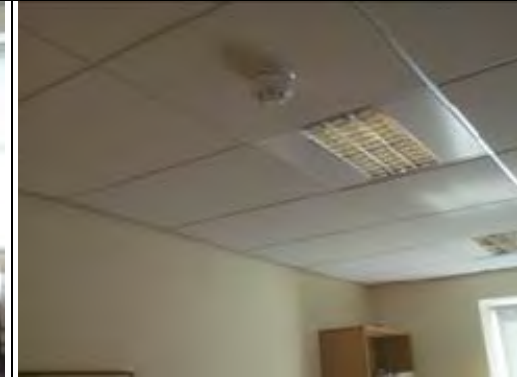
Modern non ACM suspended ceiling tiles

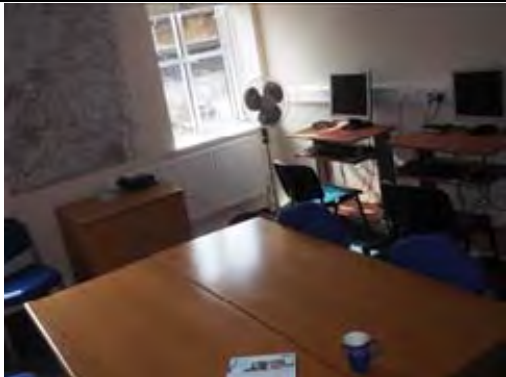
General view of 1.79

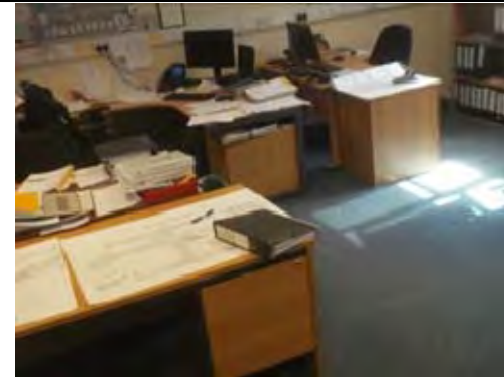
General view of 1.78

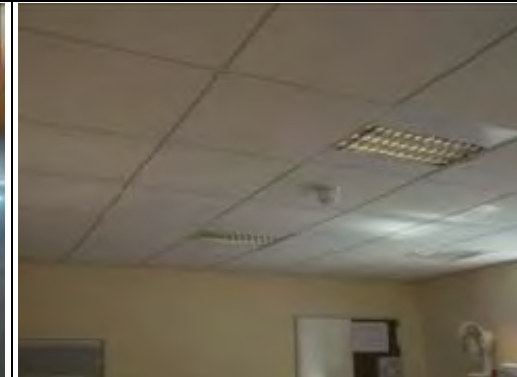
Modern non ACM suspended ceiling tiles

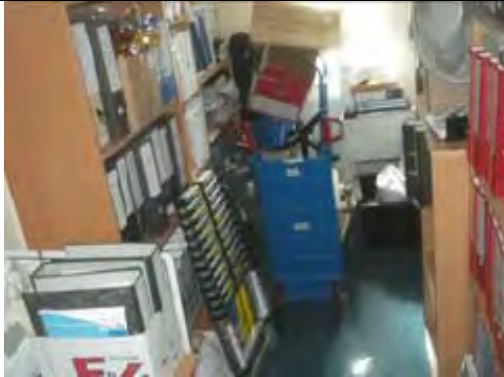
General view of 1.77

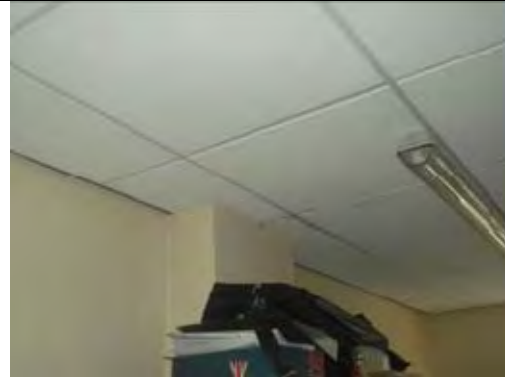
Modern non ACM suspended ceiling tiles and painted plastered walls

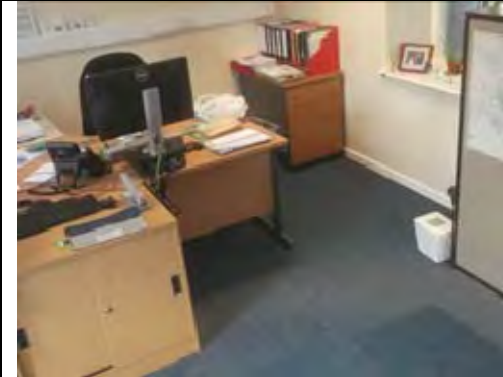
General view of 1.76

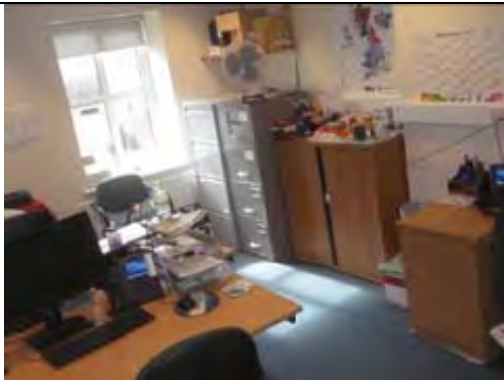
General view of 1.74

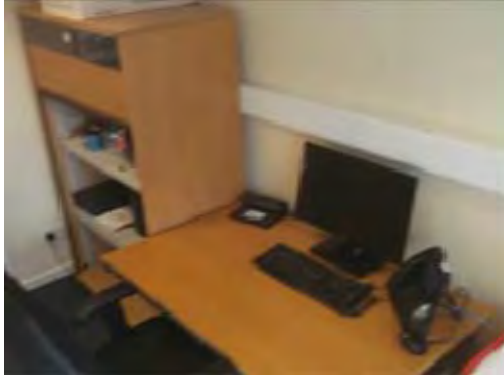
General view of 1.73

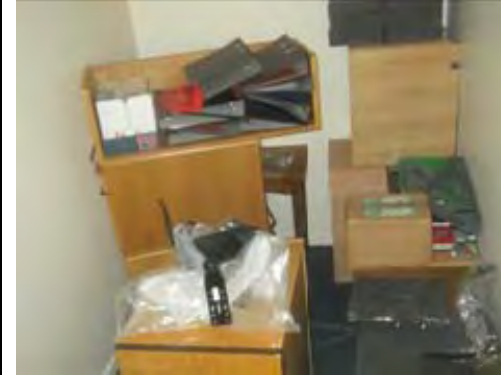
General view of 1.72

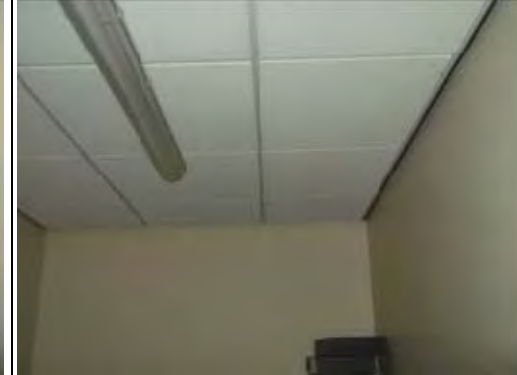
Modern non ACM suspended ceiling tiles  
and painted plastered walls

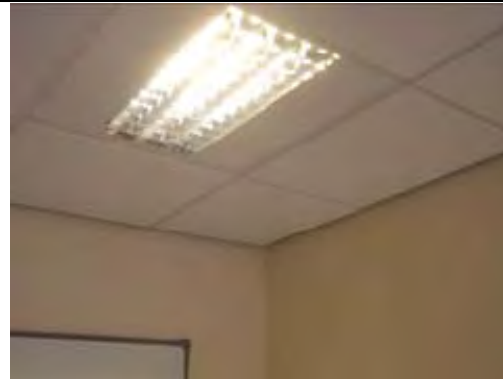
Modern non ACM suspended ceiling tiles

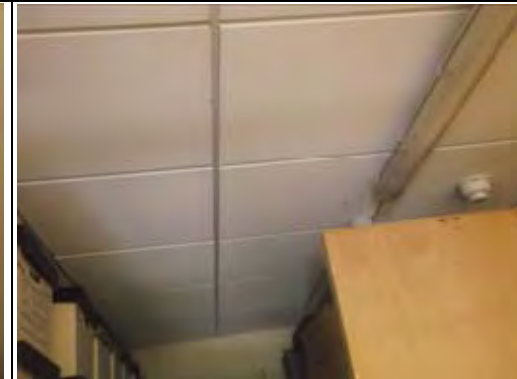
Modern non ACM suspended ceiling tiles

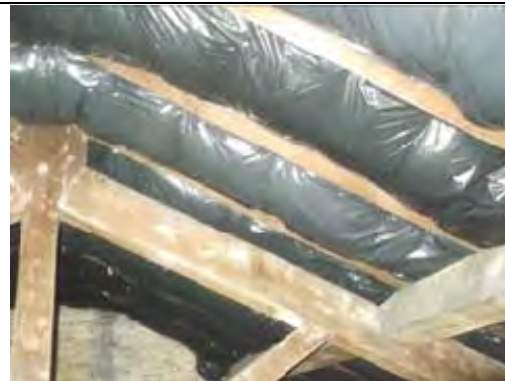
MMMF insulation in plastic

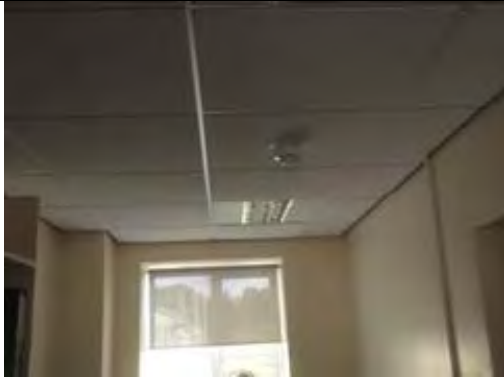
Modern non ACM suspended ceiling tiles and painted plastered walls

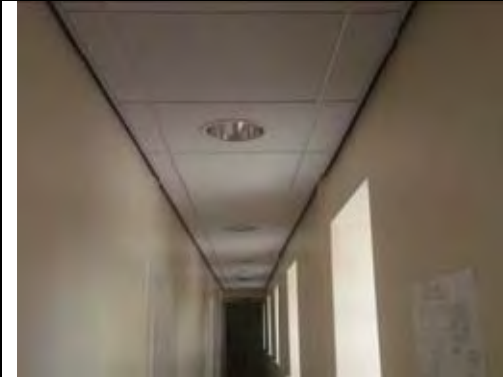
Modern non ACM suspended ceiling tiles and painted plastered walls

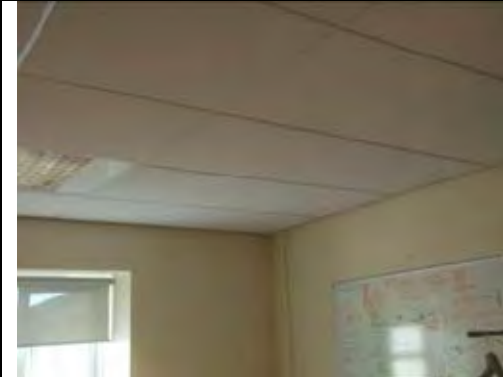
Modern non ACM suspended ceiling tiles

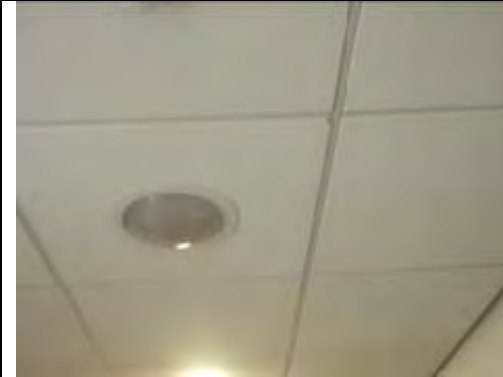
Modern non ACM suspended ceiling tiles

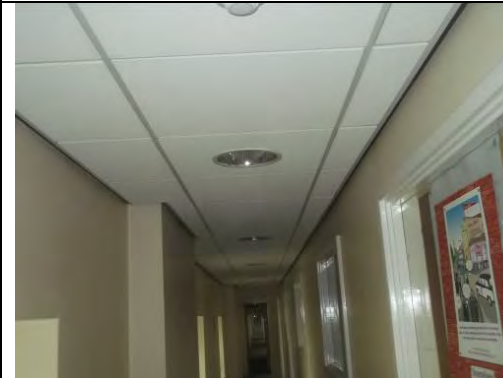
Modern non ACM suspended ceiling tiles

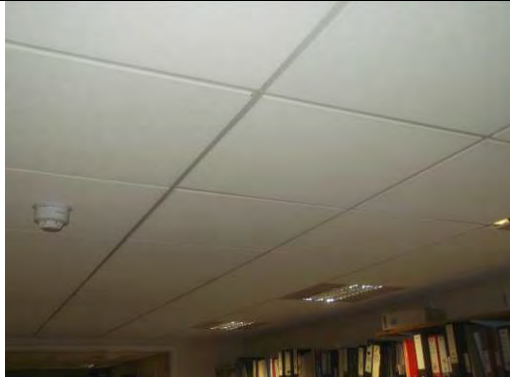
Modern non ACM suspended ceiling tiles

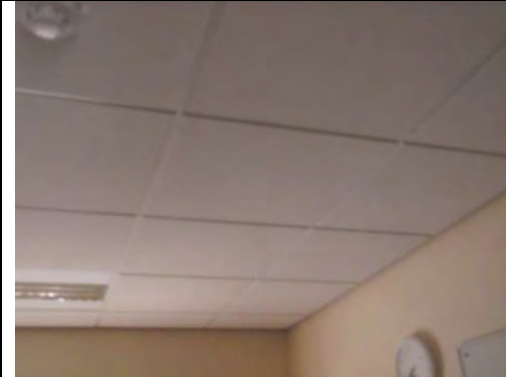
Modern non ACM suspended ceiling tiles

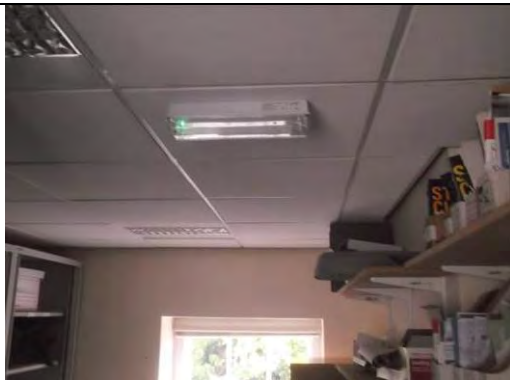
Modern non ACM suspended ceiling tiles

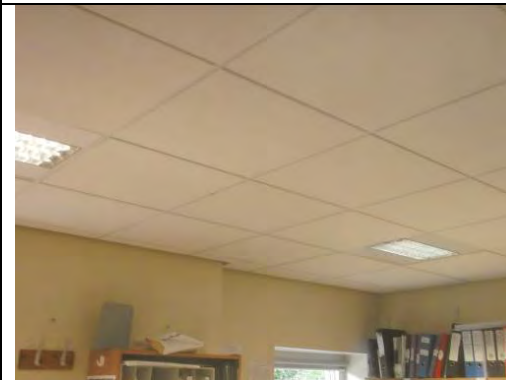
Modern non ACM suspended ceiling tiles and  
painted plastered walls

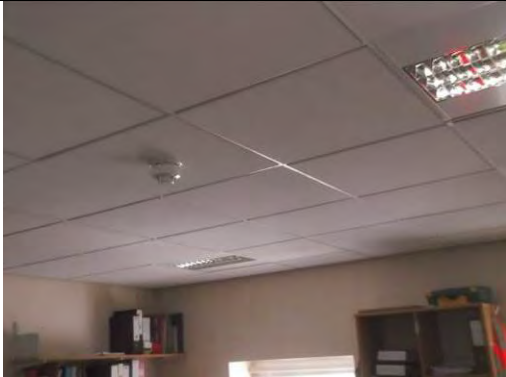
Modern non ACM suspended ceiling tiles and painted plastered walls

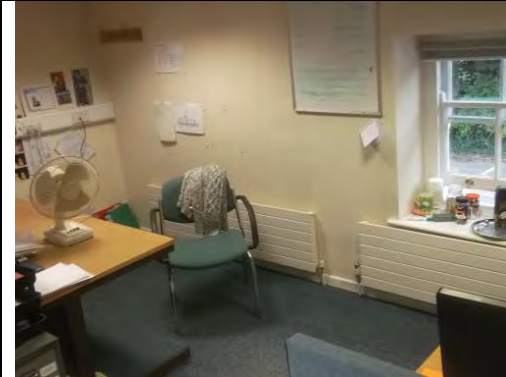
General view of 1.93

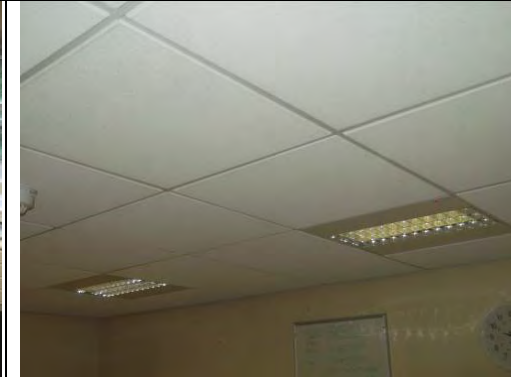
Modern non ACM suspended ceiling tiles and painted plastered walls

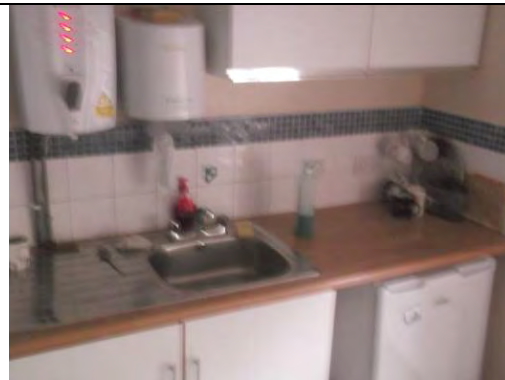
Modern non ACM kitchen units

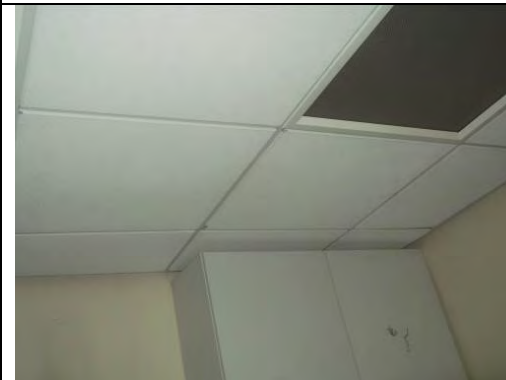
Modern non ACM suspended ceiling tiles

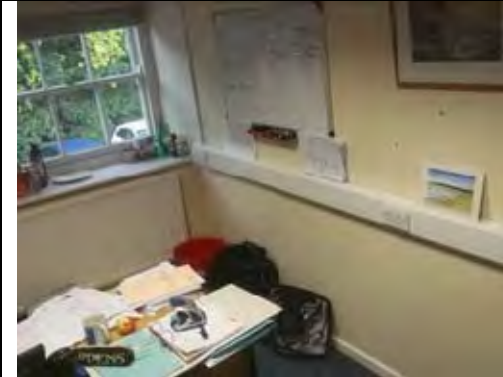
General view of 1.92

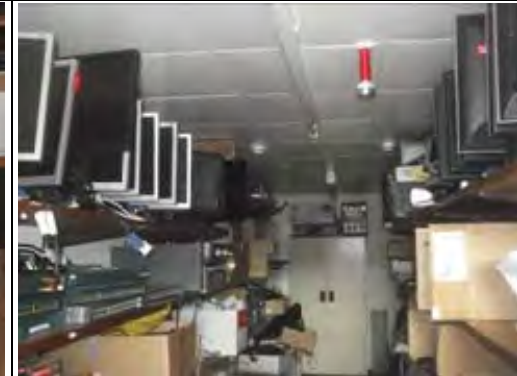
Modern non ACM suspended ceiling tiles

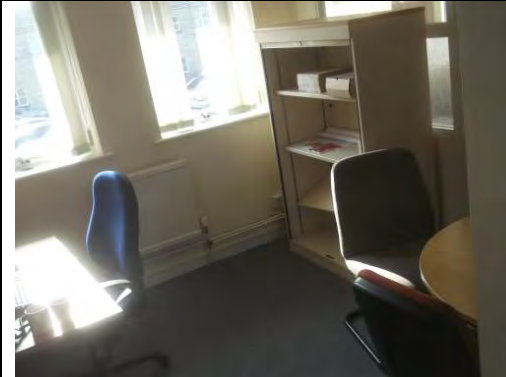
General view of 1.68

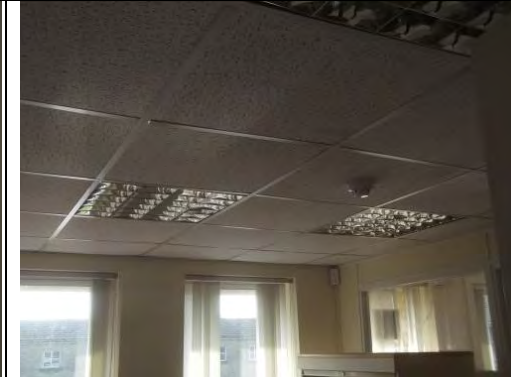
Modern non ACM suspended ceiling tiles

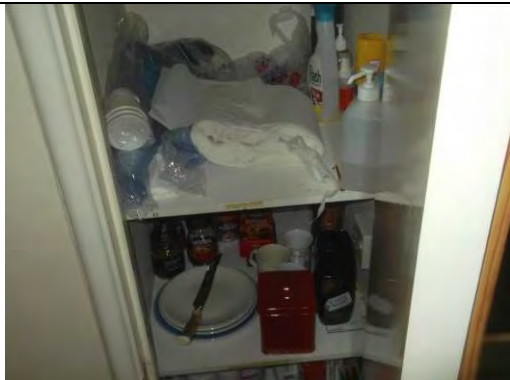
General view of Cupboard

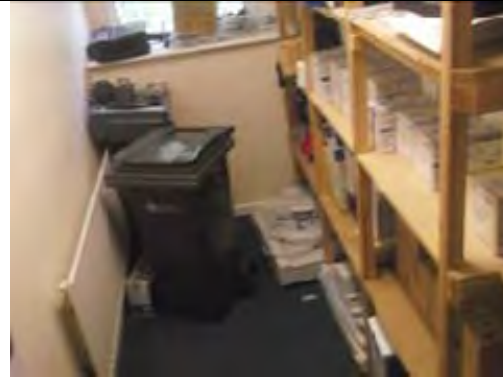
General view of 0.37

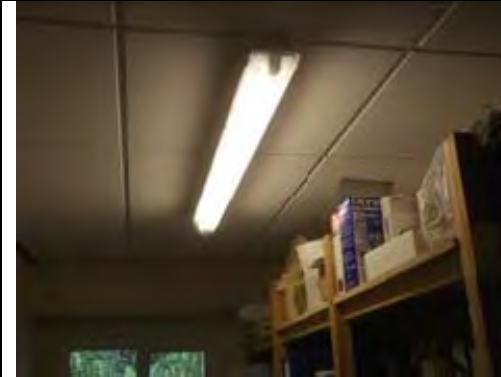
Modern non ACM suspended ceiling tiles

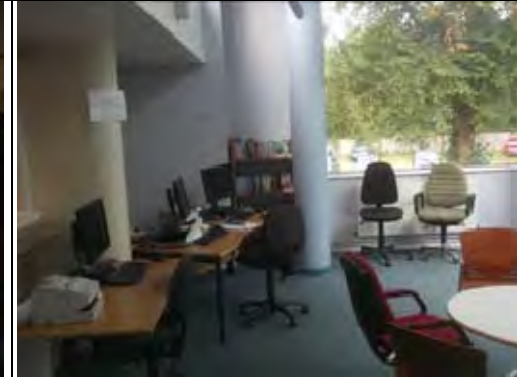
General view of 1.48

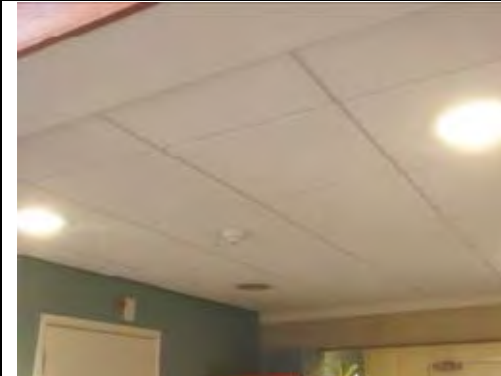
Modern non ACM suspended ceiling tiles

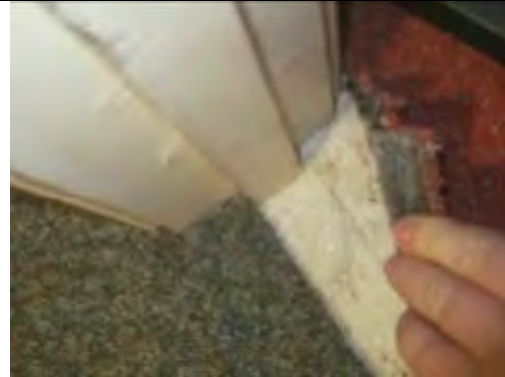
Carpet on concrete floor

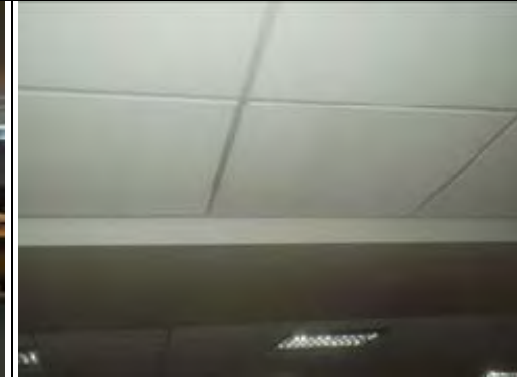
Modern non ACM suspended ceiling tiles

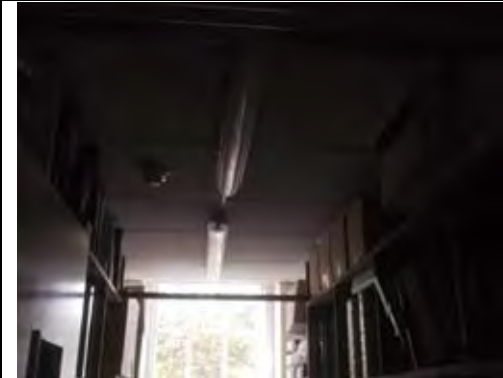
Modern non ACM suspended ceiling tiles

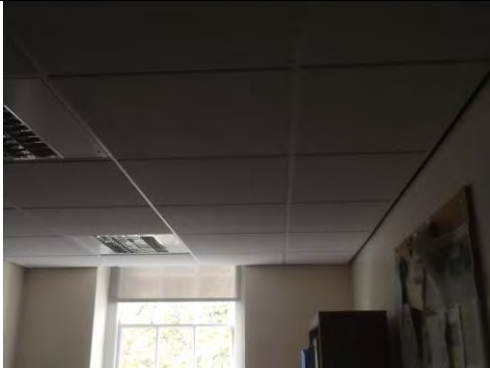
Modern non ACM suspended ceiling tiles

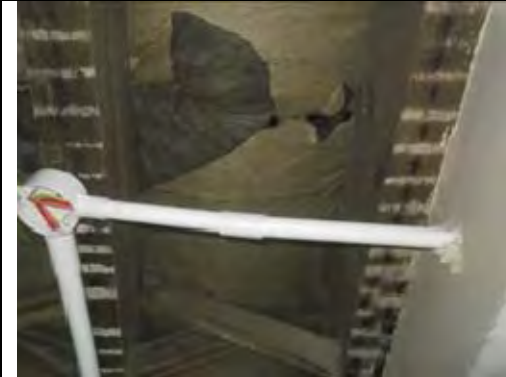
MMM insulation

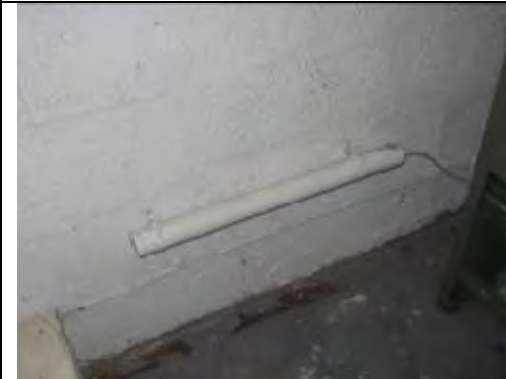
Modern non ACM bar heater

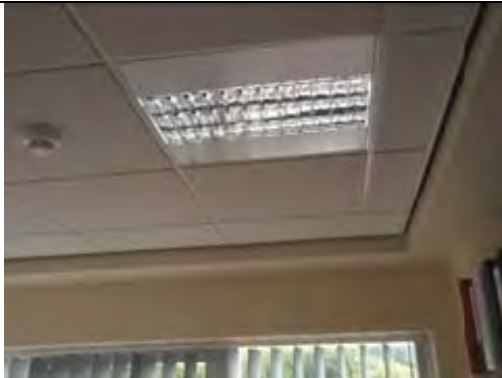
Modern non ACM suspended ceiling tiles

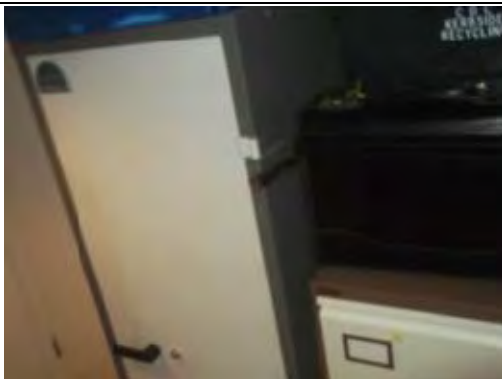
Modern non ACM fire proof safe

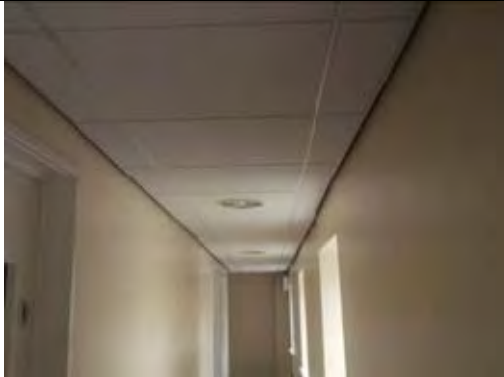
Modern non ACM suspended ceiling tiles

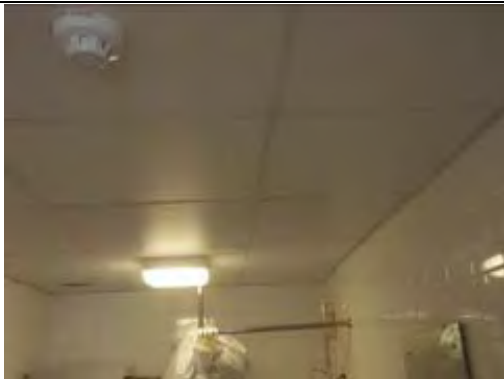
Modern non ACM suspended ceiling tiles

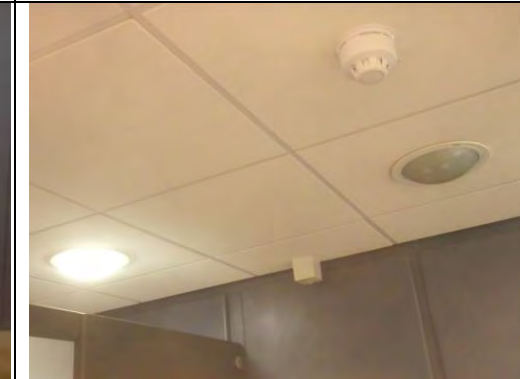
Modern non ACM suspended ceiling tiles

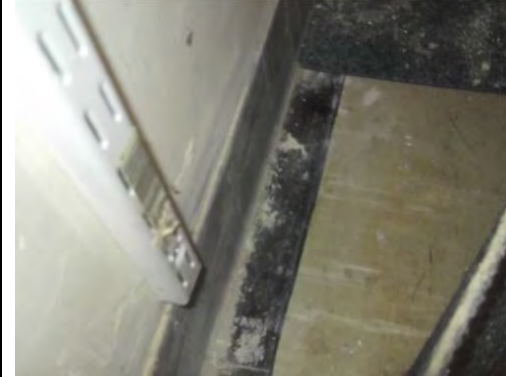
Modern non ACM lino

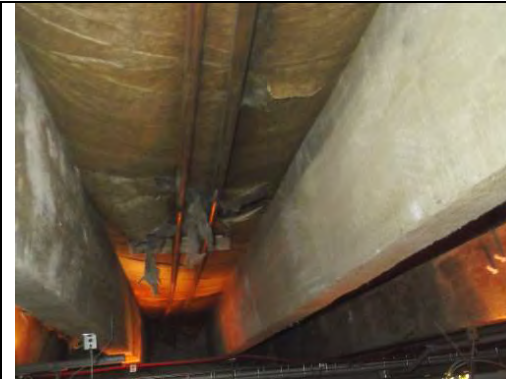
Building paper above suspended ceiling tiles  
CDCOTR/6  
NADIS

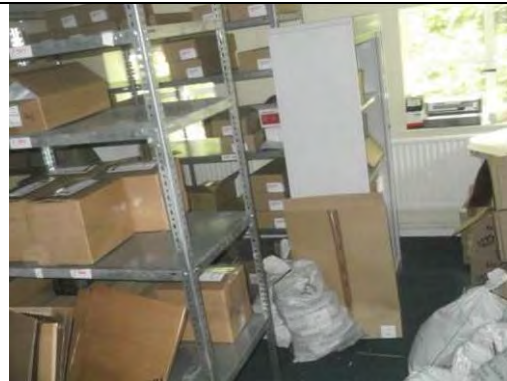
General view of 0.34

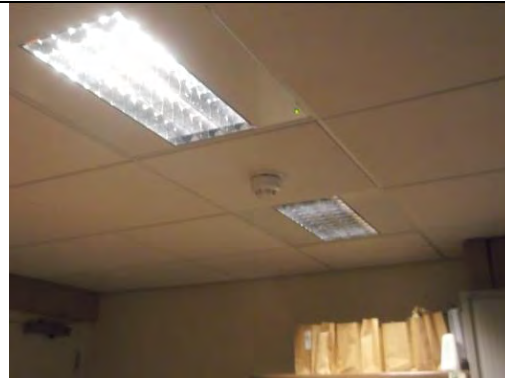
Modern non ACM suspended ceiling tiles

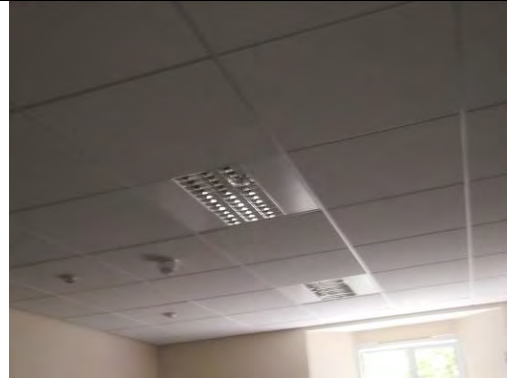
Modern non ACM suspended ceiling tiles

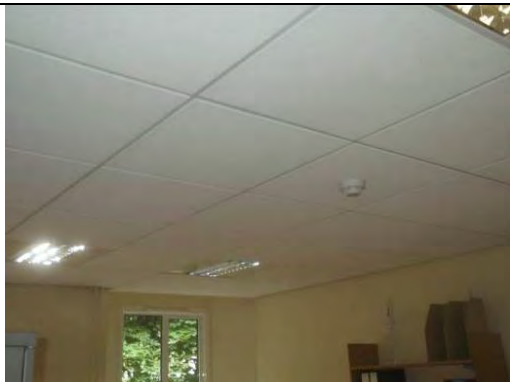
Modern non ACM suspended ceiling tiles

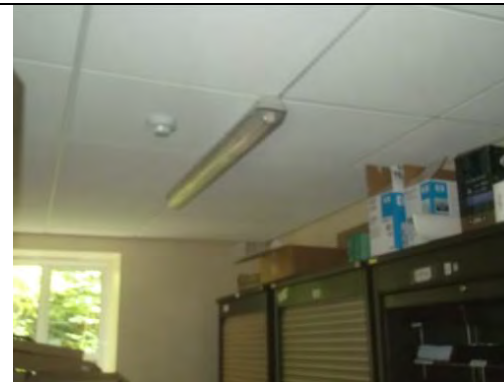
Modern non ACM suspended ceiling tiles

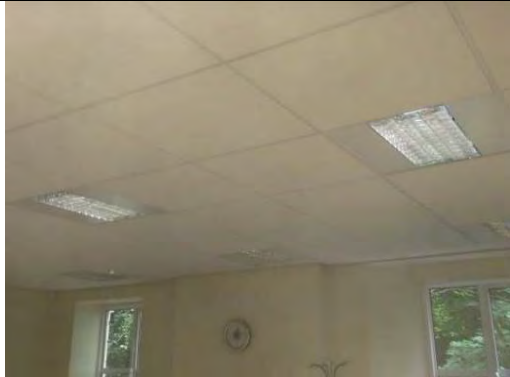
Modern non ACM suspended ceiling tiles and painted plastered walls

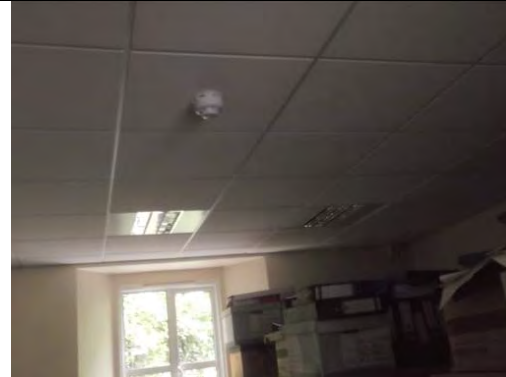
Modern non ACM suspended ceiling tiles and painted plastered walls

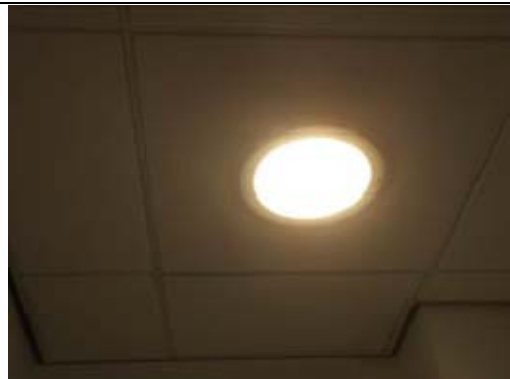
Modern non ACM suspended ceiling tiles

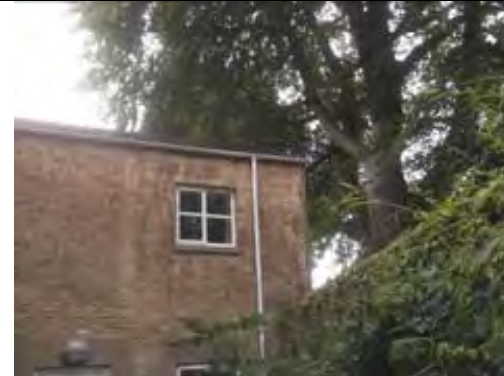
Plastic rainwater goods

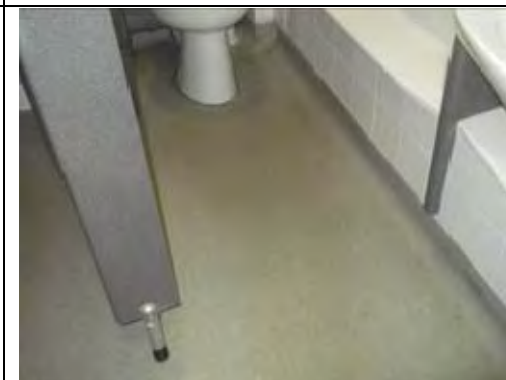
Modern non ACM flooring and modern non ACM toilet suite

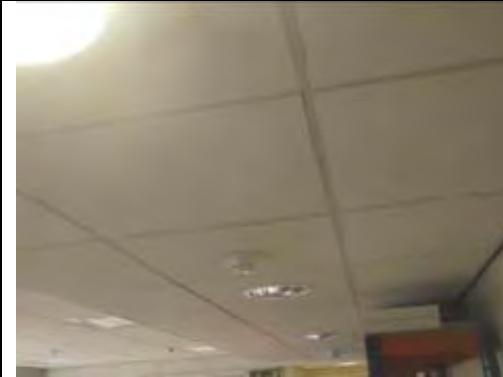
Modern non ACM suspended ceiling tiles

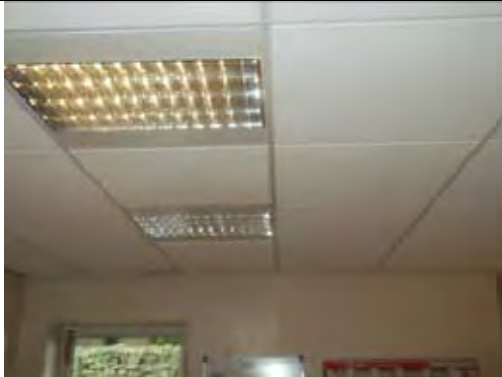
Modern non ACM suspended ceiling tiles and painted plastered walls

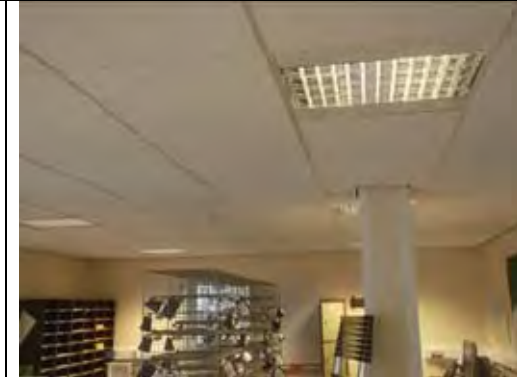
Modern non ACM suspended ceiling tiles and painted plastered walls

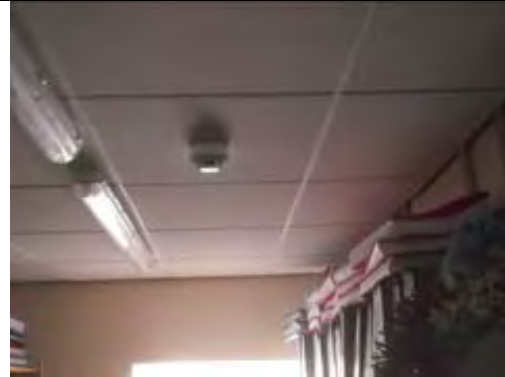
Modern non ACM suspended ceiling tiles and painted plastered walls

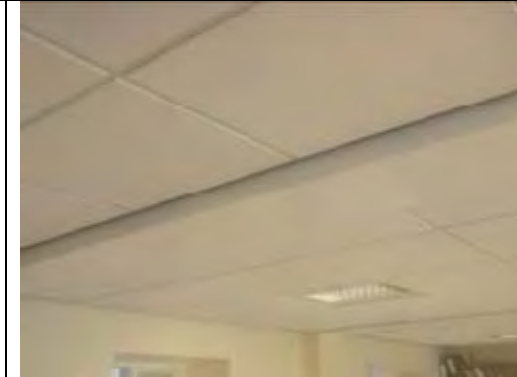
Modern non ACM suspended ceiling tiles and painted plastered walls

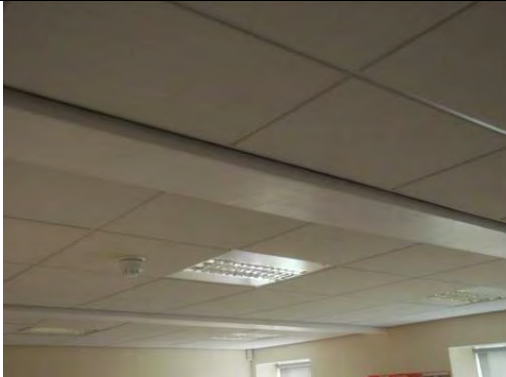
Modern non ACM suspended ceiling tiles

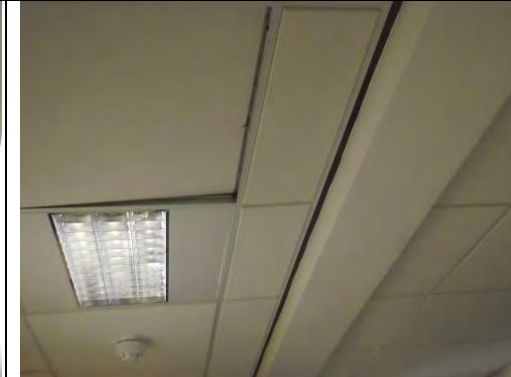
Modern non ACM suspended ceiling tiles

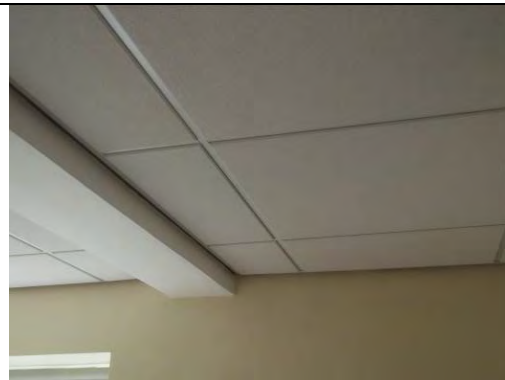
Modern non ACM suspended ceiling tiles and painted plastered walls

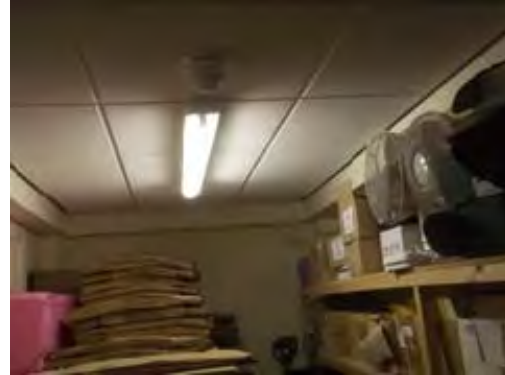
Modern non ACM suspended ceiling tiles and painted plastered walls

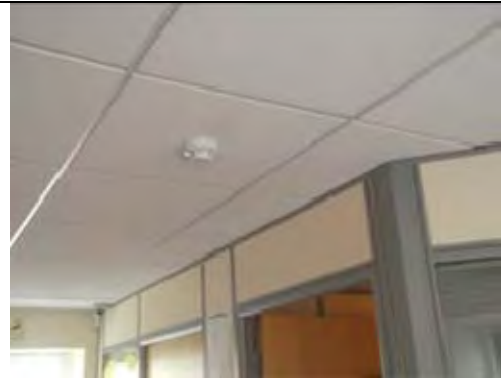
Modern non ACM suspended ceiling tiles

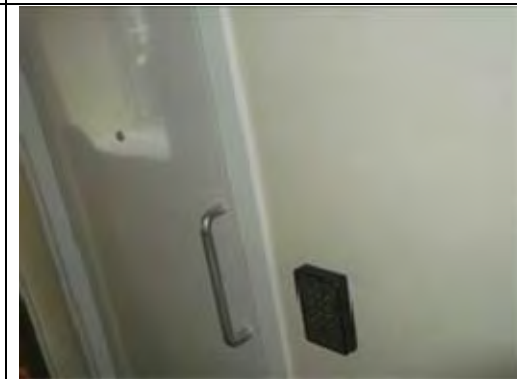
No access to 0.77

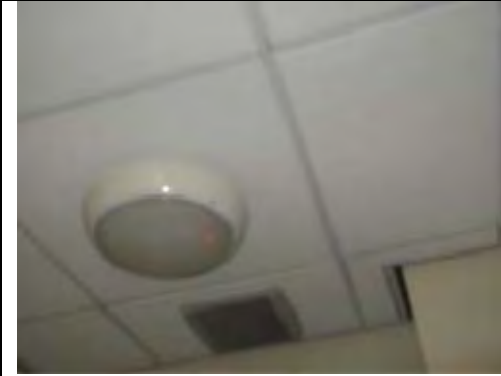
Modern non ACM suspended ceiling tiles

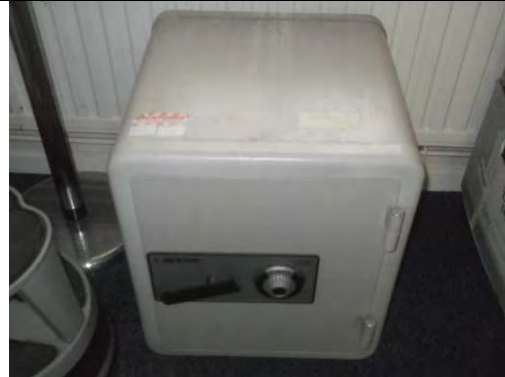
Presumed asbestos insulation board laminate  
to safe  
**Crocidolite**

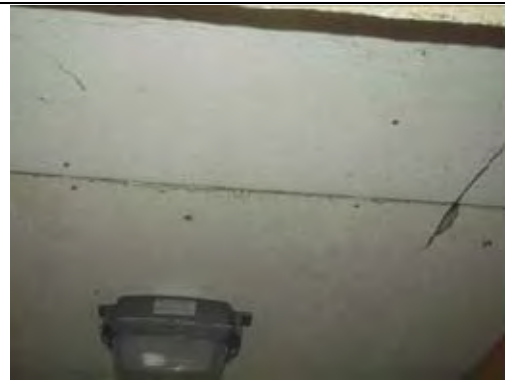
Insulation board  
CDCOT/8  
**NADIS**

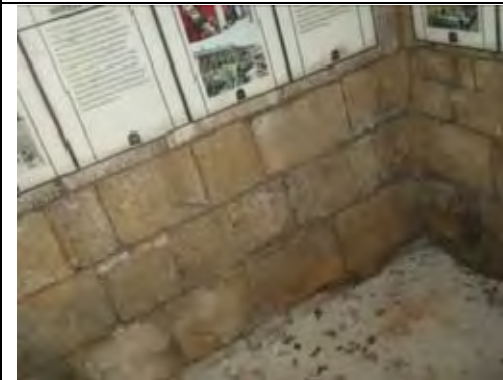
General view of Jail

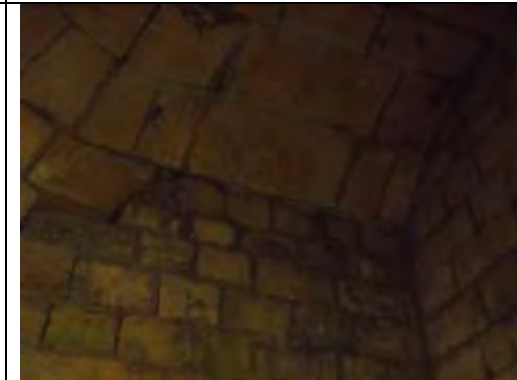
Stone walls

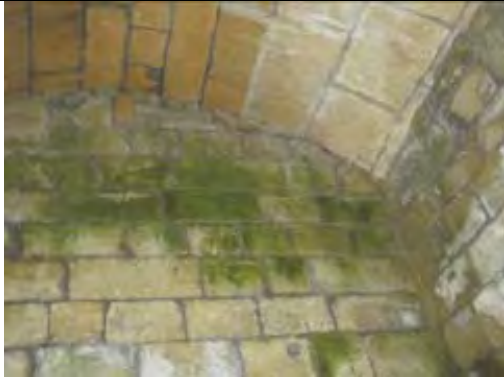
Stone vaulted ceiling

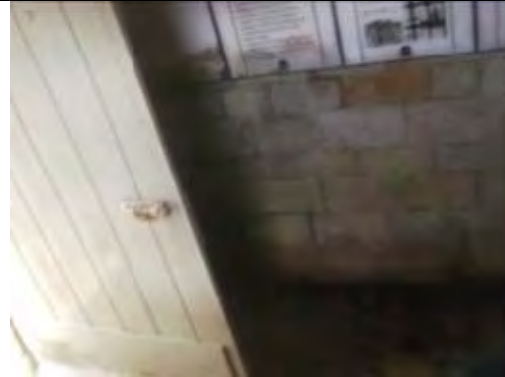
General view of Jail
