Management Asbestos Survey Report

**44 Black Jack Street
Cirencester
GL7 2AA**

**Cotswold District Council
Council Offices
Trinity Road
Cirencester
Gloucestershire
GL7 1PX**

Management Survey

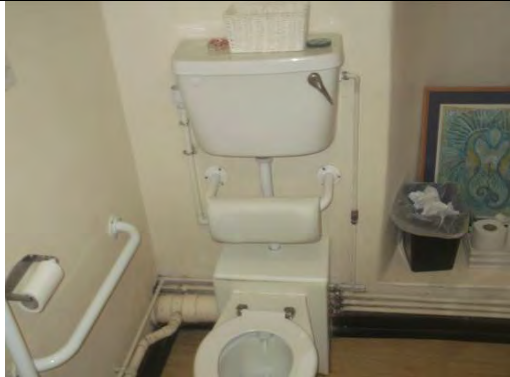
General view of WC. Modern non ACM toilet suite

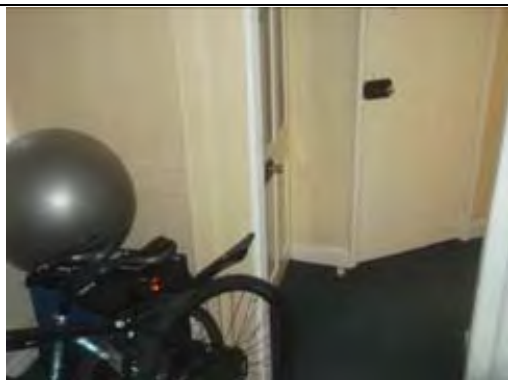
Hallway leading Room 3

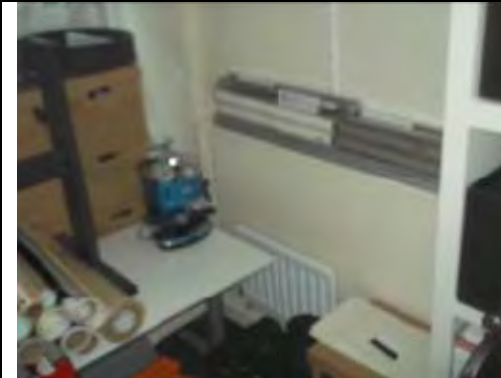
General view of Store

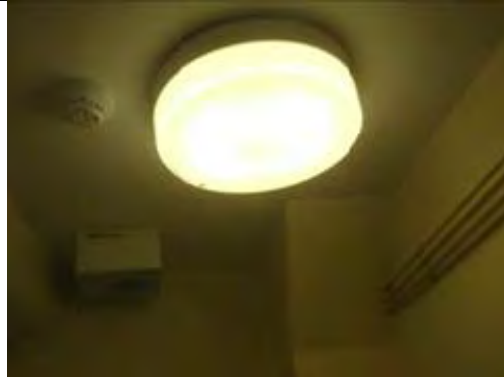
Painted plastered walls and painted plastered ceiling

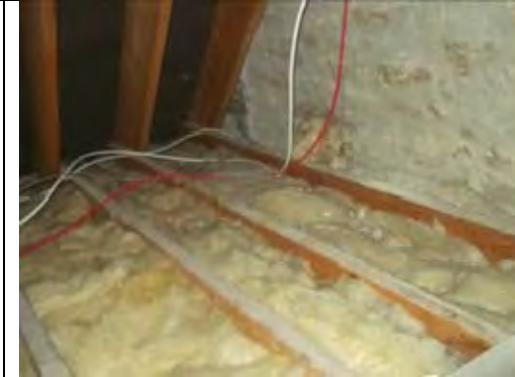
General view within Loft Space

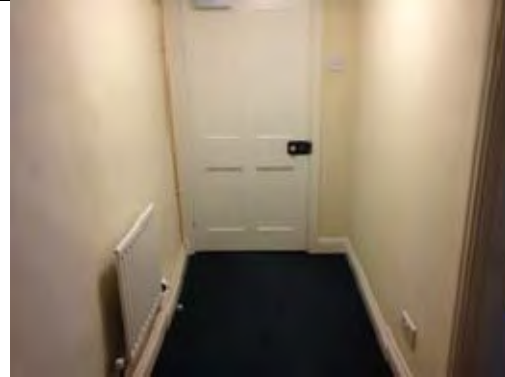
General view of Landing

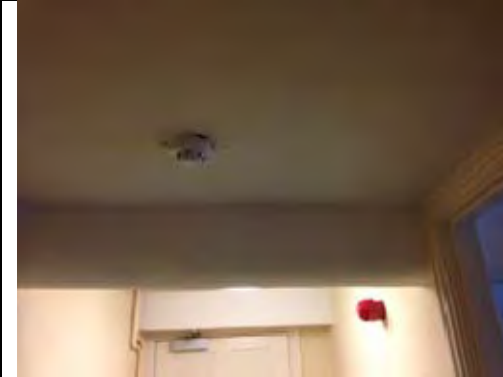
Painted plastered walls and painted plastered ceiling

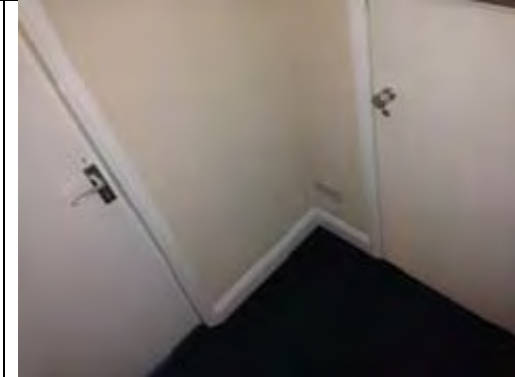
General view of Lobby

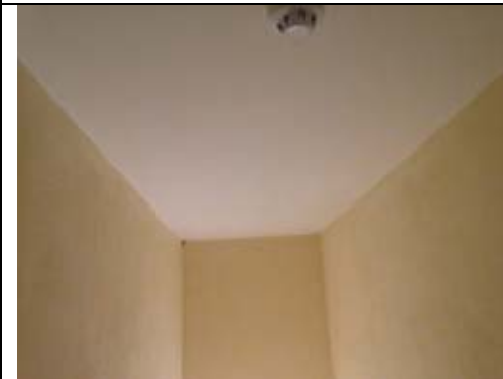
Painted plastered walls and ceiling

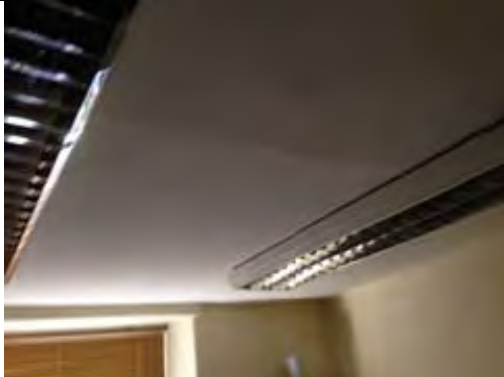
Painted plastered walls and painted plastered ceiling

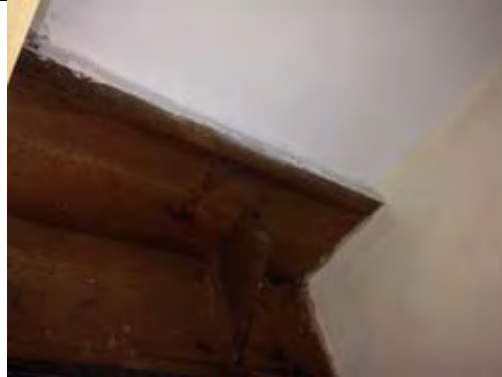
General view of Room 6

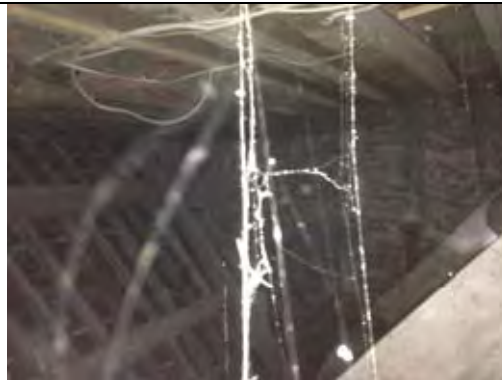
General view of Loft Space and non ACM roof

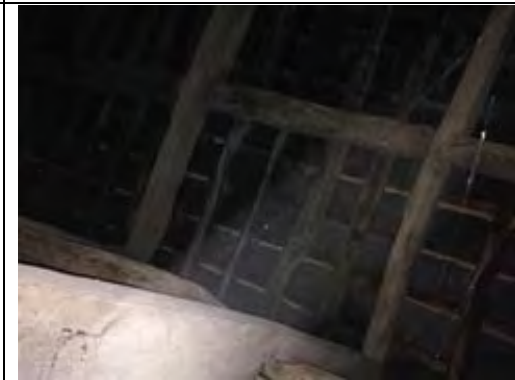
General view of Loft Space and non ACM roof
