## **Management Asbestos Survey Report**

**Abberley House  
Park Street  
Cirencester  
GL7 2BX**

**Cotswold District Council  
Council Offices  
Trinity Road  
Cirencester  
GL7 1PX**

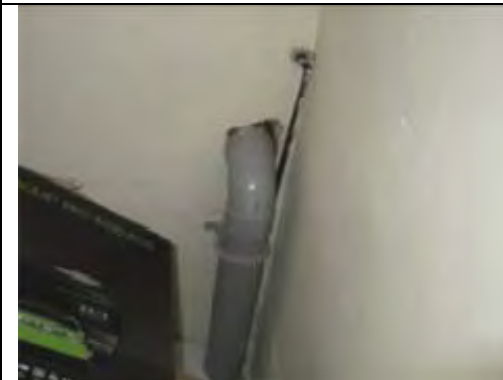
Insulation board  
AHC/8  
NADIS

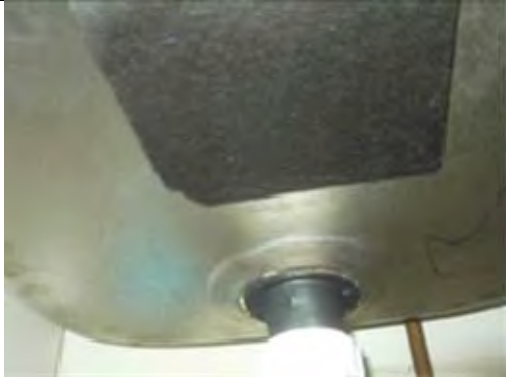
Sink pad  
AHC/9  
NADIS

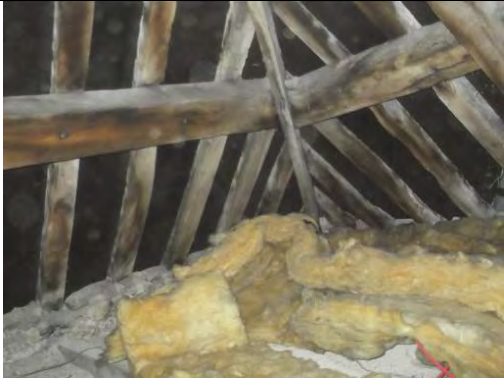
MMMMF insulation
